OCULAR INSPECTION CHECKLIST

1. Street Address of the School: State Road PR-632 Hato Viejo Ward
2. City: Ciales State: Puerto Rico Zip: 00638
3. School Name: Hato Viejo Cumbre
4. Date of inspection: January 22 - 2020
5. Inspector's Name: Jván D. Hernández González, PE-MEM

Escuela: Hato Viejo Cumbre

ANEJO A

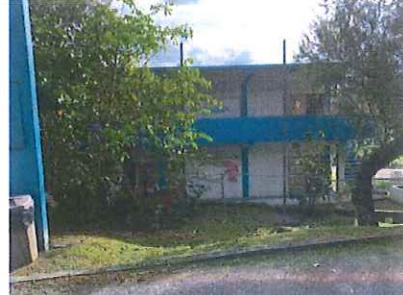
Edificio:	1

Descripción:	No se observaron daños.	
Edificio:	2	
Descripción:	No se observaron daños.	
Edificio:	3

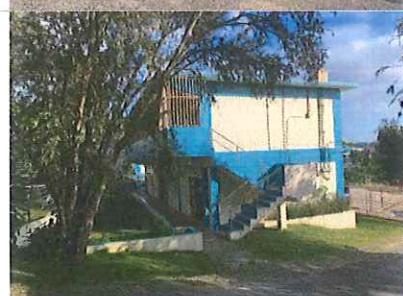
Descripción:	Se observaron daños significativos en el edificio.	
Edificio:	4

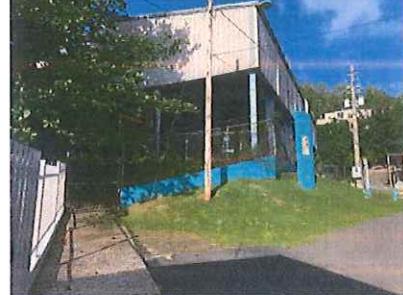
Descripción:	No se observaron daños.

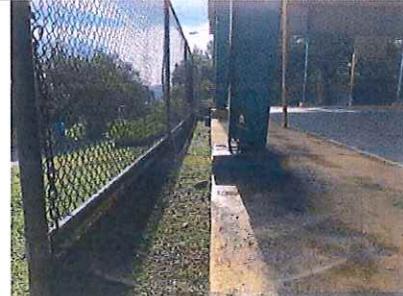
Edificio:	5

Descripción:	No se observaron daños.

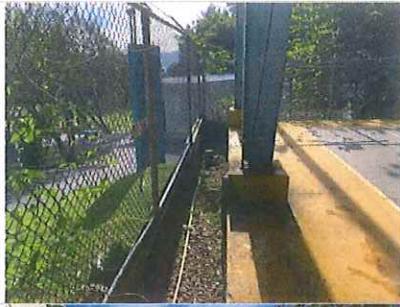
Edificio:	6

Descripción:	No se observaron daños. Soportes de acero bien en mal estado. Se requiere un análisis y/o correcciones en las piezas de acero estructural.		
Edificio:	7

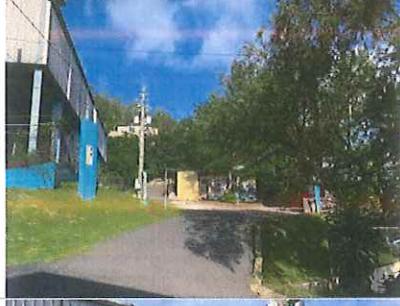
Descripción:	Se observaron daños significativos en el edificio.		
Edificio:	8

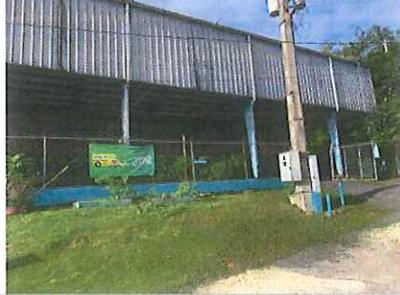
Descripción:	No se observaron daños.
