CARTA DE TRAMITE

Escuela: **Apolo San Antonio**

Código: **(71761)**

OCULAR INSPECTION CHECKLIST

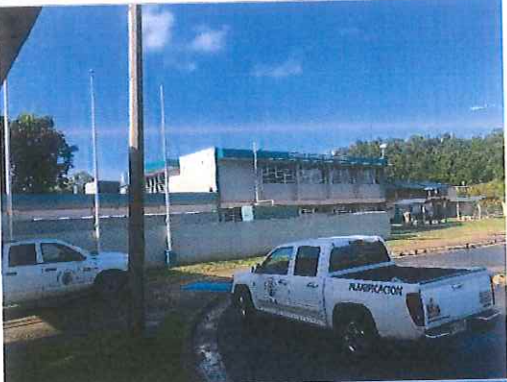
Edificio:	A

Descripción:	Visita del edificio A. No se observaron daños.	
Edificio:	B

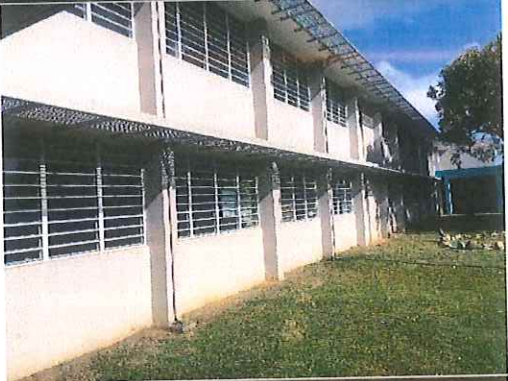
Descripción:	Visita del edificio B. No se observaron daños.	
Edificio:	Pasillo que conecta edif. B y edif. C

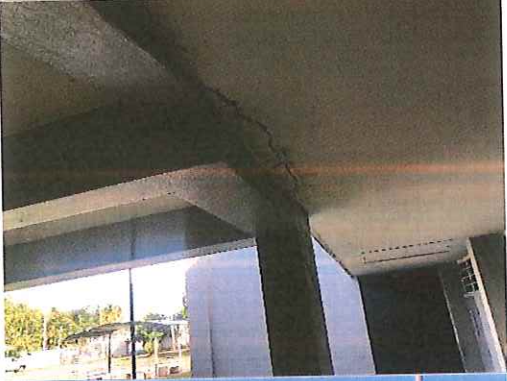
Descripción:	En la foto se observa una grieta en la losa que unen los dos edificios donde aparenta que no existía junta. Algo similar ocurre entre los edificios B y E.	
Edificio:	C

El material de las juntas de expansión entre estructuras está deteriorado debe reemplazarse.

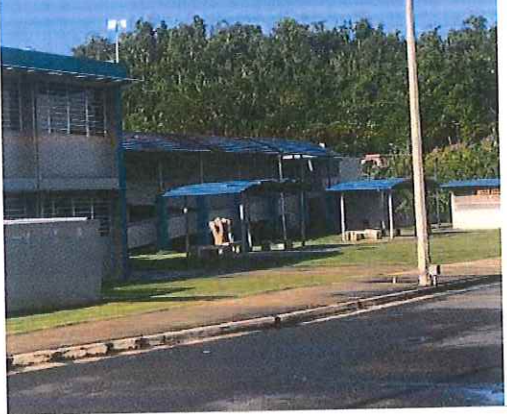
Descripción:	Visita del edificio C. No se observaron daños.

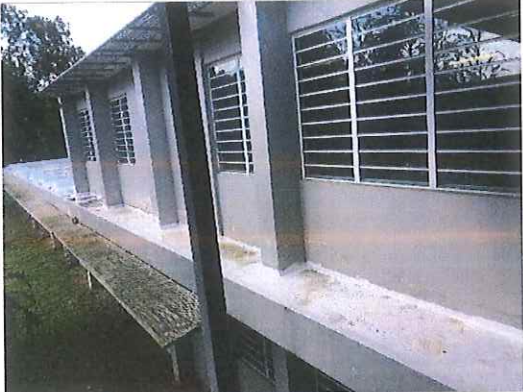
Edificio:	D

Descripción:	Visita del edificio D. No se observaron daños.	
Edificio:	Pasillo que conecta edif. D y edif. B

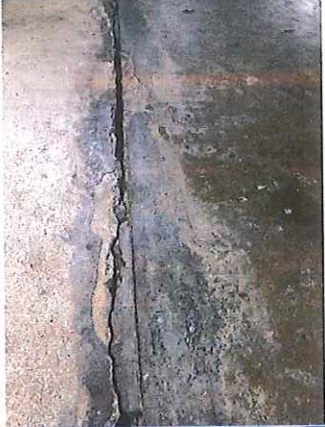
Descripción:	En la foto se observa la junta de expansión de la losa del pasillo donde se une el edificio D con el edificio B. No tiene el "joint cover plate". Algo similar ocurre entre los edificios B y E.	
Edificio:	E

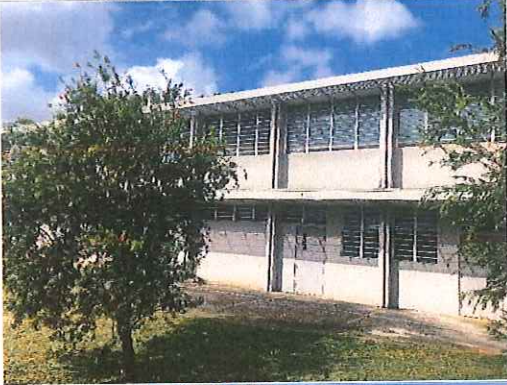
Descripción:	Visita del edificio E. No se observaron daños.	
Edificio:	F

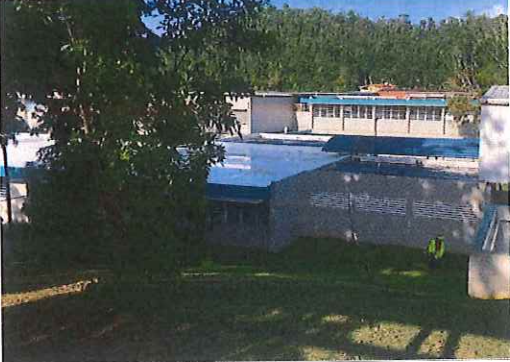
Descripción:	Vista del edificio F. No se observaron daños.

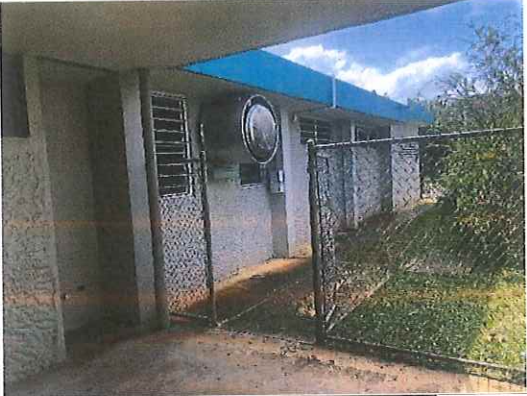
Descripción:	En la foto se observa que el sistema de extracción de la cocina pasa a través de la pared del edificio.	
Edificio:	F

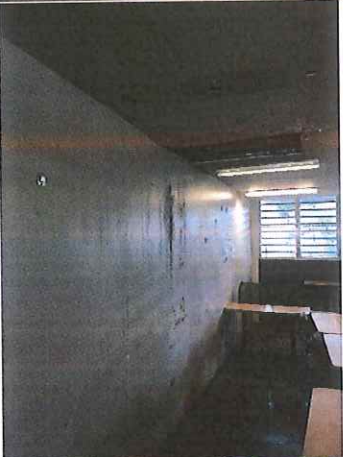
Descripción:	En la foto se observa que hay filtraciones en el techo del comedor de la escuela.	
Edificio:	G

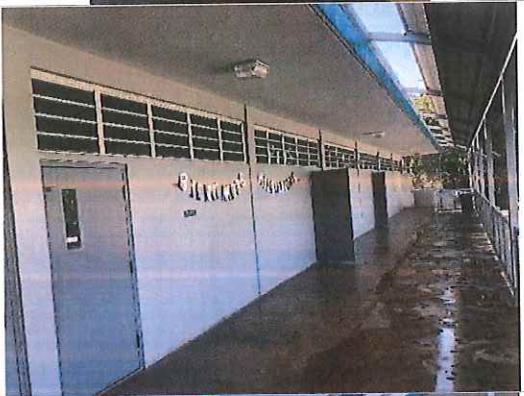
Descripción:	Vista del edificio G. No se observaron daños.	
Edificio:	G

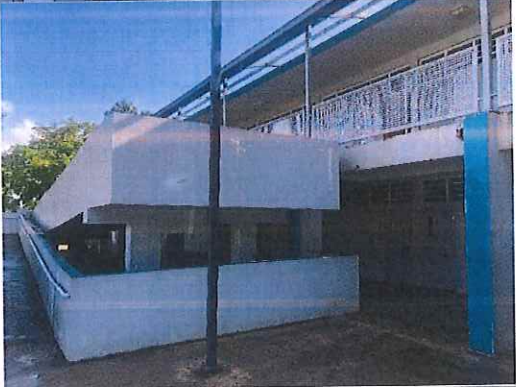
Descripción:	Vista del edificio G. No se observaron daños.

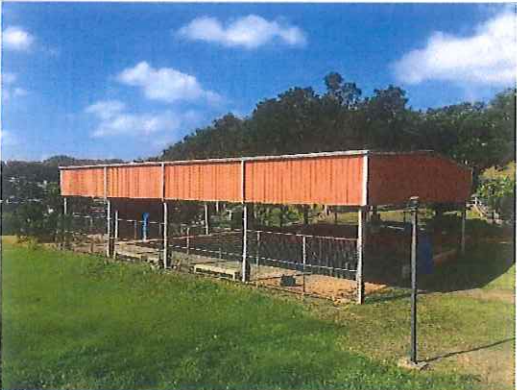
Edificio:	K

Descripción:	Vista del edificio K. No se observaron daños.	
Edificio:	L

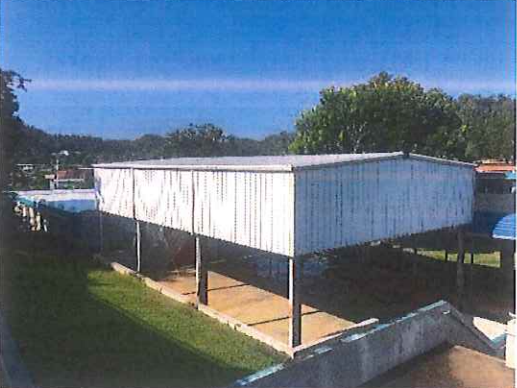
Descripción:	Vista del edificio H. No se observaron daños.
