## CARTA DE TRAMITE

Escuela: **Manuel Martinez Davila**

Código: **(72082)**

## OCULAR INSPECTION CHECKLIST

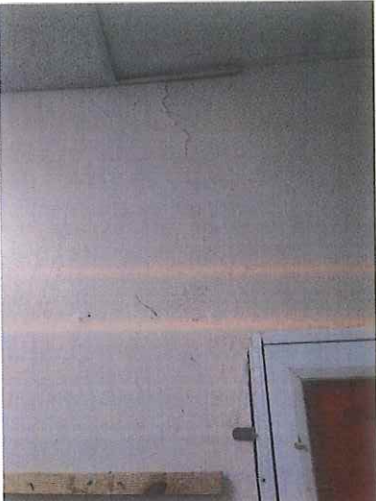
Descripción:	Aquí se observa una grieta vertical del empañetado de la pared, en la oficina administrativas.			
Edificio:	Principal

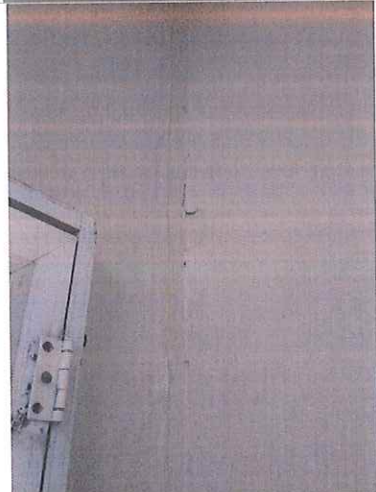
Descripción:	Aquí se observa una grieta vertical en la conexión de ambas paredes, al lado de la misma puerta de la foto anterior.			
Edificio:	Principal

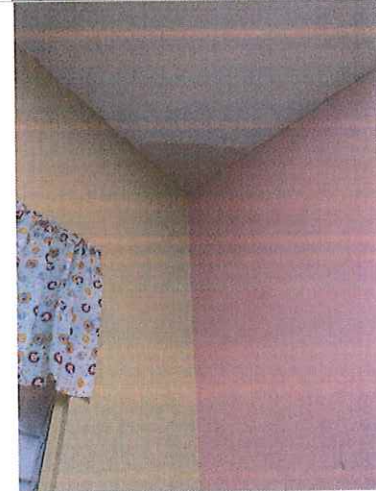
Descripción:	Empañetado despegado en la esquina salón de Kinder.

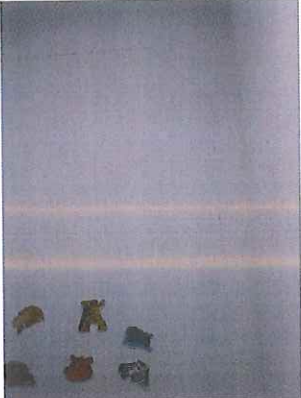
Edificio:	Principal		
Descripción:	Aquí se puede observar la grieta de la junta entre la pared de bloques y las columnas y viga preexistentes. Personal de la escuela nos notificaron que estos baños fueron contruidos el verano pasado. Se recomienda reparar la junta de inmediato.

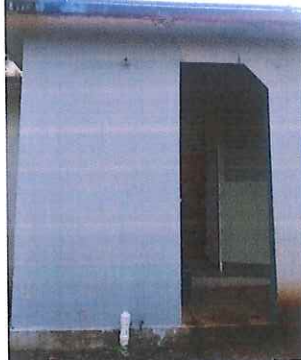
Edificio:	Principal		
Descripción:	Aquí se puede observar la misma grieta de la junta de la foto anterior, pero desde la parte de afuera. Se recomienda reparar la junta de inmediato.

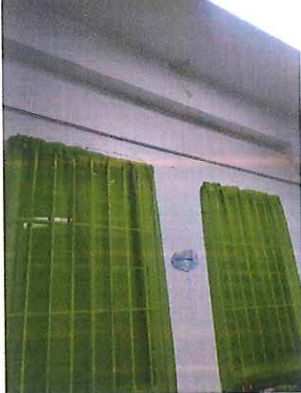
Edificio:	Principal		
Descripción:	Aquí se puede observar una grieta horizontal superficial, la cual responde a la mocheta de las ventanas. Se recomienda reparar la junta de inmediato.

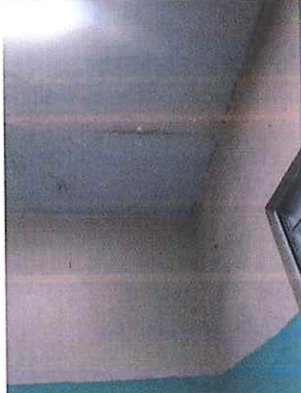
Edificio:	Principal		
Descripción:	Aquí observamos grieta horizontal en el plafón a causa de la filtración. Esto se encuentra en el salón de Terapia del Habla.

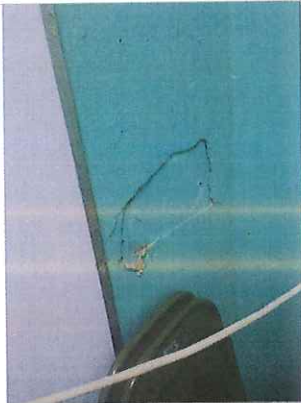
Edificio:	Principal		
Descripción:	Aquí se observa un pedazo de pared la cual fue reparada con madera y empañetado en donde parte del empañetado se despegó.

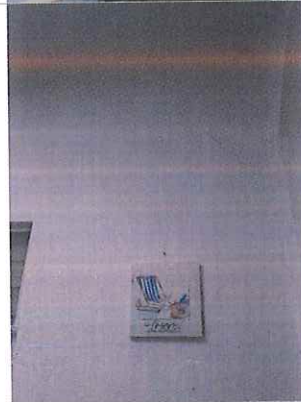
Edificio:	Principal		
Descripción:	Aquí podemos ver una grieta a causa de la junta entre la pared construida y su columna y viga. Esto se encuentra en la oficina de la Trabajadora Social.

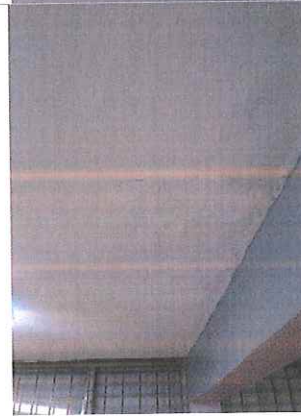
Edificio:	Edificio Ala Nueva mano derecha		
Descripción:	Se observa manchas de humedad en el techo interior.

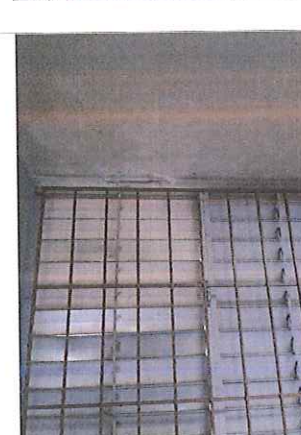
Edificio:	Edificio Ala Nueva mano derecha		
Descripción:	Se observa manchas de humedad en el techo interior.

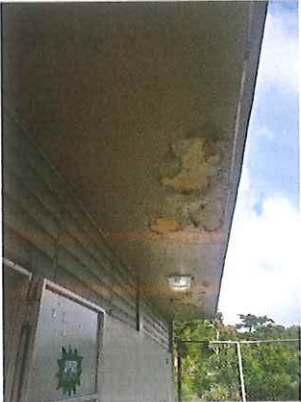
<b>Descripción:</b>	En la foto podemos ver el problema grande de humedad que tiene la estructura.		
<b>Edificio:</b>	Edificio Posterior

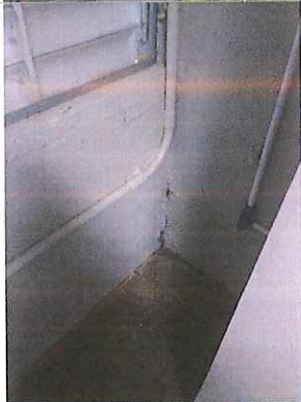
<b>Descripción:</b>	En la foto se puede apreciar una grieta entre ambas paredes y luego entre pared y piso. La misma fue identificada por el personal como preexistente.		
<b>Edificio:</b>	Edificio Posterior

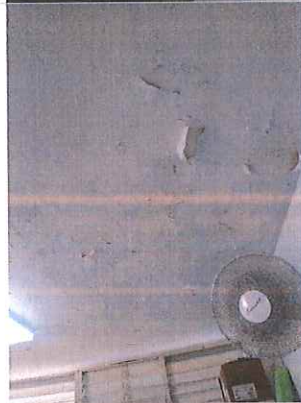
<b>Descripción:</b>	Seguimos observando humedad en los plafones. Esto es en el salón de inglés de 8vo grado.		
<b>Edificio:</b>	Edificio Posterior

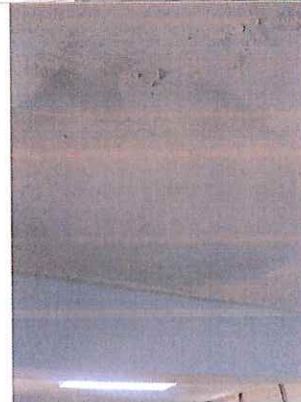
<b>Descripción:</b>	Aquí podemos observar un área de empañetado del plafón reparada, pero al no corregir el problema de filtración vemos como el área que ya fue empañetada comienza nuevamente a agrietarse.

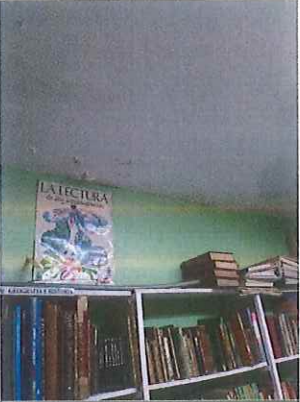
Edificio:	Edificio a la Izquierda		
Descripción:	Aquí podemos observar el continuo problema de humedad en el plafón de la biblioteca.

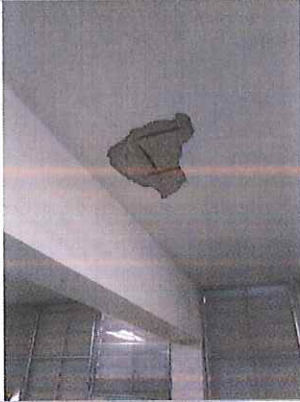
Edificio:	Edificio a la Izquierda		
Descripción:	Podemos ver como a causa de la humedad y las filtraciones la varilla del techo se oxidó e hizo que el empañetado y parte de hormigón se desprendieran. Recomendamos llevar a cabo la reparación de forma inmediata incluyendo corregir impermeabilización del techo.		 
Edificio:	Edificio del Frente		
Descripción:	Similar a la foto anterior ocurrió en el salón de español del 8vo grado. Recomendamos llevar a cabo la reparación de forma inmediata incluyendo corregir impermeabilización del techo.

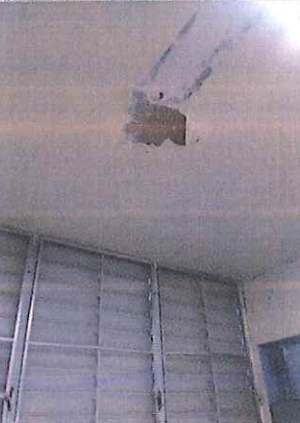
Edificio:	Edificio del Frente		
Descripción:	También se identificaron muestras en la pintura de humedad y filtraciones en el techo en el salón de español de 8vo grado.

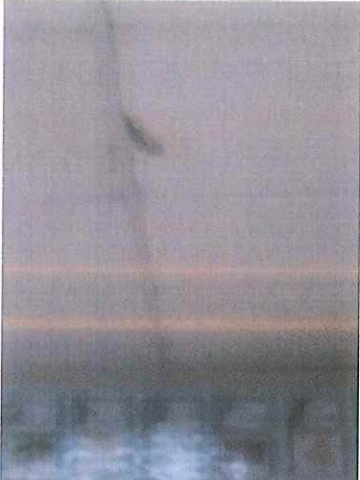
Edificio:	Vagón		
Descripción:	Aquí presentamos una foto que demuestra problemas de filtración en el salón que se encuentra dentro del vagón.
