## CARTA DE TRAMITE

Escuela: **Esperanza González**

Código: **(12260)**

## OCULAR INSPECTION CHECKLIST

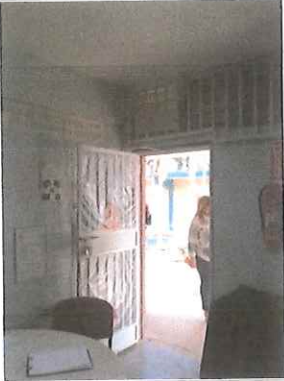
Edificio:	1	
Descripción:	<p>No se observaron daños en el edificio. Sin embargo, se recomienda atender problemas de humedad.</p> <p><b><u>NO RELACIONADO AL EVENTO SISMICO</u></b></p>

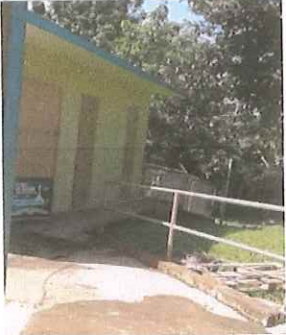
1a	
	<p>No se observaron daños relacionados a la actividad sísmica.</p> <p><b><u>NO RELACIONADO AL EVENTO SISMICO</u></b></p>

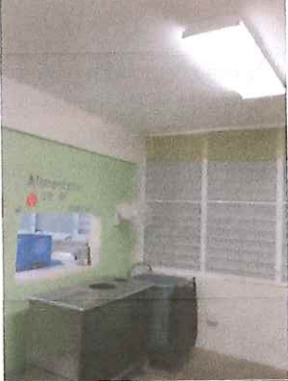
Edificio:	2	
Descripción:	<p>No se observaron daños estructurales.</p> <p><b><u>NO RELACIONADO AL EVENTO SISMICO</u></b></p>

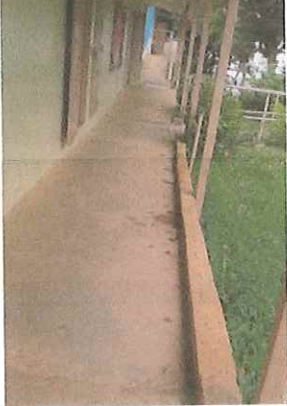
<p>No hay daños estructurales.</p> <p><b><u>NO RELACIONADO AL EVENTO SISMICO</u></b></p>

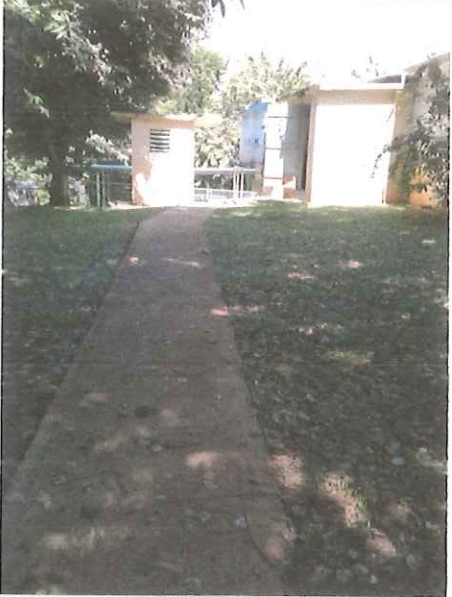
<p>Edificio: 3a</p> <p>Descripción: No se observaron daños.</p> <p><b><u>NO RELACIONADO AL EVENTO SISMICO</u></b></p>
