OCULAR INSPECTION CHECKLIST

1. **Street Address of the School:** Carr. 155, Km. 34, Hm. 1 Bo. Gato
- City:** Orocovis **State:** Puerto Rico **Zip:** 00720
2. **School Name:** Visitación Paqán Aponte
3. **Date of inspection:** January 15, 2020
4. **Inspector's Name:** Edgardo Hernández-Alvarado

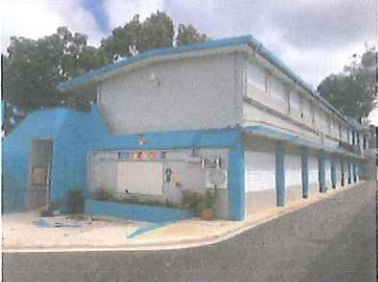
Edificio: 1			
Descripción:	No se observaron daños que pudieran ser relacionados al evento sísmico. Grietas menores y empañetado afectado previo al Terremoto.

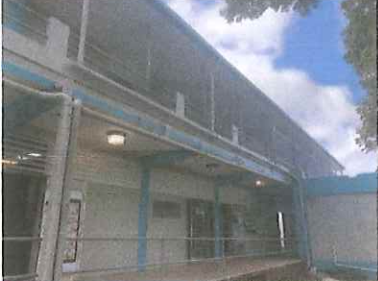
Edificio: 1			
Descripción:	No se observaron daños que pudieran ser relacionados al evento sísmico. Grietas menores y empañetado afectado previo al Terremoto.

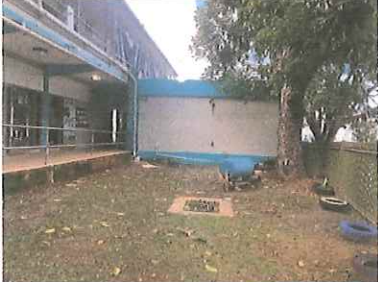
Edificio: 1			
Descripción:	No se observaron daños que pudieran ser relacionados al evento sísmico. Grietas menores y empañetado afectado previo al Terremoto.

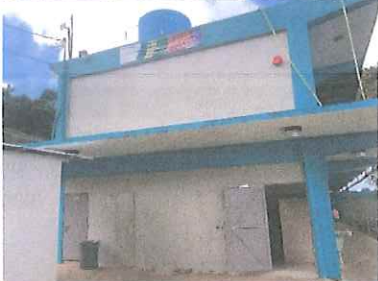
Edificio: 1			
Descripción:	No se observaron daños que pudieran ser relacionados al evento sísmico. Grietas menores y empañetado afectado previo al Terremoto.

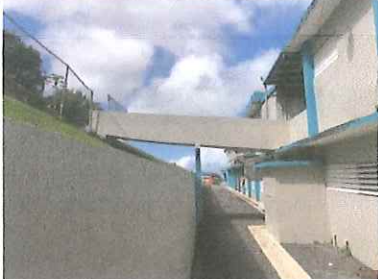
Edificio: 1			
Descripción:	No se observaron daños que pudieran ser relacionados al evento sísmico. Grietas menores y empañetado afectado previo al Terremoto.

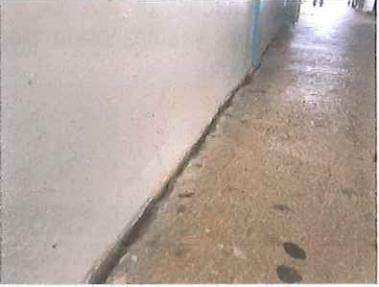
Edificio:	1		
Descripción:	Se identificó separación de acera y pared del primer nivel. Mencionado daño es previo el Terremoto.

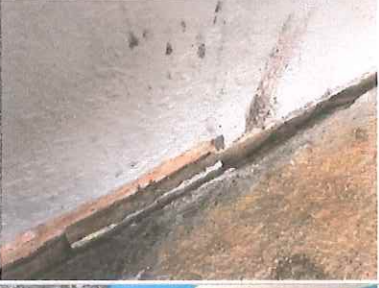
Edificio:	1		
Descripción:	Se identificó separación de acera y pared del primer nivel. Mencionado daño es previo el Terremoto.

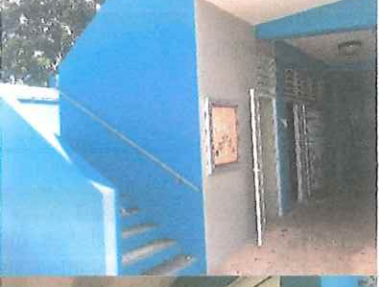
Edificio:	1		
Descripción:	No se observaron daños que pudieran ser relacionados al evento sísmico. Grietas menores y empañetado afectado previo al Terremoto.

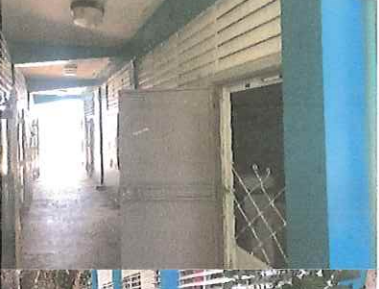
Edificio:	1		
Descripción:	No se observaron daños que pudieran ser relacionados al evento sísmico. Grietas menores y empañetado afectado previo al Terremoto.

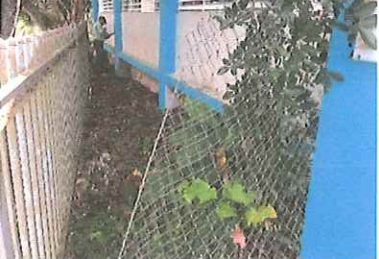
Edificio:	1		
Descripción:	No se observaron daños que pudieran ser relacionados al evento sísmico. Grietas menores y empañetado afectado previo al Terremoto.

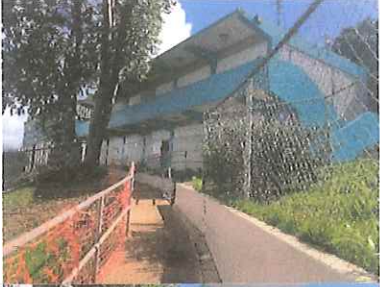
Edificio: 2			
Descripción:	No se observaron daños que pudieran ser relacionados al evento sísmico. Grietas menores y empañetado afectado previo al Terremoto.

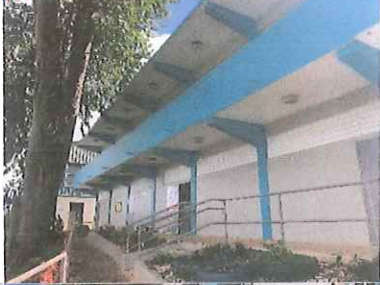
Edificio: 2			
Descripción:	No se observaron daños que pudieran ser relacionados al evento sísmico. Grietas menores y empañetado afectado previo al Terremoto.

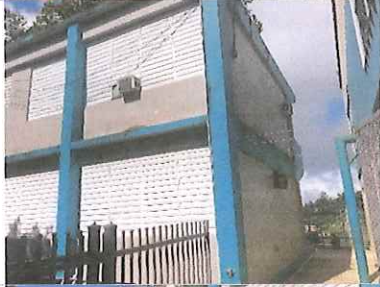
Edificio: 2			
Descripción:	No se observaron daños que pudieran ser relacionados al evento sísmico. Grietas menores y empañetado afectado previo al Terremoto.

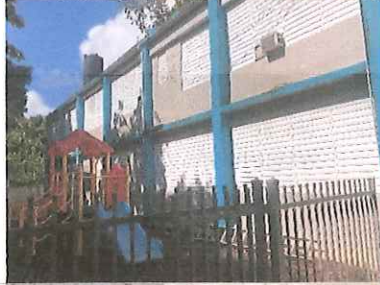
Edificio: 2			
Descripción:	No se observaron daños que pudieran ser relacionados al evento sísmico. Grietas menores y empañetado afectado previo al Terremoto.

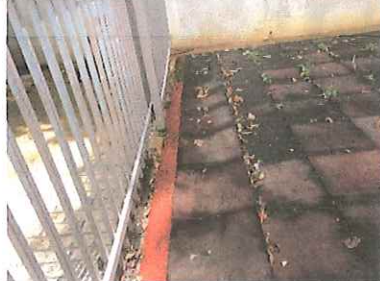
Edificio: 2			
Descripción:	Se identificó "Pad" en Corcho levantado en área de juego de niños. Posible riesgo a la seguridad de los ocupantes.

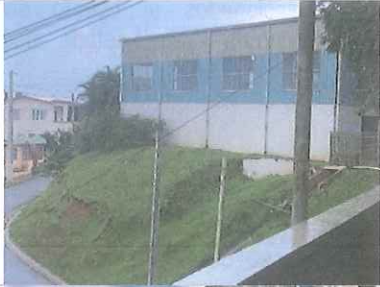
Descripción:	No se observaron daños que pudieran ser relacionados al evento sísmico.		
Edificio:	Cancha Bajo Techo

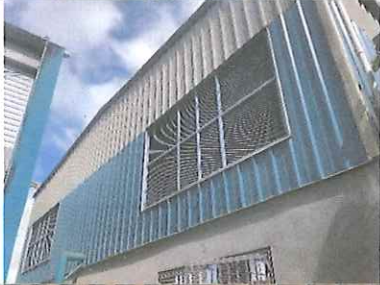
Descripción:	No se observaron daños que pudieran ser relacionados al evento sísmico.		
Edificio:	Cancha Bajo Techo

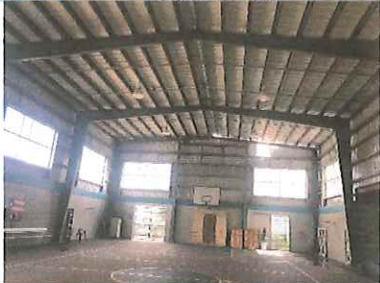
Descripción:	No se observaron daños que pudieran ser relacionados al evento sísmico.		
Edificio:	Cancha Bajo Techo

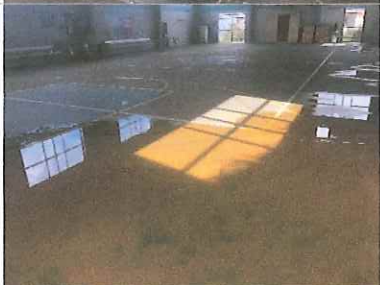
Descripción:	No se observaron daños que pudieran ser relacionados al evento sísmico. Cancha presenta filtraciones a través de la pared que la separa de la propiedad colindante por el sur donde existe un muro de contención		
Edificio:	Cancha Bajo Techo

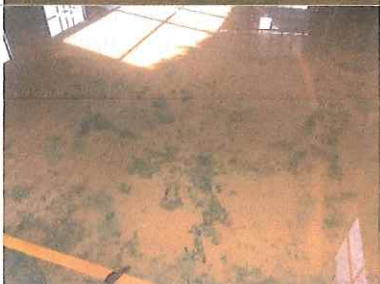
Descripción:	No se observaron daños que pudieran ser relacionados al evento sísmico. Cancha presenta filtraciones a través de la pared que la separa de la propiedad colindante por el sur donde existe un muro de contención

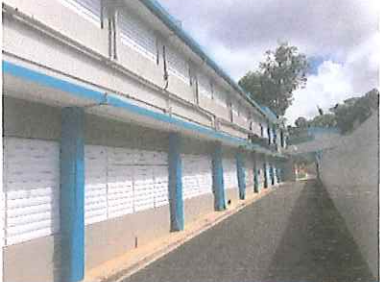
Descripción:	No se observaron daños que pudieran ser relacionados al evento sísmico. Se identificó que muro de contención se encuentra entre 2-4 grados de inclinación frontal. Directora indica que la causa fue las raíces de unas palmas que ya fueron removidas.		
Edificio:	Muro de Contención

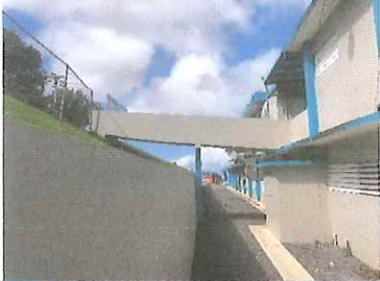
Descripción:	No se observaron daños que pudieran ser relacionados al evento sísmico. Se identificó que muro de contención se encuentra entre 2-4 grados de inclinación frontal. Directora indica que la causa fue las raíces de unas palmas que ya fueron removidas.		
Edificio:	Muro de Contención

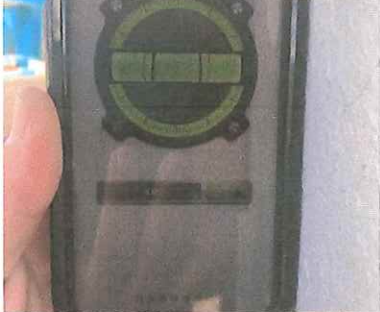
Descripción:	No se observaron daños que pudieran ser relacionados al evento sísmico. Se identificó que muro de contención se encuentra entre 2-4 grados de inclinación frontal. Directora indica que la causa fue las raíces de unas palmas que ya fueron removidas		
Edificio:	Muro de Contención

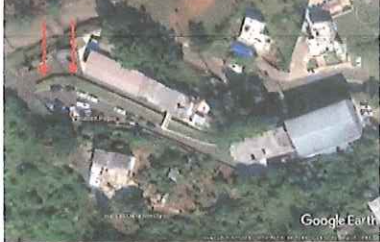
Descripción:	Ubicación dell daño en muro de contención.		
Edificio:	Muro de Contención

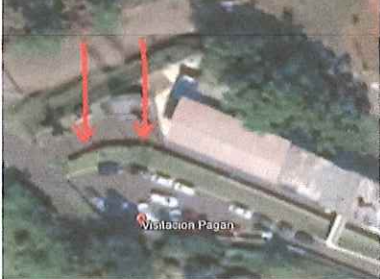
Descripción:	Ubicación dell daño en muro de contención.
