CARTA DE TRAMITE

Escuela: Julio Ressy

Código: (70292)

OCULAR INSPECTION CHECKLIST

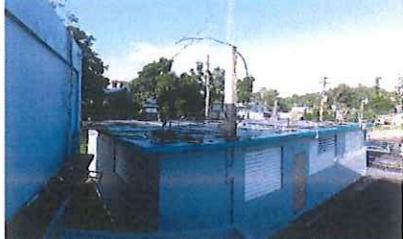
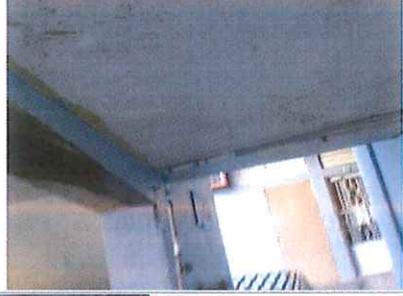
Edificio:	1

Descripción:	No se observaron daños en el edificio. Sin embargo, se recomienda atender problemas de humedad. <u>NO RELACIONADO AL EVENTO SISMICO</u>

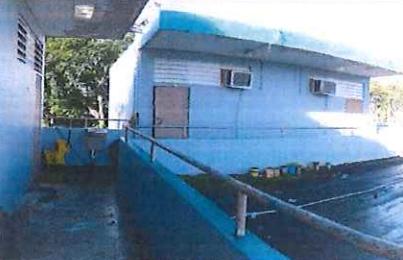
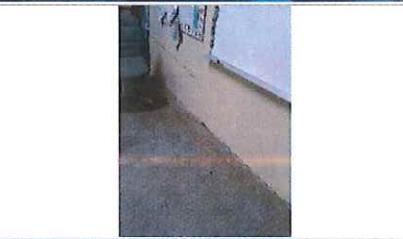
Edificio:	2

Descripción:	No se observaron daños estructurales. Sin embargo, se recomienda verificar las escaleras y atender problemas de humedad, grietas no estructurales en el techo y pedazos de empañetado de plafón de techo desprendidos.

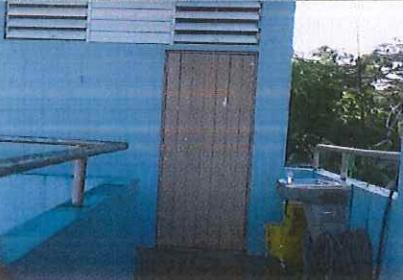
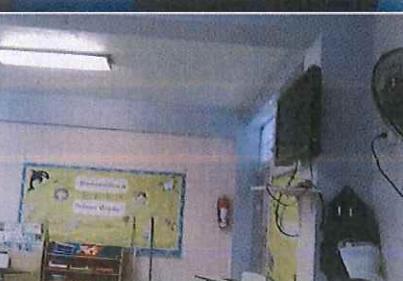
Edificio:	3

Descripción:	No se observaron daños estructurales. <u>NO RELACIONADO AL EVENTO SISMICO</u>

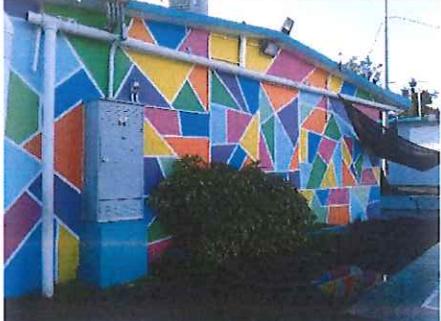
Edificio: 4 Descripción: No se observaron daños estructurales. <u>NO RELACIONADO AL EVENTO SISMICO</u>

Deben verificar problema generalizado de humedad en todo el plantel. <u>NO RELACIONADO AL EVENTO SISMICO</u>

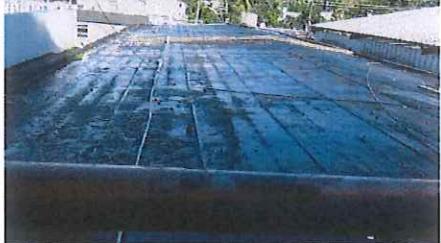
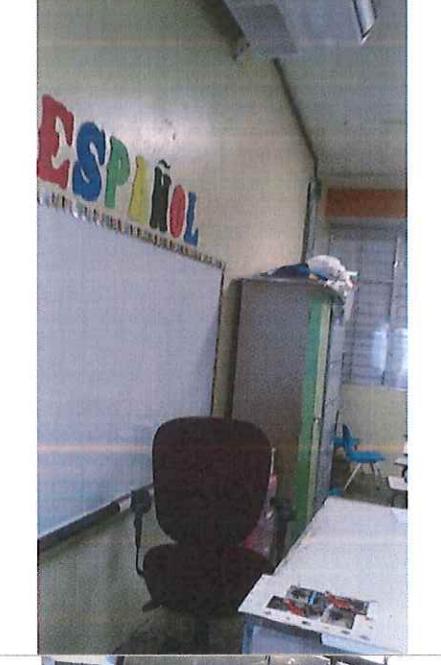
No se observaron daños estructurales. <u>NO RELACIONADO AL EVENTO SISMICO</u>

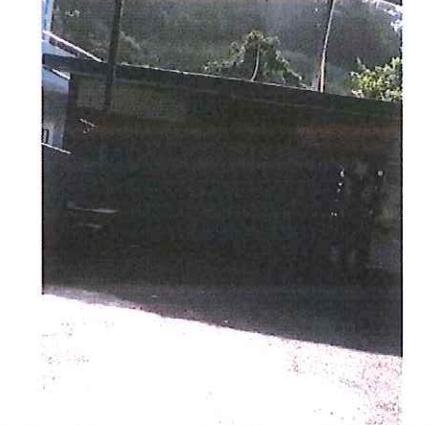
Edificio: 5 Descripción: No se observaron daños estructurales. Lo que hay son problemas de humedad y empozamiento de aguas. <u>NO RELACIONADO AL EVENTO SISMICO</u>

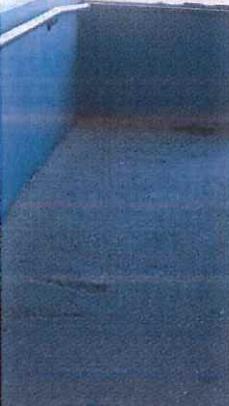
Deficiencias en la superficie de la rampa. <u>NO RELACIONADO AL EVENTO SISMICO</u>

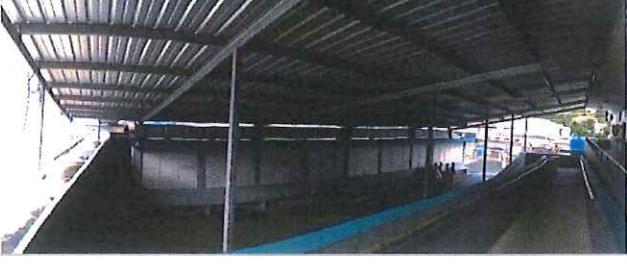
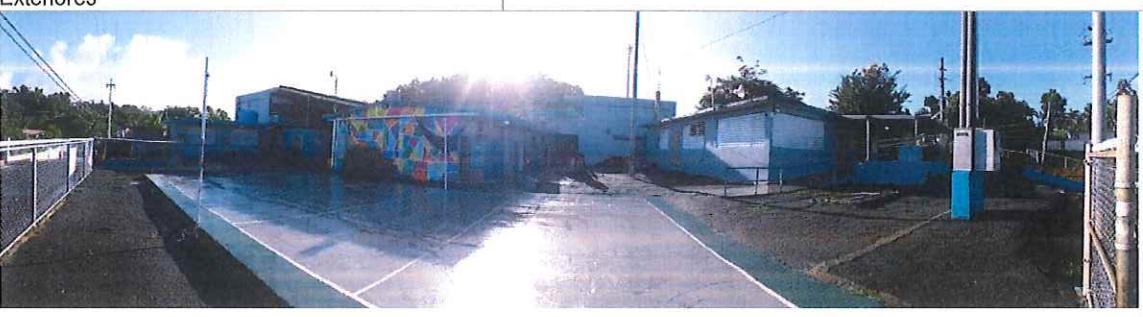
Exteriores Se revisaron todos los alrededores de las facilidades sin encontrar rasgos de fallas por causa del terremoto. Lo que encontramos muy evidente ha sido el problema de humedad, deficiencias en los drenajes en los techos y luego en las superficies sobre terreno.

<u>NO RELACIONADO AL EVENTO SISMICO</u>
