CARTA DE TRAMITE

Escuela: BA Miguel A. Julia Collazo

Municipio: Cayey

OCULAR INSPECTION CHECKLIST

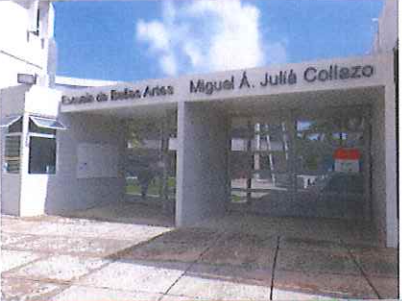
| Edificio: | 1 | |

| Descripción: | No se observaron daños. | |

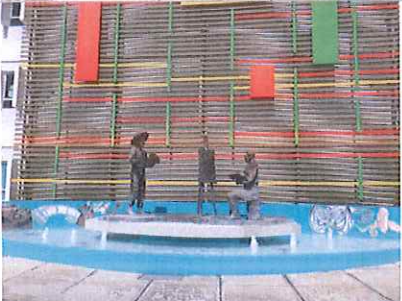
| Edificio: | 1 | |

| Descripción: | No se observaron daños. | |

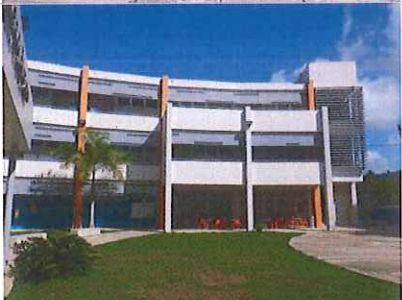
| Edificio: | 1 | |

| Descripción: | No se observaron daños. | |

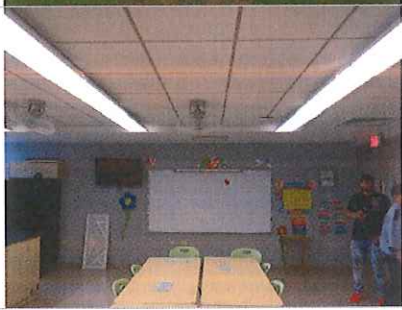
| Edificio: | 2 | |

| Descripción: | No se observaron daños. | |

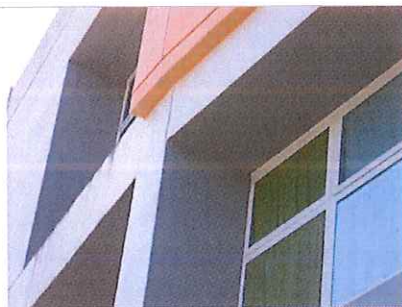
| Edificio: | 3 | |

No obstante en el edificio # 3 de acuerdo al Key Plan que tiene 3 niveles, hay una columna que muestra grietas en el exterior y las mismas continuan al interior.

| Descripción: | No se observaron daños, Excepto en el piso # 3 en el cual hay una columna agrietada y la Grieta se extiende al interior. (Ver fotos) Recomiendo que la misma sea inspeccionada por un ingeniero estructural para que determine, que peligrosidad ofrece y que se debe hacer para repararla. | |

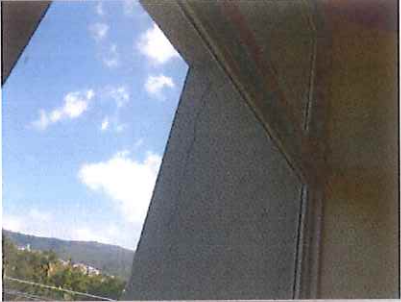
| Edificio: | 3 | | |

| Descripción: | Fotos adicionales de la columna, desde adentro hacia afuera. | | |
