## CARTA DE TRAMITE

Escuela: **Pedro Bosch Salgas**

Código: **(30643)**

OCULAR INSPECTION CHECKLIST

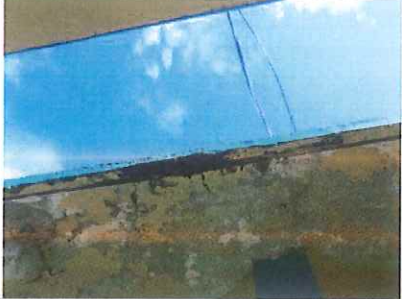
Edificio:	1

Edificio 1- Salones de clases. No muestra daños en sus elementos estructurales. Tiene un desprendimiento en el alero que se observa que lleva tiempo.

Descripción:	Ejemplo de área desprendida por filtración de agua. Se recomienda reparación de estas. Están con limo y sucio representa llevan tiempo en el edificio.
