CARTA DE TRAMITE

Escuela: La Fermina

Municipio: Las Piedras

OCULAR INSPECTION CHECKLIST

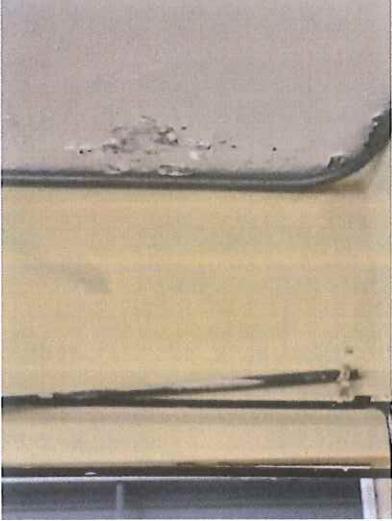
Edificio:	8		
Descripción:	La foto presenta evidencia de humedad (preexistente) en el plafón del comedor. Esta condición es prácticamente en toda la parte del plafón del lado de las ventanas.

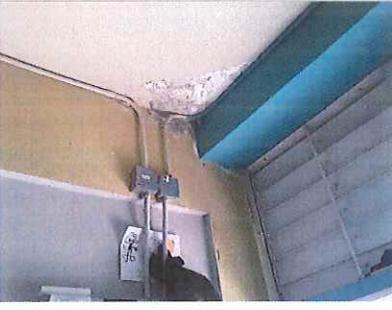
Edificio:	8		
Descripción:	La foto muestra la humedad (preexistente) en el plafón en la esquina de la entrada del salón s-1-11-07

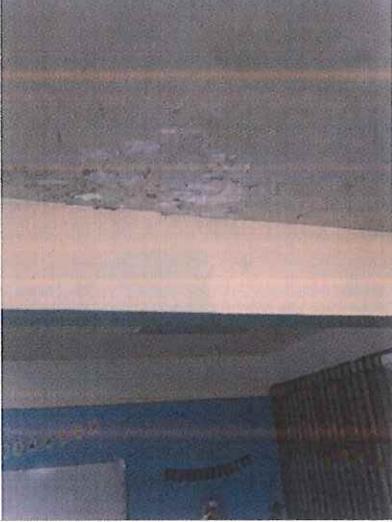
Edificio:	8		
Descripción:	Evidencia de filtración (preexistente) en el segundo piso salón S-2-05-07

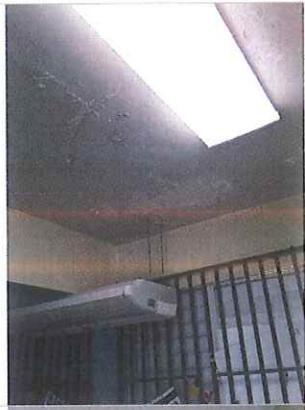
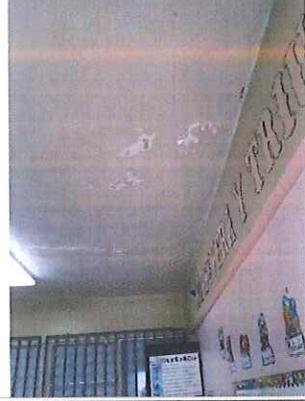
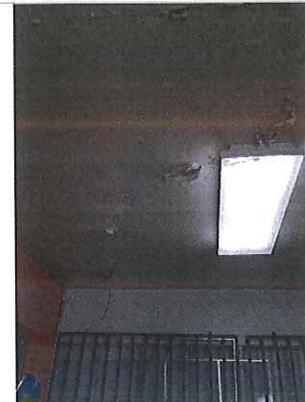
Descripción:	Filtraciones preexistentes en el salón S-2-05-07.	
Edificio:	8	
Descripción:	Filtraciones preexistentes en el salón S-2-06-07	
Edificio:	8

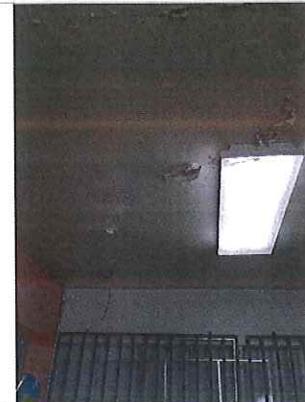
Descripción:	Filtraciones preexistentes en el salón S-2-08-07	
Edificio:	8

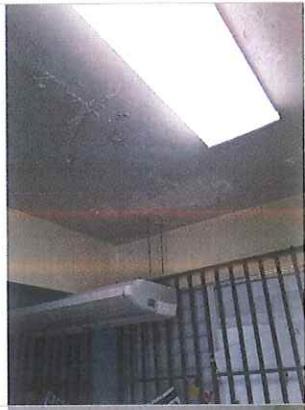
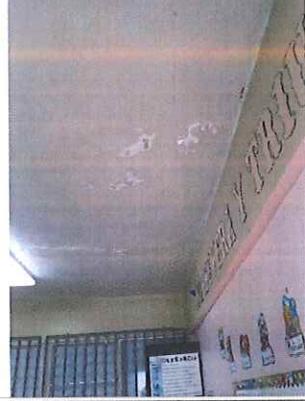
Descripción:	Filtración severa preexistente cercana a lámpara de techo.

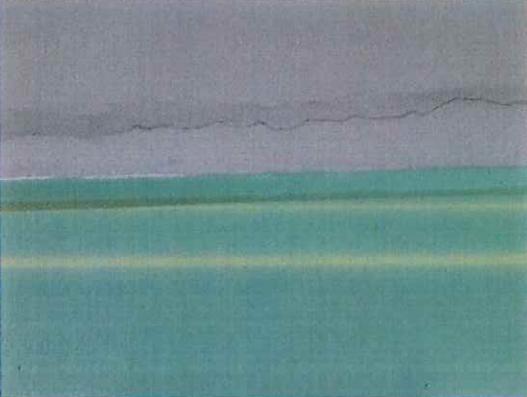
Edificio:	8

Descripción:	Grieta preexistente aparenta ser superficial en el empañetado de la viga, salón S-2-07-07.

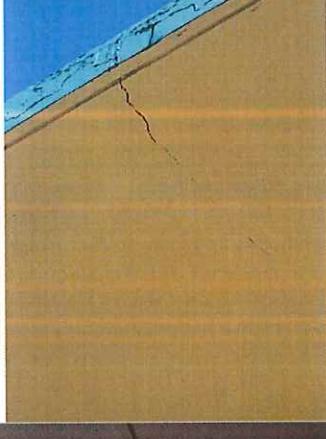
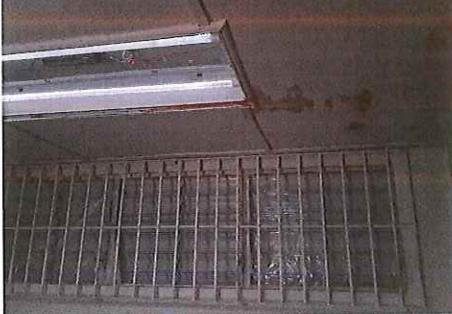
Edificio:	8

Descripción:	Se puede observar grieta horizontal preexistente en el plafón del pasillo en el segundo piso.

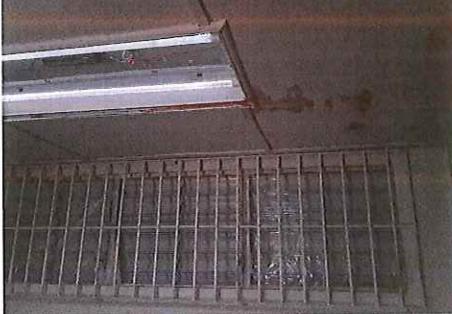
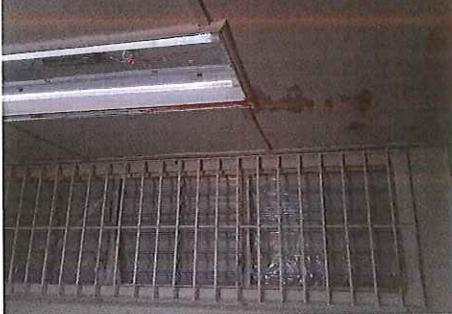
Edificio:	9

Descripción:	A pesar de tener paneles en el plafón, podemos observar muestras de filtración en el mismo (preexistente). Esto es en el salón de contenido.

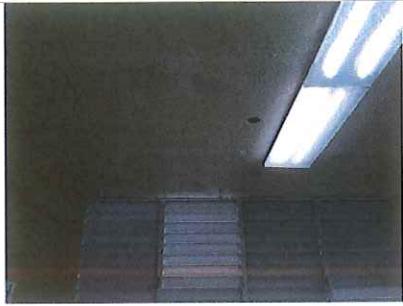
Edificio:	1

Descripción:	La foto muestra humedad severa preexistente en el plafón del salón S-2-01-03.4	
Edificio:	4

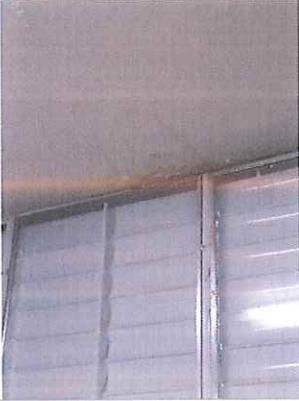
Descripción:	En la foto podemos identificar humedad y filtración preexistente en el área de la biblioteca.	
Edificio:	3

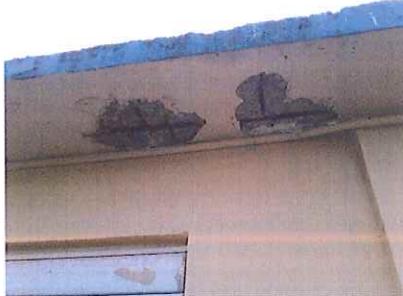
Descripción:	En la foto se puede observar el problema de varilla expuesta corroída y el desprendimiento del empañetado y parte del hormigón de la losa de techo (condición preexistente).	
Edificio:	3

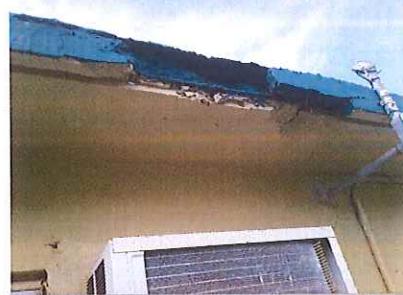
Descripción:	La misma estructura de la foto anterior mas al lado. Podemos observar como se desprendió la orilla del petril debido a la corrosión de la varilla (condición preexistente).	
Edificio:	7

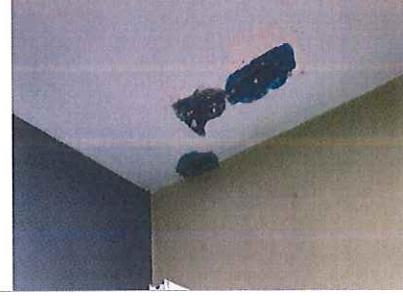
Descripción:	La foto muestra la varilla expuesta y empañetado con parte del hormigón de la losa de techo desprendido en el plafón del salón S-1-15-08 (condición preexistente).

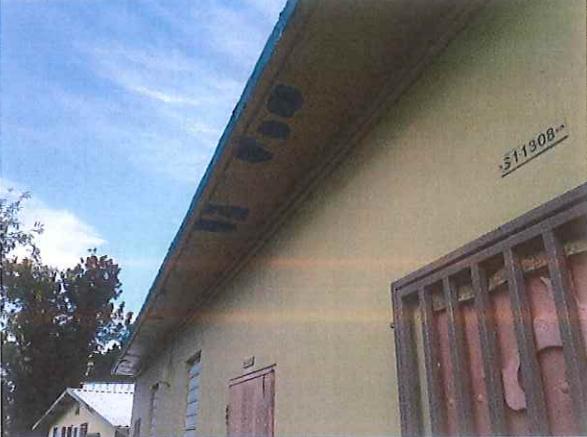
Edificio:	7	
Descripción:	La foto muestra el mismo problema de desprendimiento del alero que se observó en el Edificio 3 (condición preexistente).

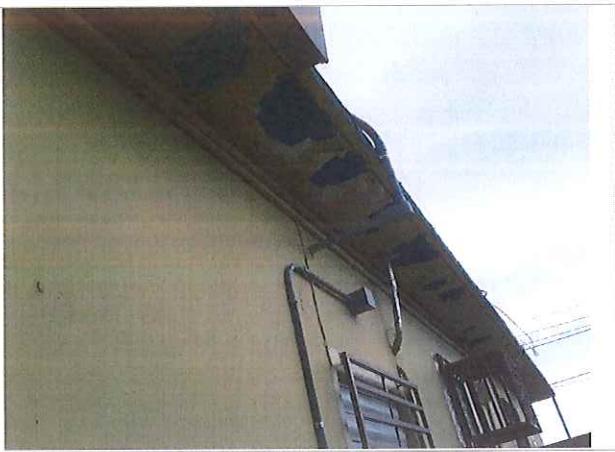
Edificio:	7	
Descripción:	Como se puede observar la condición descrita en la foto anterior la observamos en toda la extensión del alero de este edificio. Se observa además que han comenzado a reparar (condición preexistente).
