CARTA DE TRAMITE

Escuela: Luis Muñoz Rivera

Municipio: Las Piedras

OCULAR INSPECTION CHECKLIST

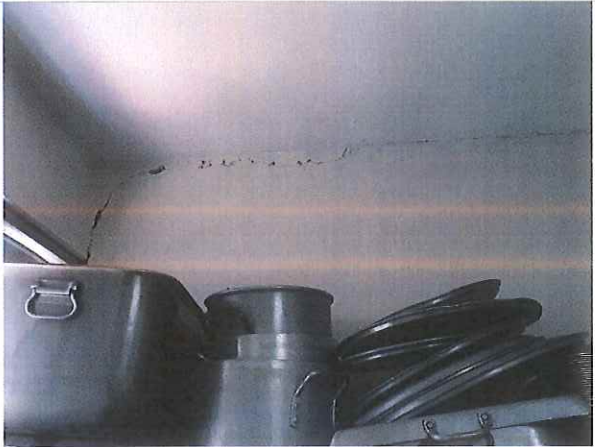
Edificio:	B	<p>Descripción: Aquí se observa una grieta longitudinal en la junta de la pared que divide el área del almacén de los baños. Se recomienda llevara cabo un análisis más profundo debido que aparenta haber sido una división posterior a la construcción de la estructura y se desconoce el amarre de dicha pared.</p>

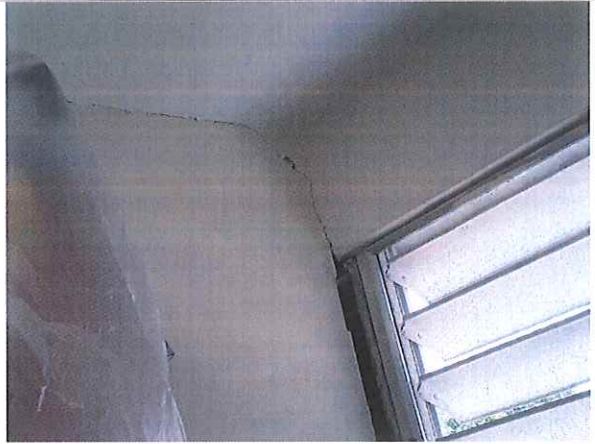
Edificio:	B		
Descripción:	<p>Aquí se observa la misma grieta de la foto anterior, pero del otro lado (baños). Como se puede observar la pared llega hasta el área de las ventanas sin tener columna en dicho extremo. Es por esto que resulta necesario llevar a cabo una evaluación de la condición. Cabe señalar que el personal de la escuela nos mencionó que la misma es una condición preexistente a los sismos.</p>

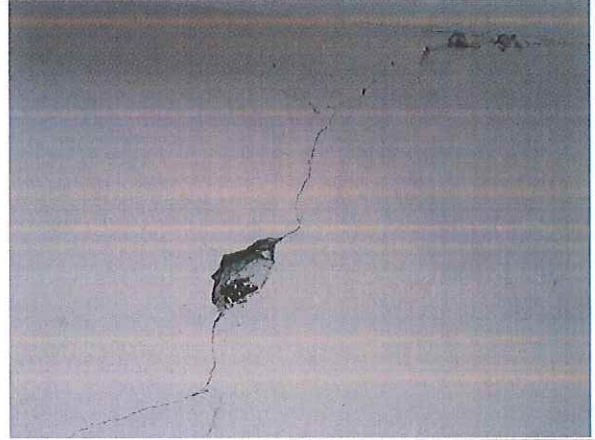
Edificio:	B	<p>Descripción: Esta es la continuación de la grieta de la foto anterior en el área de los baños. Podemos ver que parte del empañetado se desprendió. Se recomienda reparar de inmediato.</p>

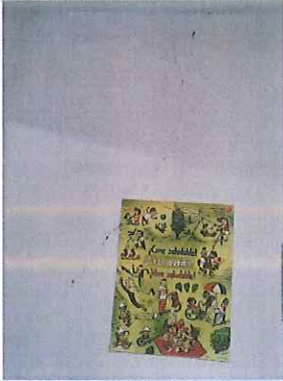
Edificio:	B	
Descripción:	La foto muestra una grieta, la cual aparenta ser superficial en una pared del comedor.

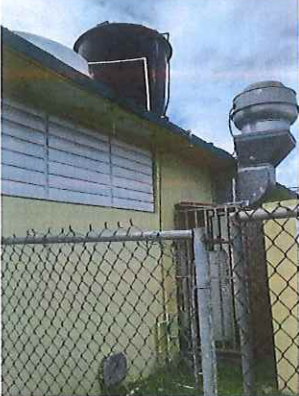
Edificio:	B	
Descripción:	La foto muestra el extractor de la cocina el cual sale por la pared de atrás.

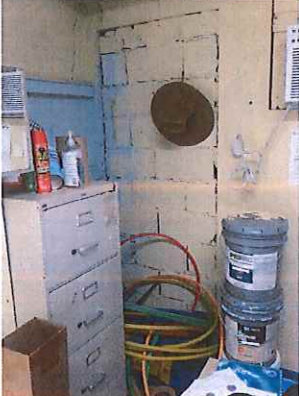
Edificio:	B	
Descripción:	Se identificó una puerta la cual se clausuró con bloques, pero no se empañetó. Esto se encuentra en la oficina del profesor de educación física.

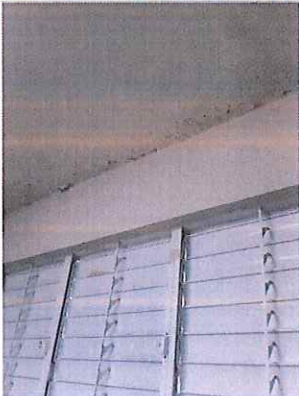
Edificio:	C	
Descripción:	Aquí observamos problemas de humedad en el plafón. Cabe señlas que este salón fue uno añadido a la estructura original de dos niveles. Este es el salón de segundo grado.

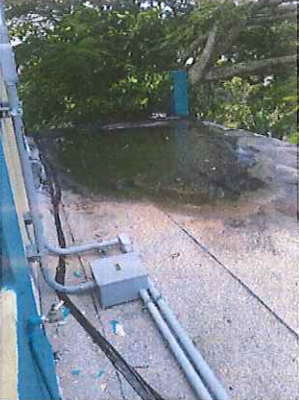
Edificio:	C	
Descripción:	Vista del techo del salón añadido descrito en la foto anterior y con problema de humedad en el mismo. Podemos observar el empozamiento del agua.

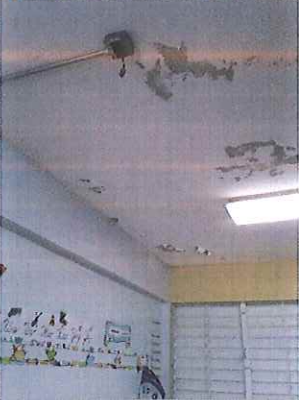
Edificio:	C	
Descripción:	Aquí podemos observar el problema serio de humedad. El salón es en el primer nivel 102-02.

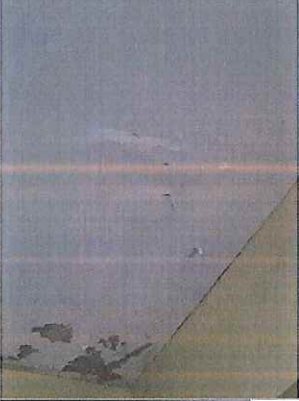
Edificio:	C	
Descripción:	La foto es el mismo salón de la foto anterior. Además de la humedad se puede observar el empañetado despegado en el plafón. Esta condición es preexistente.

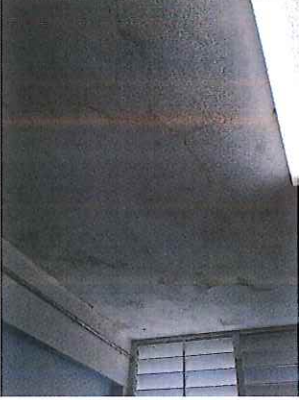
Edificio:	C	
Descripción:	En la foto podemos observar grietas en el empañetado del plafón (preexistente) debido al problema de humedad severa con el cual cuenta la estructura. Es necesario resolver el problema de filtración en el techo para luego corregir esto y así evitar que se desprenda el empañetado del plafón. Esto es en el Salón 202-02.

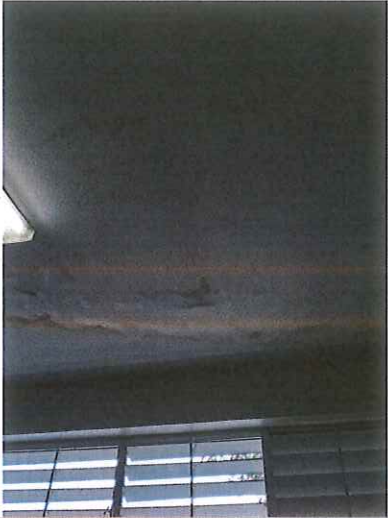
Edificio:	C	
Descripción:	En la foto podemos ver el problema de humedad que tiene la estructura. Esto se encuentra en el mismo salón de la foto anterior 202-02.

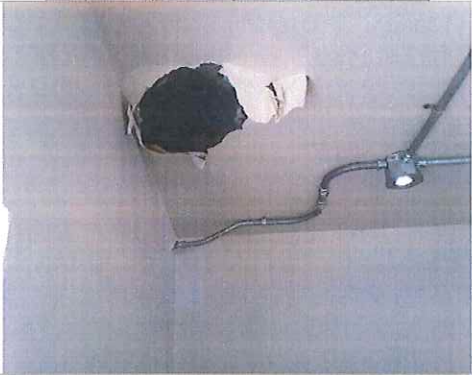
Edificio:	D	
Descripción:	En la foto se puede apreciar parte del empañetado desprendido en el área de los baños de los estudiantes. Esto es al lado de la biblioteca.

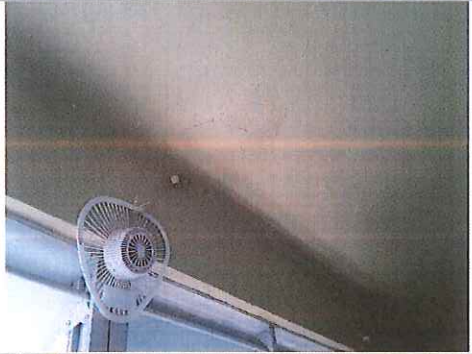
Edificio:	D	
Descripción:	En la foto se observa el otro baño en el cual se presenta el empañetado despegándose, lo cual si no se corrige terminará igual a la foto anterior.

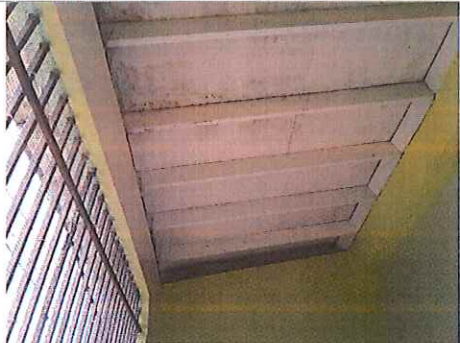
Edificio:	D	
Descripción:	El edificio que alberga la biblioteca tiene un techo en el área de la entrada de madera.

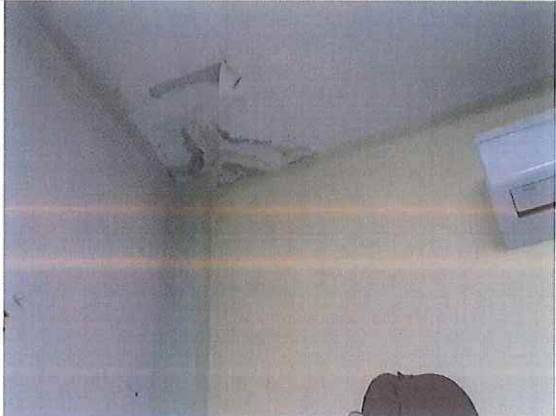
Edificio: D

Descripción: Dentro de la biblioteca el techo es de hormigón y se puede observar problemas de humedad y filtraciones (preexistentes).		
Edificio: E

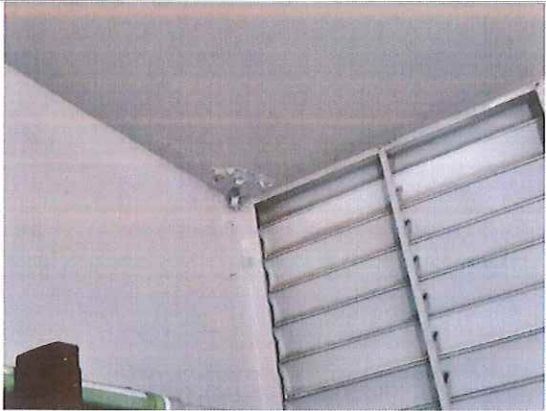
Descripción: Problema de humedad en el salón #1 (preexistentes).		
Edificio: E

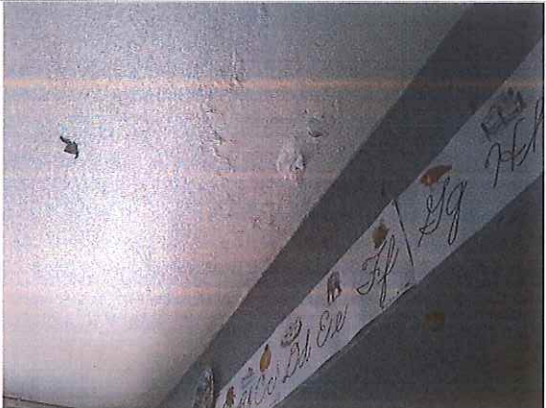
Descripción: Problema de humedad en el salón #2 (preexistente).
