### **CARTA DE TRAMITE**

Informe de inspección Ocular

SCHOOL	CODE	REGION	MUNICIPALITY	INSPECTOR	DATE
Jesus Manuel Suarez	60228	San Juan	Carolina	Juan C. Rodriguez Trinidad	11-Jan-2020

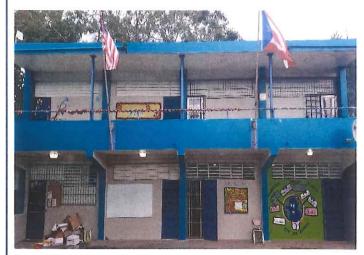
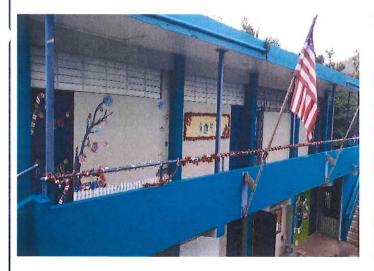
1) All buildings had short columns, however none of the structural element shows cracks that comprise the structure integrity.
