CARTA DE TRAMITE

Escuela: Centro Eugenio María de Hostos Código: (61366)
Municipio: San Juan Fecha de: 11-enero-20
Inspección

OCULAR INSPECTION CHECKLIST

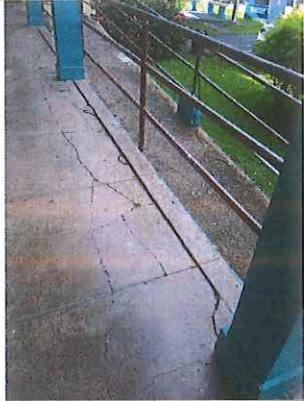
Edificio:	Principal Administración	
Descripción:	En la foto podemos observar varias grietas en la losa de piso del primer nivel. Personal de la escuela nos indicó que las mismas son preexistentes a los sismos.

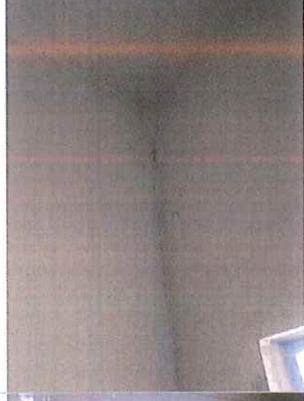
Edificio:	Principal Administración	
Descripción:	Aquí se observa una grieta en la esquina. La misma se encuentra en la oficina de Trabajo Social.

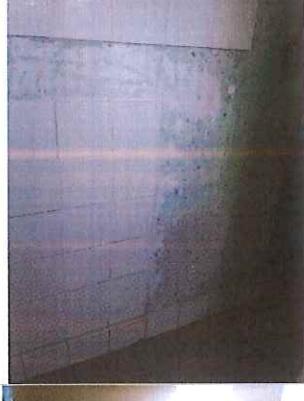
Edificio:	Principal Administración	
Descripción:	Gran parte de las losas de pared en el baño de los caballeros en el primer piso necesitan ser reemplazadas.

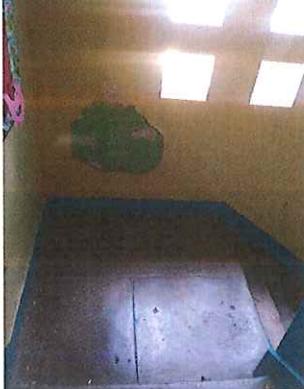
Edificio:	Principal Administración	
Descripción:	Aquí se puede observar un desprendimiento del empaquetado de la pared en el área de la escalera. Personal de la escuela nos notificaron que esta condición era preexistente a los sismos.

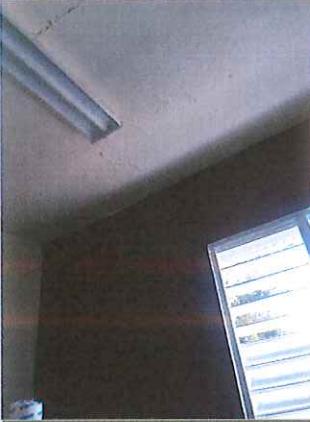
Descripción:	Aquí se puede observar el plafón de uno de los baños del segundo piso con una grieta superficial debido al problema de humedad y filtraciones.	
Edificio:	Principal Administración

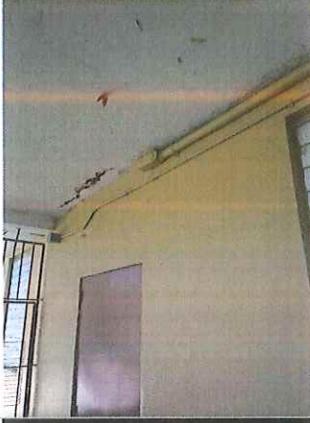
Descripción:	Aquí se puede observar una grieta en la esquina del plafón en el segundo piso a consecuencia del grado severo de humedad y filtración. La misma muestra hongo debido al tiempo que lleva.	
Edificio:	Taller de Carpintería

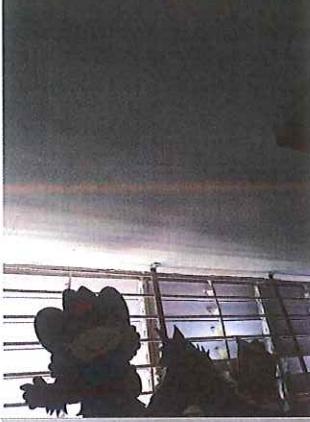
Descripción:	En la foto podemos observar una grieta superficial en el empañetado en el plafón del Taller de Carpintería. En gran parte del plafón del taller se pudo observar pintura desprendida y humedad, lo cual es indicio de un serio problema de humedad y filtraciones aún con el tratamiento del elastomérico instalado.	
Edificio:	Oficina de Terapia

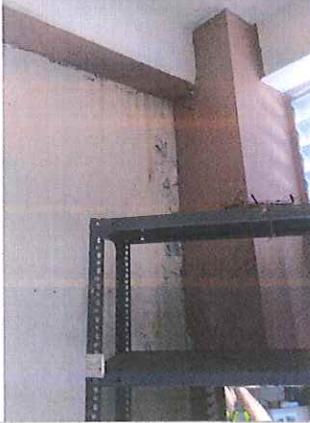
Descripción:	Aquí podemos observar una grieta en la junta entre el plafón con la columna y viga. Además, vemos el alto grado de humedad y filtración en el lugar. Dado las condiciones de humedad y hongos en el lugar se recomienda relocalizar este salón en lo que se lleva a cabo las reparaciones.

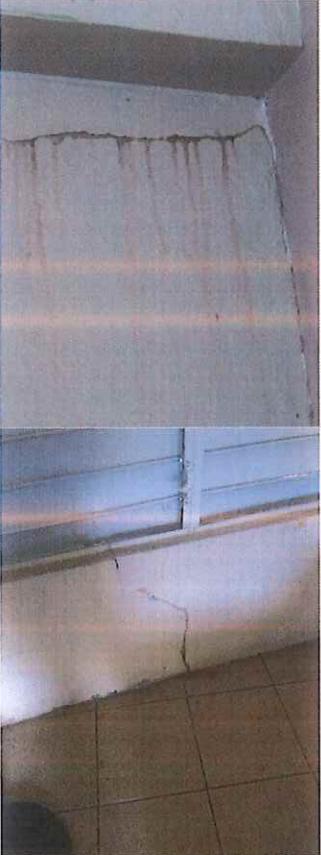
Descripción:	Otra de las paredes del mismo salón de la foto anterior. Dado las condiciones de humedad y hongos en el lugar se recomienda relocalizar este salón en lo que se lleva a cabo las reparaciones.	
Edificio:	Oficina de Terapia

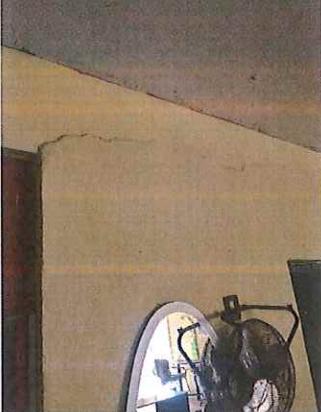
Descripción:	La foto demuestra el alto grado de humedad y filtración que tiene en el lugar. Esta foto es en el salón de Historia. En el Taller de Mecánica que esta justo al lado no tuvimos acceso al mismo.	
Edificio:	Edificio B	
Descripción:	En el salón de Cosmetología construyeron una pared divisoria, la grieta que se observa en la foto se debe a la junta del empaquetado con la viga. Cabe señalar del exceso de mezcla, el cual es visible. Nos indicó el personal de la escuela que estos trabajos fueron realizados por los mismos estudiantes de Carpintería.

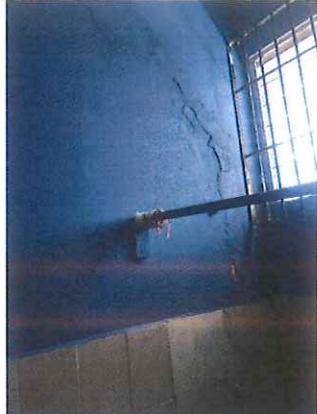
Descripción:	<p>En la foto podemos observar una grieta en la pared en el área de los baños en el Taller de Colición. La misma aparenta haber sido reparada y posteriormente pintada. Cabe señalar que al lado de este taller se encuentra el antiguo comedor de la escuela el cual tuvo unos problemas de asentamiento y se cerró, mudando el mismo para el primer piso del Edificio F. Cabe señalar que no tuvimos acceso al nuevo comedor.</p>	
Edificio:	Edificio D

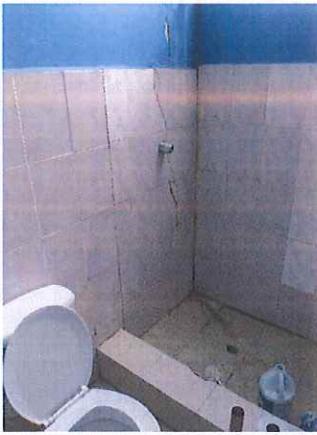
Descripción:	<p>La foto muestra la misma grieta, como se proyecta hacia el área de los azulejos. Cabe señalar que al lado de este taller se encuentra el antiguo comedor de la escuela el cual tuvo unos problemas de asentamiento y se cerró, mudando el mismo para el primer piso del Edificio F. Cabe señalar que no tuvimos acceso al nuevo Comedor.</p> <p>Debido a lo antes expuesto es altamente recomendable se lleve a cabo un análisis más profundo del lugar.</p>

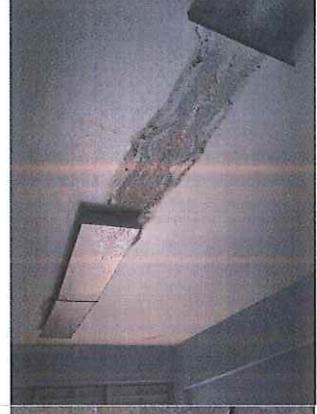
Descripción:	<p>La foto muestra la grieta superficial producto de la humedad y filtración en el techo del lugar.</p>	
Edificio:	Edificio F

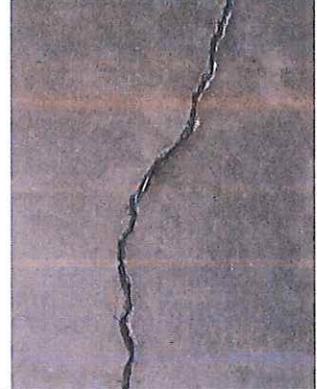
Descripción:	<p>La foto muestra una grieta en el piso del salón de inglés en el segundo nivel. Este salón es el penúltimo del segundo nivel. El personal de la escuela nos indicó que la misma era preexistente a los sismos. Debido a que la grieta se proyecta hacia el área del pasillo se recomienda llevar a cabo una evaluación más detallada de la losa de piso.</p>

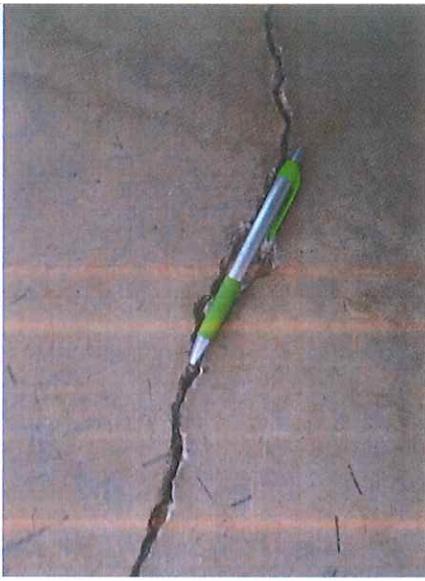
Edificio:	Edificio F	<p>Descripción: Esta es la misma grieta de la foto anterior, localizada hacia el centro del salón. Este salón es el penúltimo del segundo nivel. El personal de la escuela nos indicó que la misma era preexistente a los sismos. Debido a que la grieta se proyecta hacia el área del pasillo se recomienda llevar a cabo una evaluación más detallada de la losa de piso.</p>

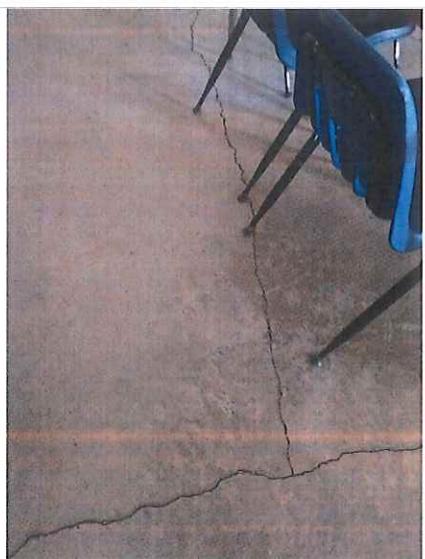
Edificio:	Edificio F	<p>Descripción: La foto muestra grietas en el piso del salón de español. Este salón es el último en el segundo nivel. El personal de la escuela nos indicó que las mismas eran preexistentes a los sismos reportados. Debido a que la grieta se proyecta hacia el área del pasillo se recomienda llevar a cabo una investigación más profunda de la losa de piso.</p>
