CARTA DE TRAMITE

Escuela: Luis Paléz Matos (La esperanza) Código: (61424)
Municipio: San Juan Fecha de: 11-enero-20
Inspección

OCULAR INSPECTION CHECKLIST

Plano de Sitio	Luis Palés Matos (La Esperanza)
Descripción:	Vista aérea de la escuela identificando las estructuras donde se llevó a cabo una inspección visual.

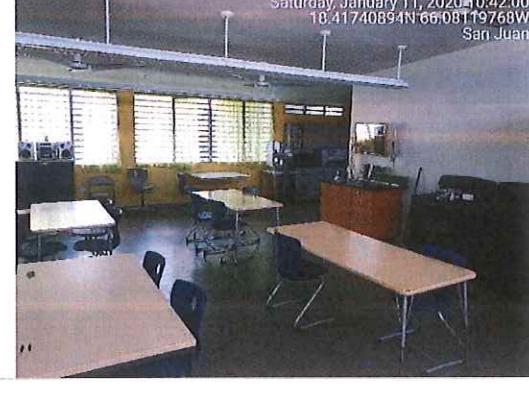
Descripción:	Vista de salón de clases. No se observaron daños en esta estructura.	Saturday, January 11, 2020 10:44:19 18.4175443N 66.08131458W San Juan
Edificio:	5

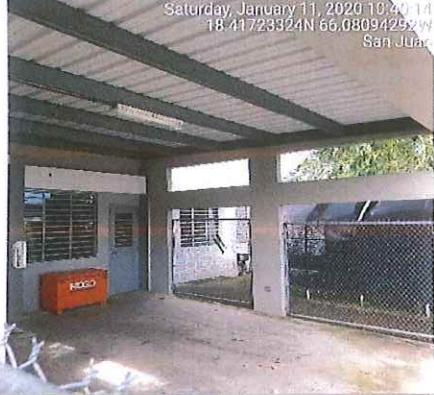
Edificio:	6

Descripción:	Vista de la estructura Núm. 6. No se observaron daños.	
Edificio:	7

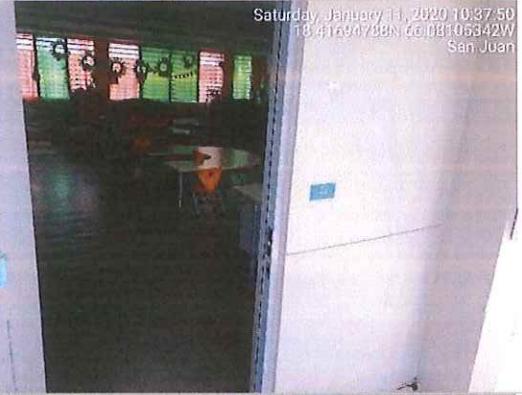
Descripción:	Vista de salón de clases. No se observaron daños en esta estructura.	
Edificio:	8

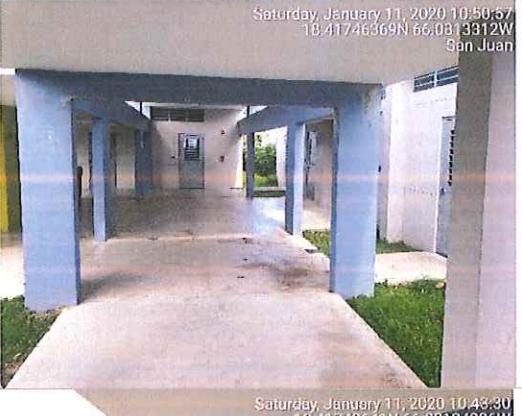
Descripción:	En la foto se observa que el pórtico presenta grietas en la junta de la columna con la viga (grietas).	
Edificio:	8

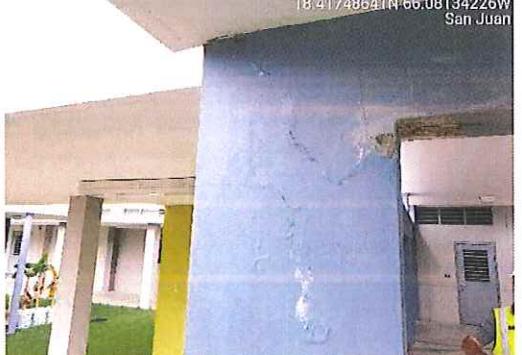
Descripción:	En la foto se observa las grietas en la junta de la columna con la viga.

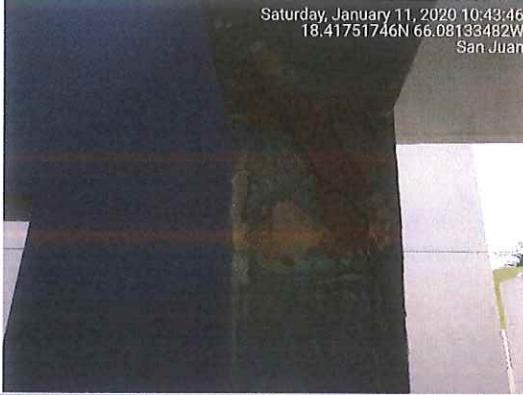
Descripción:	En la foto se observa que la grieta en la junta de la columna con la viga. Aparenta que ya existía la condición antes del evento.	
Edificio:	8

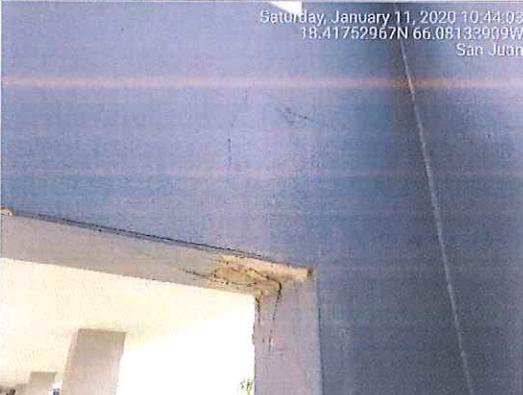
Descripción:	En la foto se observan las grietas en la junta de la columna con la viga.	
Edificio:	10

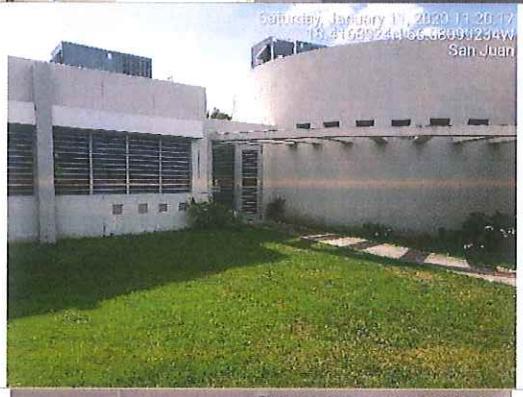
Descripción:	Vista de la estructura Núm. 10. No se observaron daños.	
Edificio:	11

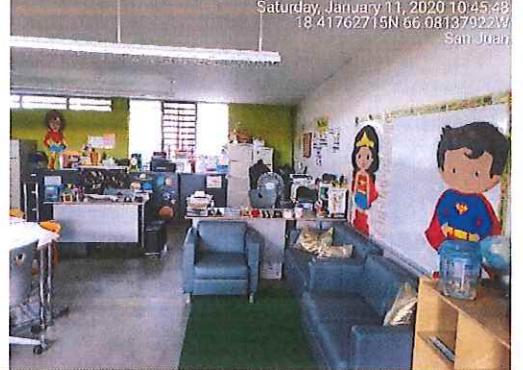
Descripción:	Vista de salón de clases. No se observaron daños en esta estructura.

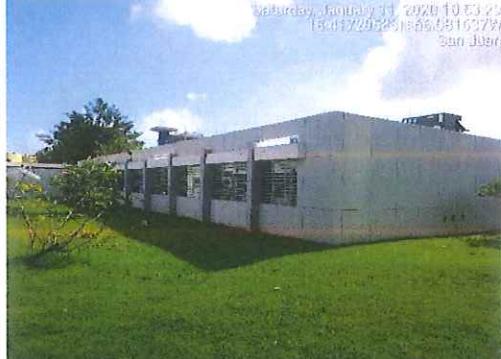
Edificio:	13

Descripción:	Vista de la estructura Núm. 13. No se observaron daños.	
Edificio:	17

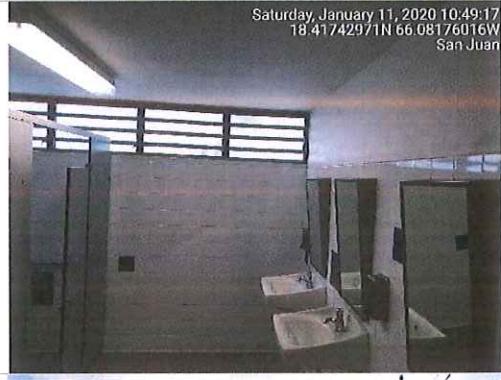
Descripción:	Vista de la estructura del baño. No se observaron daños en esta estructura.	
Edificio:	19

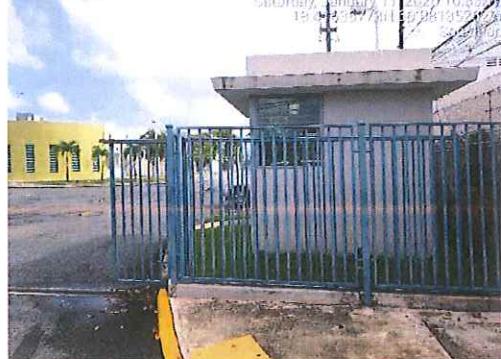
Descripción:	Vista de la estructura Núm. 19. No se observaron daños.
