## CARTA DE TRAMITE

Escuela: Ernesto Ramos Antonini Código: (64402)

Municipio: San Juan Fecha de:  
Inspección 11-enero-20

## OCULAR INSPECTION CHECKLIST

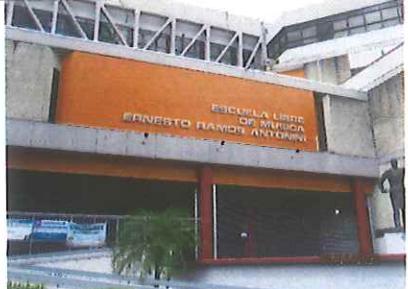
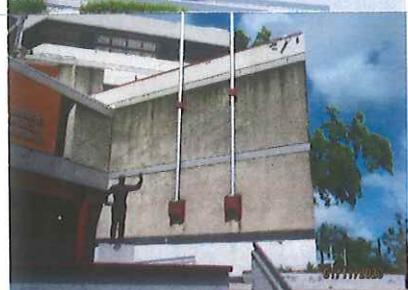
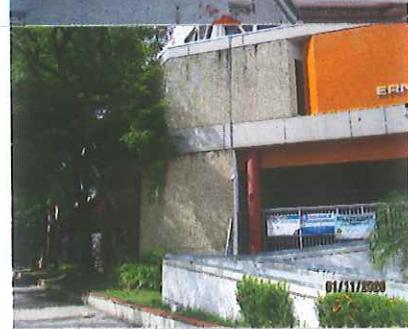
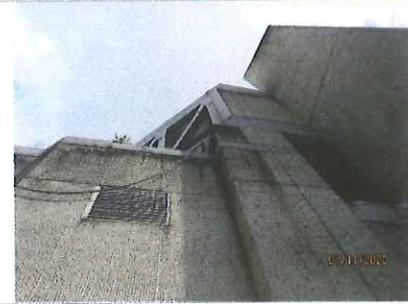
Descripción:	No se observaron daños.	
Edificio:	EXTERIOR	
Descripción:	No se observaron daños.	
Edificio:	EXTERIOR	
Descripción:	Se observaron daños	
Edificio:	EXTERIOR	
Descripción:	No se observaron daños.

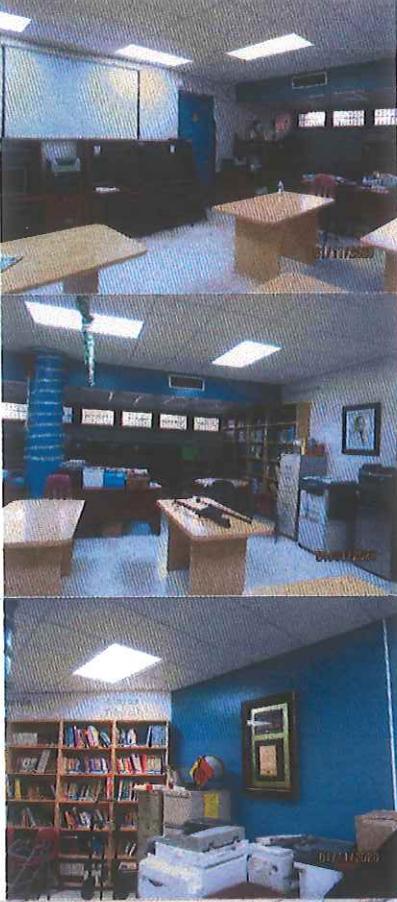
Descripción:	No se observaron daños.	
Edificio:	BIBLIOTECA	
Descripción:	No se observaron daños.	
Edificio:	BIBLIOTECA

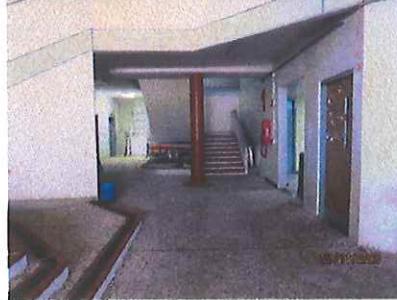
Descripción:	No se observaron daños.

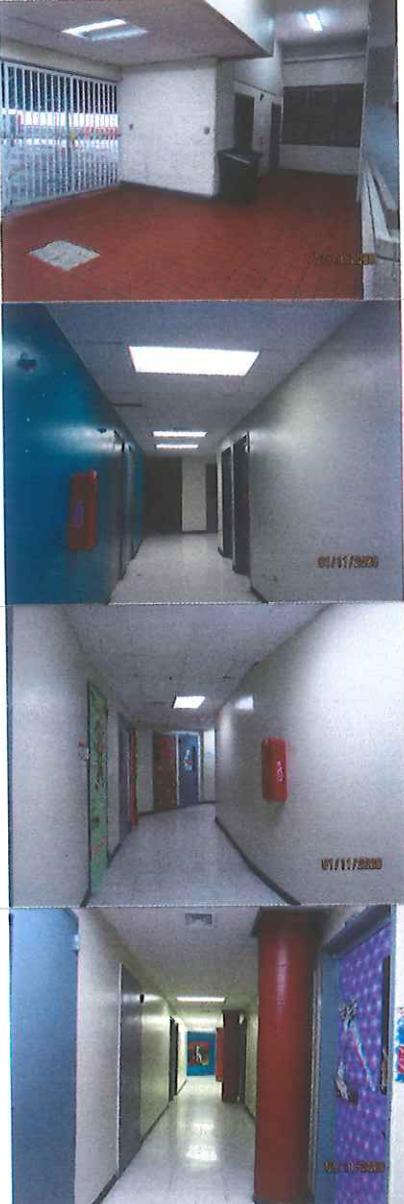
The table contains four rows of inspection data for hallways. Each row has two columns: 'Edificio:' and 'Descripción:'. The first three rows show hallways where no damage was observed, while the fourth row shows significant damage. The images show: 1) A hallway with red carpeting and a metal railing; 2) A long hallway with blue walls and doors; 3) A hallway with grey walls and doors; 4) A hallway with blue and red walls and doors.
Descripción:	No se observaron daños.	
Edificio:	PASILLO	
Descripción:	No se observaron daños.	
Edificio:	PASILLO	
Descripción:	Se observaron daños significativos en el edificio.	
Edificio:	PASILLO	
Descripción:	No se observaron daños.

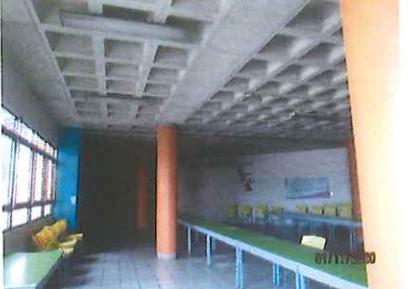
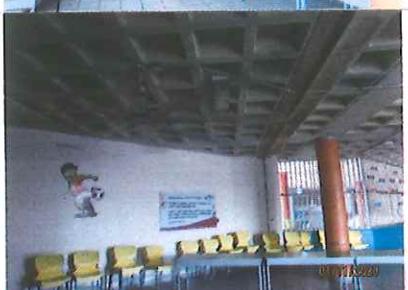
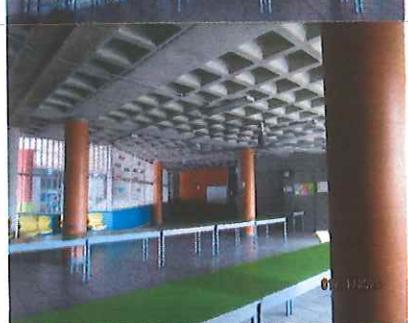
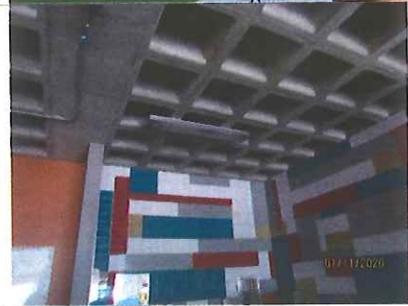
Descripción:	No se observaron daños.	
Edificio:	COMEDOR	
Descripción:	No se observaron daños.	
Edificio:	COMEDOR

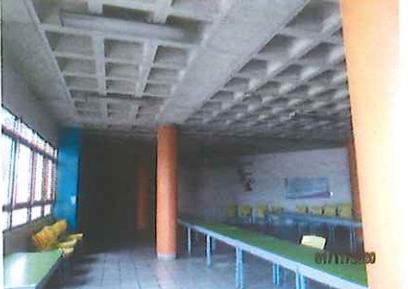
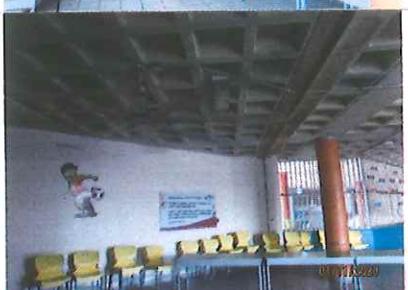
Descripción:	Se observaron daños significativos en el edificio.	
Edificio:	COMEDOR

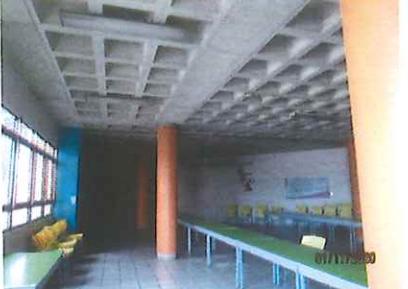
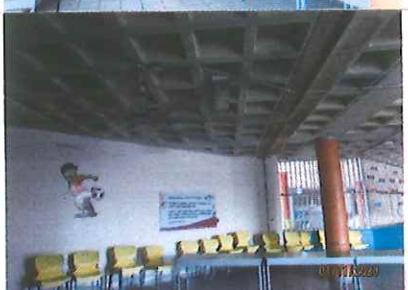
Descripción:	No se observaron daños.

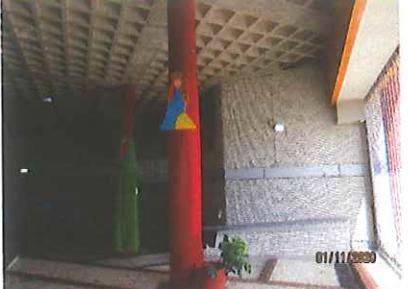
Descripción:	No se observaron daños.		
Edificio:	ENTRADA

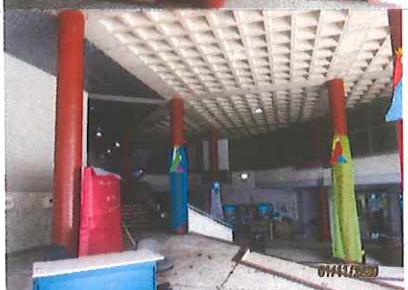
Descripción:	No se observaron daños.		
Edificio:	ESCALERA

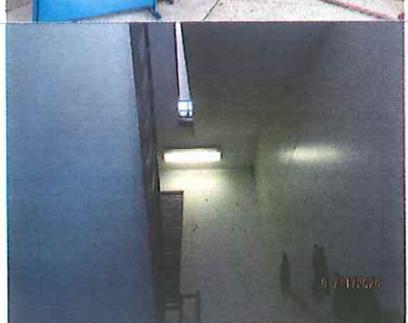
Descripción:	Se observaron daños.		
Edificio:	ESCALERA

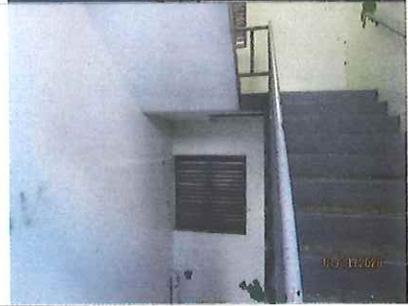
Descripción:	No se observaron daños.

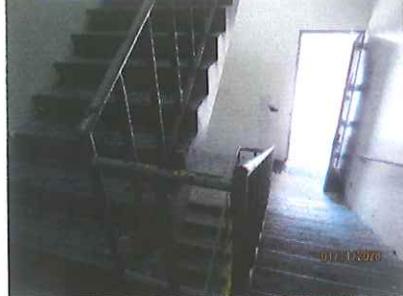
Descripción:	No se observaron daños.		
Edificio:	ESCALERA

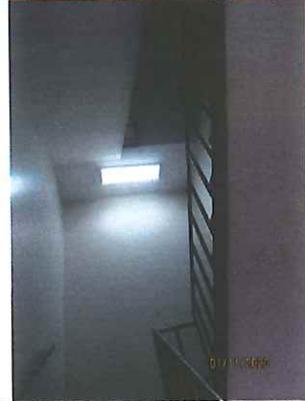
Descripción:	No se observaron daños.		
Edificio:	ESCALERA

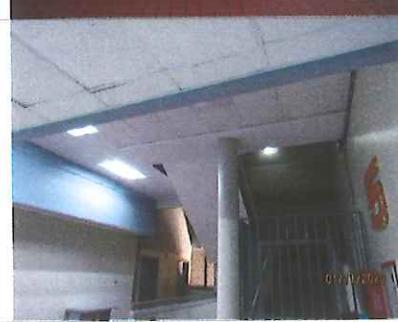
Descripción:	No se observaron daños.

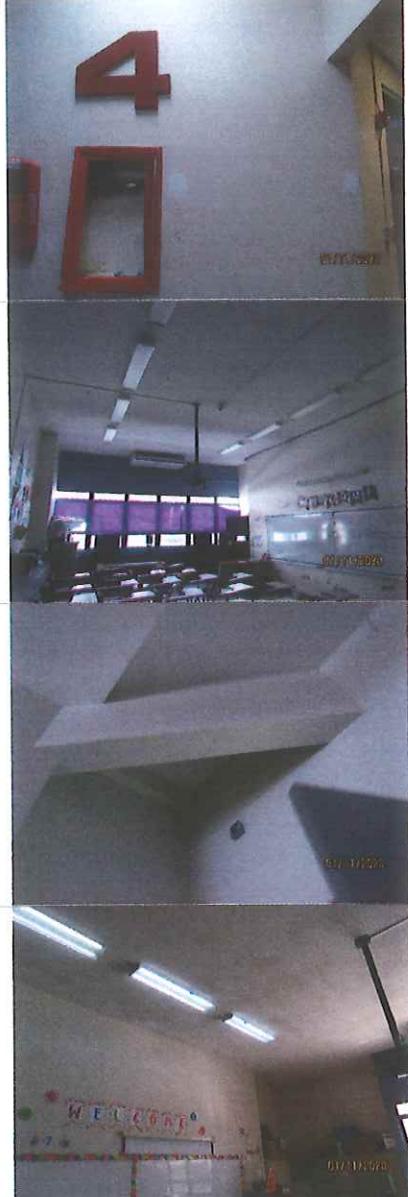
Edificio:	PISO 4
Descripción:	No se observaron daños.
Edificio:	PISO 4
Descripción:	No se observaron daños.
Edificio:	PISO 4
Descripción:	Se observaron daños.
Edificio:	PISO 4
Descripción:	No se observaron daños.
