CARTA DE TRAMITE

Escuela: Cotto Anexo

Código: (10173)

OCULAR INSPECTION CHECKLIST

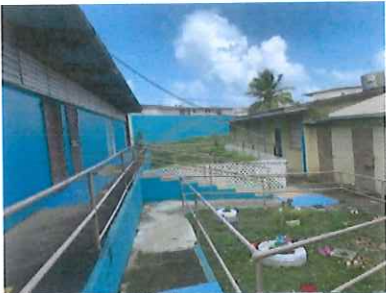
Edificio:	1	
Descripción:	No se observaron daños.

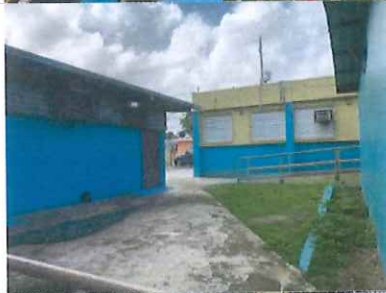
Edificio:	2	
Descripción:	No se observaron daños.

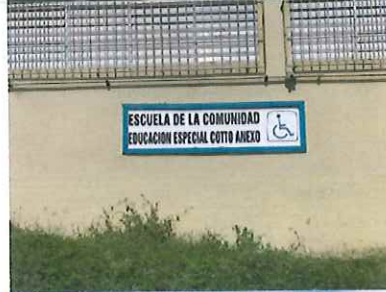
Edificio:	3	
Descripción:	Se observaron daños significativos en el edificio.

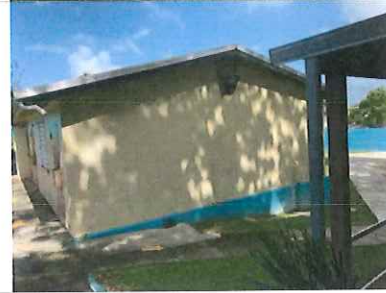
Edificio:	4	
Descripción:	No se observaron daños.

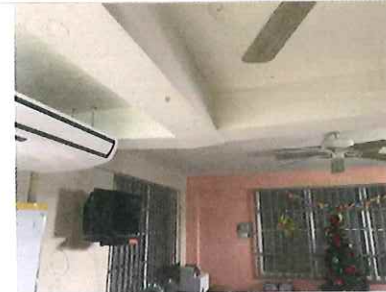
Edificio:	5	
Descripción:	No se observaron daños.

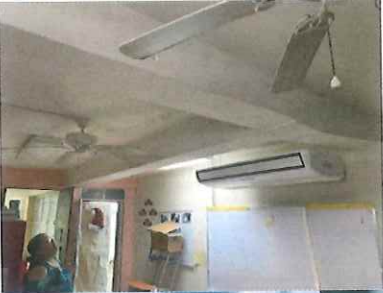
Edificio:	6		
Descripción:	No se observaron daños. Verificar esta configuración de vigas y la eliminación de la columna en los salones de "Kindergarden"

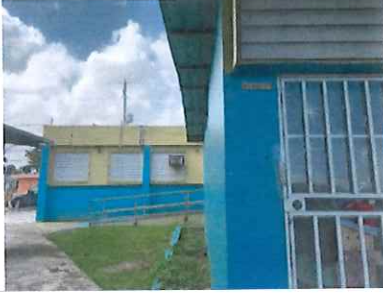
Edificio:	7		
Descripción:	Se observaron daños significativos en el edificio.		 
Edificio:	8		
Descripción:	No se observaron daños.
