## CARTA DE TRAMITE

Escuela: **Julio Seijo**

Municipio: **Arecibo**

## OCULAR INSPECTION CHECKLIST

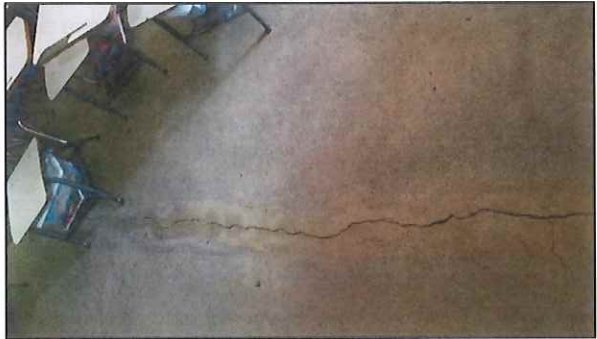
Edificio:	2	
Descripción:	No se observaron daños estructurales causados por el terremoto. El segundo piso debe cerrarse por condiciones preexistentes. Grietas de piso.

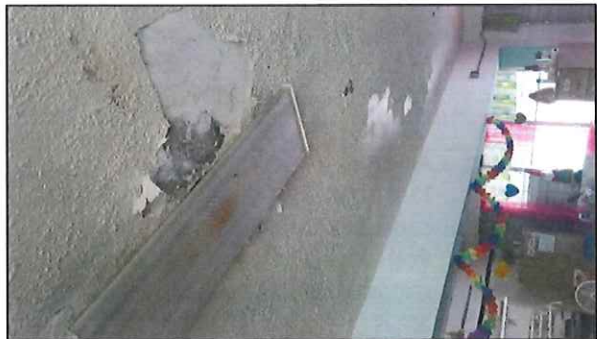
Edificio:	2	
Descripción:	No se observaron daños estructurales causados por el terremoto. El primer piso debe cerrarse por condiciones preexistentes. Grietas de piso en nivel de arriba y filtración de agua.

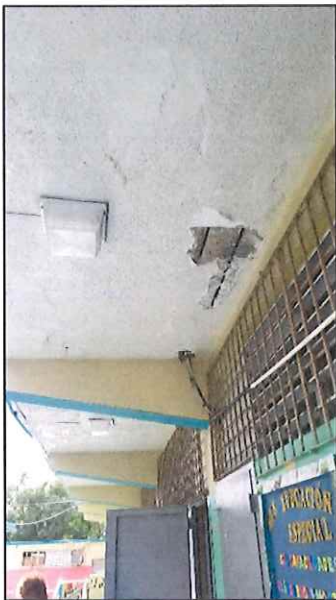
Edificio:	Aleros	
Descripción:	No se observaron daños estructurales causados por el terremoto. Concreto desprendido debe ser completamente removido antes de permitir acceso a estas áreas.

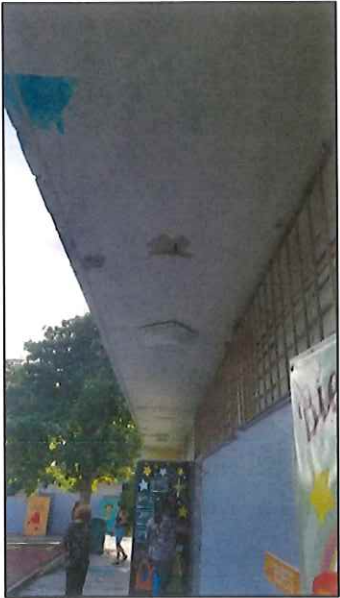
<p>Edificio: Aleros</p> <p>Descripción: No se observaron daños estructurales causados por el terremoto. Concreto desprendido debe ser completamente removido antes de permitir acceso a estas áreas.</p>

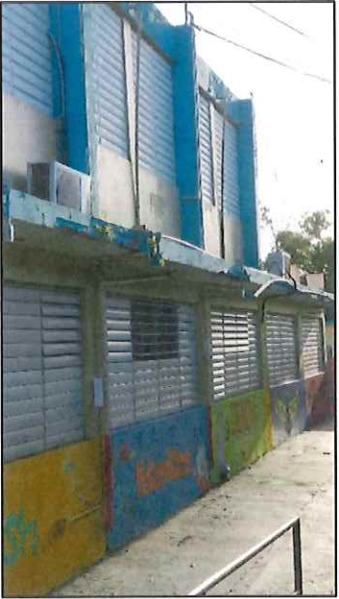
<p>Edificio: Aleros</p> <p>Descripción: No se observaron daños estructurales causados por el terremoto. Concreto desprendido debe ser completamente removido antes de permitir acceso a estas áreas.</p>

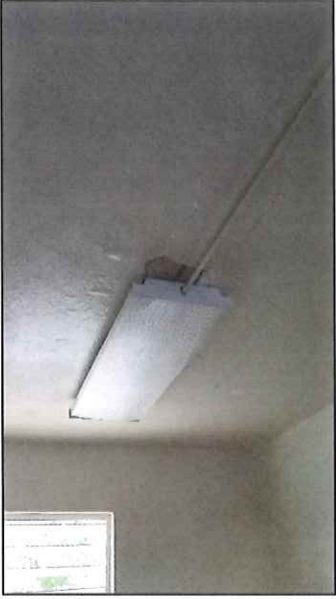
<p>Edificio: 10 - Baños</p> <p>Descripción: No se observaron daños estructurales causados por el terremoto. Concreto desprendido debe ser completamente removido antes de permitir acceso a esta área.</p>

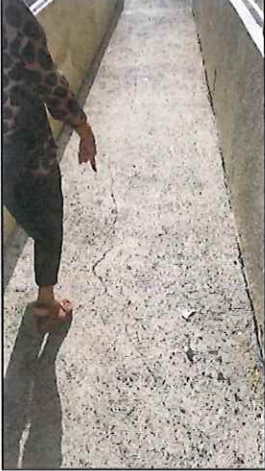
A photograph showing a ceiling with a rectangular light fixture. A sign is visible on the wall in the lower-left corner of the image.
<p>Edificio: Rampa</p> <p>Descripción: No se observaron daños estructurales causados por el terremoto. Rampa debe ser cerrada.</p>
