CARTA DE TRAMITE

Escuela: Enrique de Jesús Borrás

OCULAR INSPECTION CHECKLIST

ANEJO A

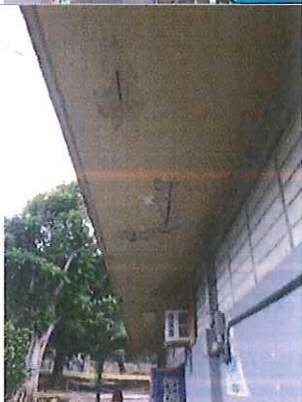
Sin embargo, en el edificio principal del plantel se encuentra un salón en el segundo piso esquina oeste que cuenta con unas significativas grietas en el piso. Estas grietas, en conjunto con cierta deflexión en el piso de hormigón del salón, nos sugiere que el estado de la estructura no es el mejor y se requiere que se haga un análisis más detallado del estado del edificio. Este edificio se encuentra en la esquina norte que conecta a su vez con los dos edificios principales y la cancha techada y accesos de rampas. Recomendamos un estudio más detallado de la capacidad estructural de este edificio.

Edificio: 1		
Descripción: No se observaron daños.		 
Edificio: 2		
Descripción: No se observaron daños.		 
Edificio: 3		
Descripción: Se observaron daños significativos en el edificio.

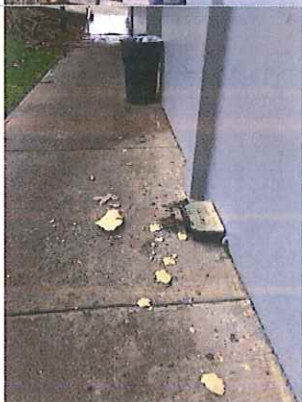
Edificio: 4		
Descripción: No se observaron daños.
