CARTA DE TRAMITE

Escuela: Víctor Rojas I

Municipio: Arecibo

Fecha de:
Inspección 10-Jan-20

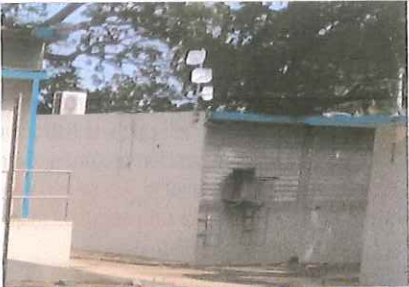
Edificio:	1 - Oficina

Descripción:	No se observaron daños relacionados con los eventos recientes. Grietas menores previas al terremoto. Foto ilustra la parte lateral derecha del edificio.			
Edificio:	2 – Comedor y Salones - Exterior

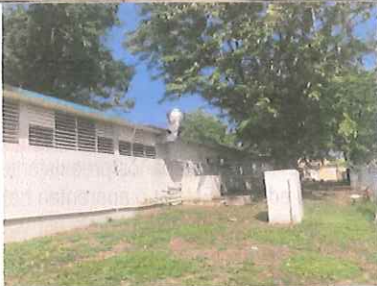
Descripción:	No se observaron daños relacionados con los eventos recientes. Grietas menores previas al terremoto. Foto ilustra la parte posterior del edificio.			
Edificio:	2 – Comedor y Salones - Interior

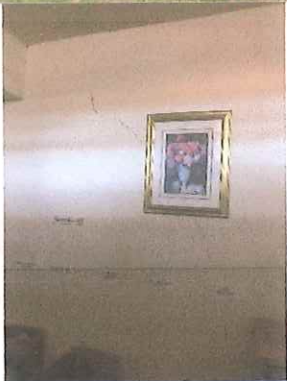
Descripción:	Se observaron daños preexistentes de grietas en paredes de bloques que no aparentan comprometen la integridad estructural de la estructura. Estas condiciones requieren trabajos de mantenimiento para su corrección.*			
Edificio:	3 – Artes Industriales - Exterior

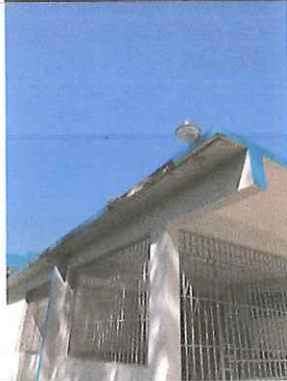
Descripción:	Se observaron daños preexistentes y nuevos en el edificio. Estos no aparentan haber afectado la integridad estructural de la estructura, pero requieren inspección profunda. Se recomienda inspección adicional. Se debe forzar el desprendimiento de empaquetado suelto en el alero. No se recomienda el uso de este salón hasta una segunda inspección más detallada.

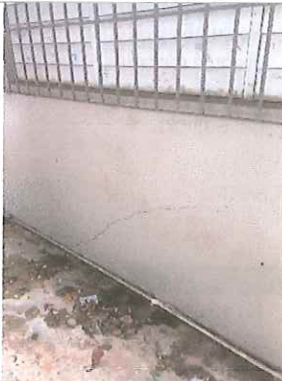
Edificio:	3 – Artes Industriales - Exterior

Descripción:	Se observaron daños preexistentes y nuevos en el edificio. Estos no aparentan haber afectado la integridad estructural de la estructura, pero requieren inspección profunda. Se recomienda inspección adicional. No se recomienda el uso de este salón hasta una segunda inspección más detallada.		
Edificio:	3 – Artes Industriales - Interior

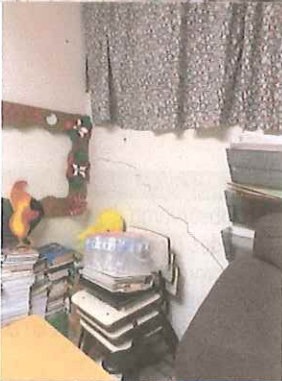
Descripción:	Se observaron daños preexistentes y nuevos y en el edificio. Estos no aparentan haber afectado la integridad estructural de la estructura, pero requieren inspección profunda. Se recomienda inspección adicional. No se recomienda el uso de este salón hasta una segunda inspección más detallada.		
Edificio:	3 – Artes Industriales - Interior

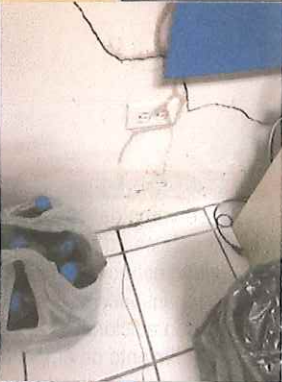
Descripción:	Se observaron daños preexistentes y nuevos y en el edificio. Estos no aparentan haber afectado la integridad estructural de la estructura, pero requieren inspección profunda. Se recomienda inspección adicional. No se recomienda el uso de este salón hasta una segunda inspección más detallada.

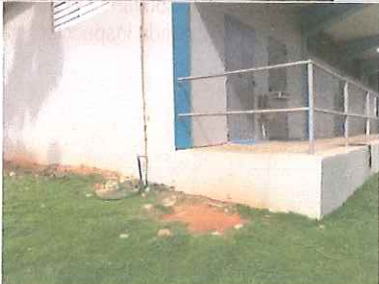
Edificio:	4 – Salones de Clases (Vida Individual) y Baños - Exterior

Descripción:	No se observaron daños relacionados con los eventos recientes. Se observó asentamiento diferencial no significativo entre la acera frente al edificio y el edificio observadas comúnmente en este tipo de construcción. Se observó erosión en los alrededores de la estructura. Estas condiciones requieren trabajos de mantenimiento para su corrección.

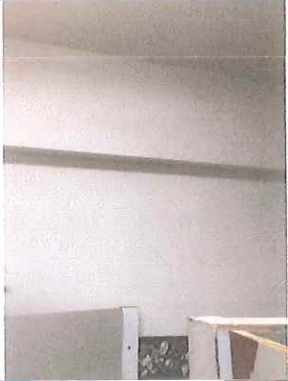
Edificio:	4 – Salones de Clases (Vida Individual) y Baños - Interior

Descripción:	No se observaron daños relacionados con los eventos recientes. Se observaron daños preexistentes de grietas del ancho de un cabello en paredes de bloques y vigas que no aparentan comprometen la integridad estructural de la estructura. Estas condiciones requieren trabajos de mantenimiento para su corrección.	
Edificio:	5 – Salones (Artes Visuales & Matemática) - Exterior

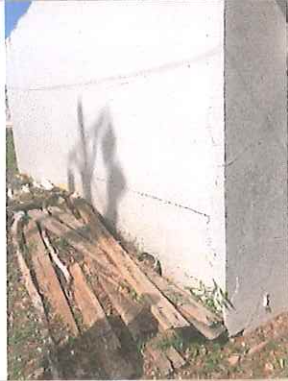
Descripción:	No se observaron daños relacionados con los eventos recientes. La estructura requiere mantenimiento de los paneles que conforman las paredes exteriores del edificio.	
Edificio:	5 – Salones (Artes Visuales & Matemática) - Interior

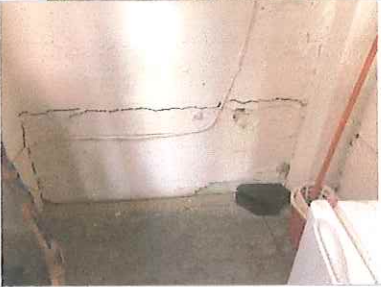
Descripción:	No se observaron daños relacionados con los eventos recientes. La estructura requiere mantenimiento de los paneles que conforman las paredes exteriores del edificio.
