OCULAR INSPECTION CHECKLIST

1. Street Address of the School: PR-485
 City: Camuy State: Puerto Rico Zip: 00627
2. School Name: PEDRO AMADOR
3. Date of inspection: January 16, 2020
4. Inspector's Name: Carlos E. Oquendo-Larracuente

ANEJO A

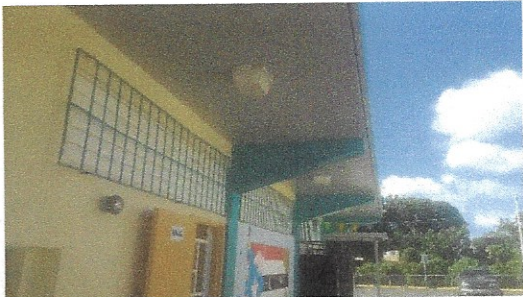
Edificio:	1

Descripción:	No se observaron daños en el edificio. <u>NO RELACIONADO AL EVENTO SISMICO</u>	
Edificio:	2

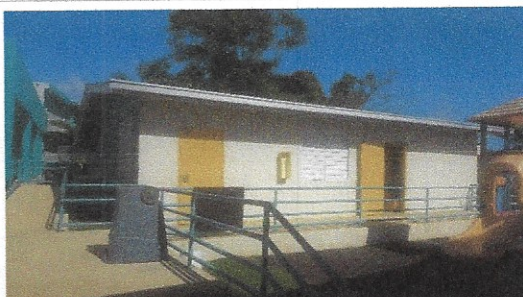
Descripción:	No se observaron daños en el edificio. <u>NO RELACIONADO AL EVENTO SISMICO</u>	
Edificio:	3

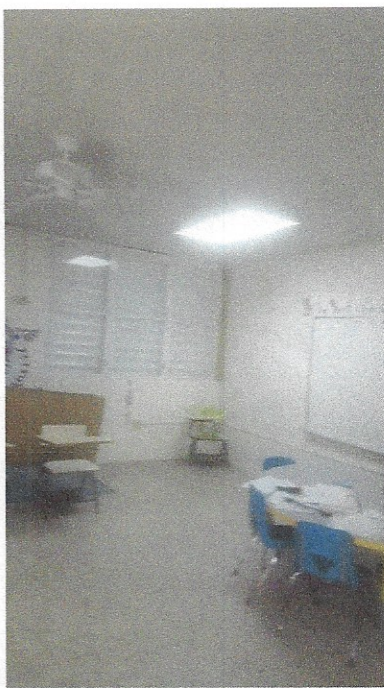
Descripción:	No se observaron daños estructurales. <u>NO RELACIONADO AL EVENTO SISMICO</u>

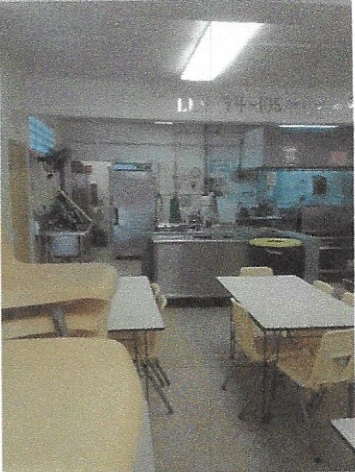
Edificio:	4		
Descripción:	<p>No se observaron daños estructurales.</p> <p><u>NO RELACIONADO AL EVENTO SISMICO</u></p>

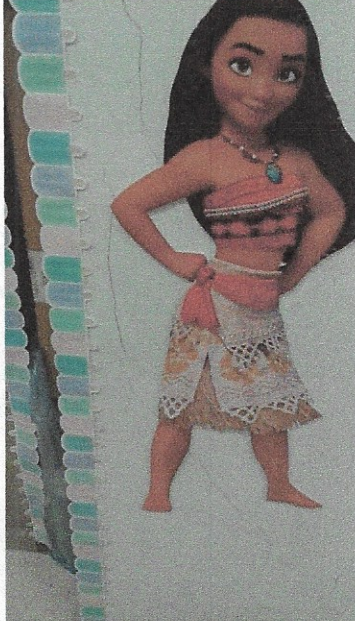
Edificio:	5		
Descripción:	<p>No se observaron daños estructurales. Atender grietas en el salón que queda sobre los baños (entendemos que es el de 4to) y los baños a nivel de primer piso. No son grietas estructurales, pero pueden desprenderse y convertirse en filos cortantes, al igual que las losetas de baño, las cuales ya algunas están rotas o desprendidas.</p> <p><u>NO RELACIONADO AL EVENTO SISMICO</u></p>

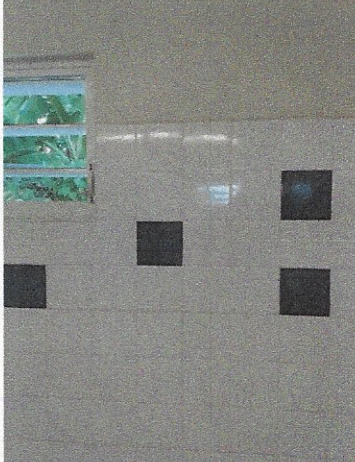
<p>Losetas de baño, las cuales ya algunas están rotas o desprendidas.</p> <p><u>NO RELACIONADO AL EVENTO SISMICO</u></p>

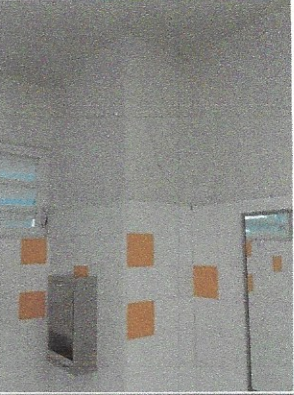
<p>No son grietas estructurales, pero pueden desprenderse y convertirse en filos cortantes, al igual que las losetas de baño, las cuales ya algunas están rotas o desprendidas.</p> <p><u>NO RELACIONADO AL EVENTO SISMICO</u></p>

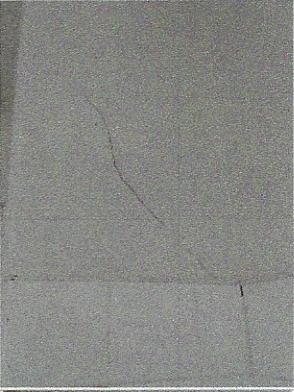
<p>No son grietas estructurales, pero pueden desprenderse y convertirse en filos cortantes, al igual que las losetas de baño, las cuales ya algunas están rotas o desprendidas.</p> <p><u>NO RELACIONADO AL EVENTO SISMICO</u></p>

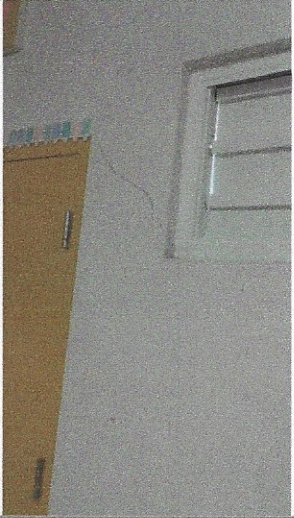
<p>No son grietas estructurales, pero pueden desprenderse y convertirse en filos cortantes, al igual que las losetas de baño, las cuales ya algunas están rotas o desprendidas.</p> <p><u>NO RELACIONADO AL EVENTO SISMICO</u></p>

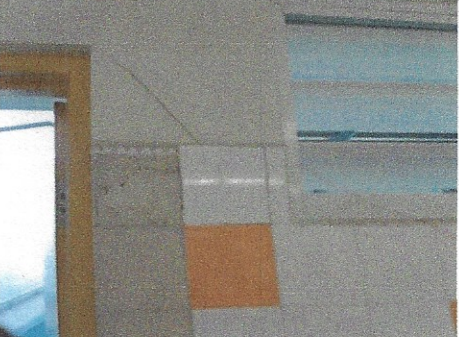
<p>No son grietas estructurales, pero pueden desprenderse y convertirse en filos cortantes, al igual que las losetas de baño, las cuales ya algunas están rotas o desprendidas.</p> <p><u>NO RELACIONADO AL EVENTO SISMICO</u></p>

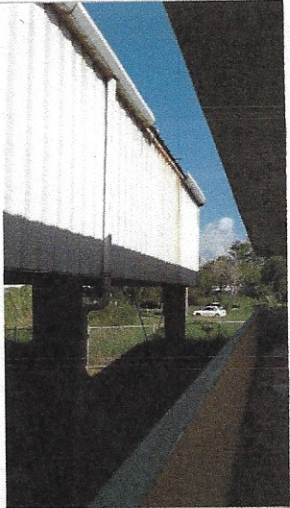
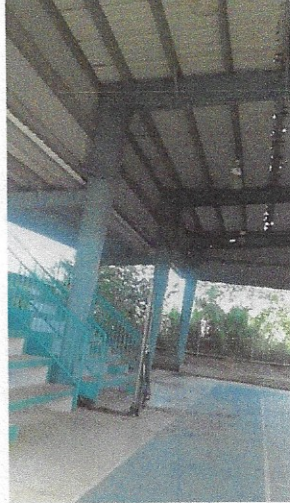
<p>Edificio:</p>	<p>CANCHA</p>

<p>Descripción:</p>	<p>No se observaron daños relacionados a la actividad sísmica. No obstante, se recomienda atender de inmediato la avanzada corrosión de los techos, algunas piezas de las vigas secundarias y las bases de las columnas.</p> <p><u>NO RELACIONADO AL EVENTO SISMICO</u></p>		
	<p>Planchas de techo y purlings en estado avanzado de corrosión.</p> <p><u>NO RELACIONADO AL EVENTO SISMICO</u></p>
