Práctica de: Ingeniería  
Licencia: 15844  
Renglón: Servicio Profesional  
Descripción del Trabajo: Investigaciones  
Fecha de Emisión: 2020-01-23  
Monto Emitido: \$5  
Número de Serie: 1417-8797-7610-7933  
Número de Caso: 11312  
Proyecto / Unidad: ESC SU TORIBIO RIVERA - INSPECCION POST-TERREMOTC  
Rol del Profesional: Evaluador

## OCULAR INSPECTION CHECKLIST

1. **Street Address of the School:** PR-146 KM 14.6, Bo. Fronton  
**City:** Ciales **State:** Puerto Rico **Zip:** 00638
2. **School Name:** SU TORIBIO RIVERA
3. **Date of inspection:** January 22, 2020
4. **Inspector's Name:** Carlos E. Oquendo-Larracuente

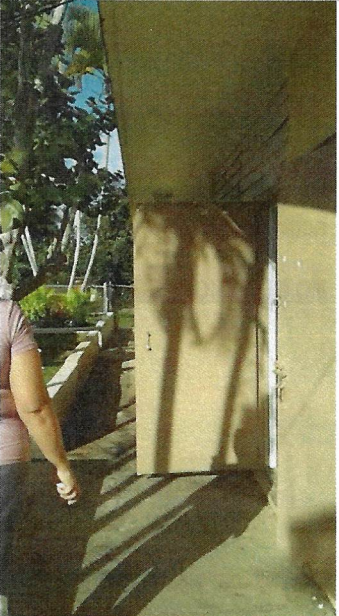
Edificio:	4		
Descripción:	No se observaron daños estructurales.  <b><u>NO RELACIONADO AL EVENTO SISMICO</u></b>

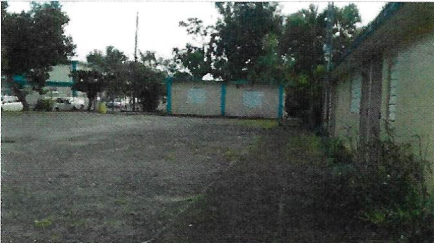
Edificio: 10	No se observaron daños relacionados a la actividad sísmica. No obstante, el problema de humedad en este plantel es muy agudo.  <b><u>NO RELACIONADO AL EVENTO SISMICO</u></b>

Como observación general, la escuela debe ser atendida por problemas de humedad. Se recomienda verificar en detalle si las cisternas están localizadas adecuadamente en términos de soporte estructural.
