## OCULAR INSPECTION CHECKLIST

1. Street Address of the School: PR-130
- City: Hatillo State: Puerto Rico Zip: 00659
2. School Name: Luis Muñoz Rivera
3. Date of inspection: January 13, 2020
4. Inspector's Name: Carlos E. Oquendo-Larracuente

### ANEJO A

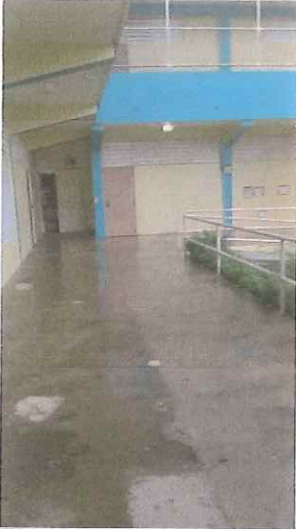
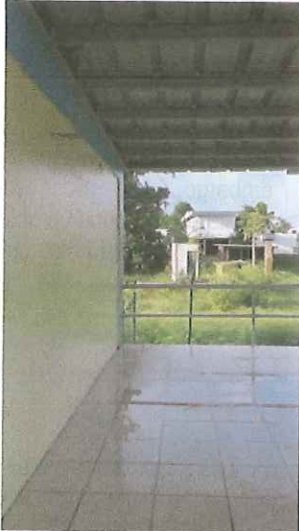
Edificio:	3

Descripción:	No se observaron daños estructurales.  <u><b>NO RELACIONADO AL EVENTO SISMICO</b></u>		
	Canopy en excelentes condiciones.

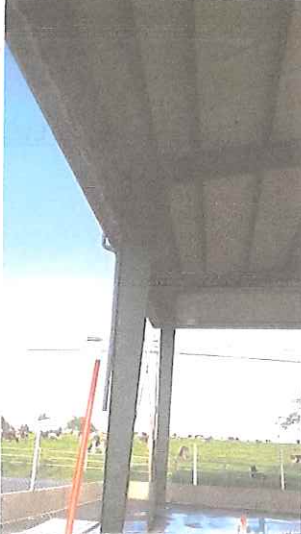
Edificio:	4

Descripción:	No se observaron daños estructurales. No obstante, se recomienda ofrecer mantenimiento a la estructura para evitar que la corrosión avance.  <u><b>NO RELACIONADO AL EVENTO SISMICO</b></u>

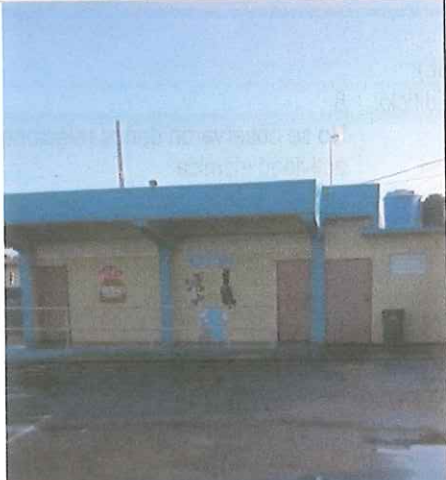
Edificio:	5

Descripción:	<p>No se observaron daños estructurales. Se recomienda revisar si la estructura resiste la carga de las cisternas en funcionamiento.</p> <p><b><u>NO RELACIONADO AL EVENTO SISMICO</u></b></p>		
Edificio:	6

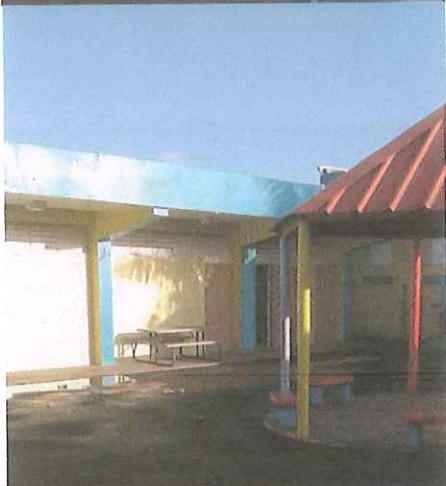
Descripción:	<p>No se observaron daños relacionados a la actividad sísmica.</p> <p><b><u>NO RELACIONADO AL EVENTO SISMICO</u></b></p>		
Edificio:	7

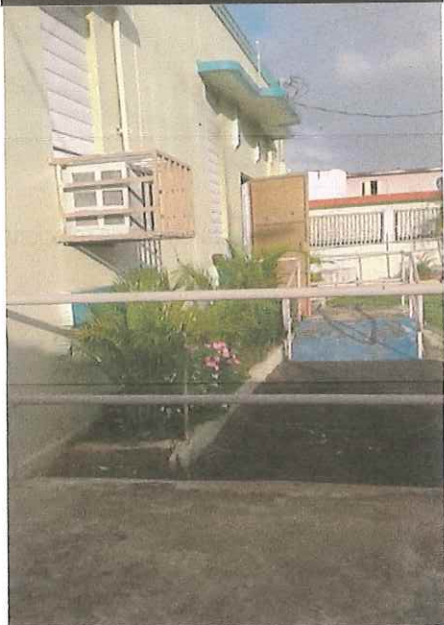
Descripción:	<p>No se observaron daños significativos en el edificio. No obstante, se recomienda evaluar si el techo de este edificio tiene la capacidad para resistir la carga de la cisterna que tiene instalada estando en funciones.</p> <p><b><u>NO RELACIONADO AL EVENTO SISMICO</u></b></p>

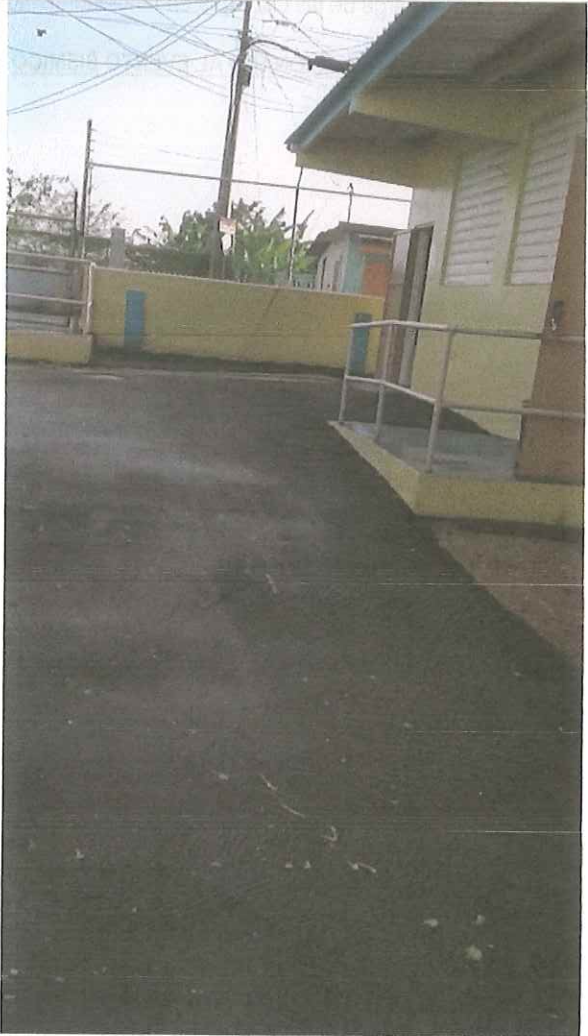
<p>Edificio: 8</p>	<p>No se observaron daños relacionados a la actividad sísmica.</p> <p><b><u>NO RELACIONADO AL EVENTO SISMICO</u></b></p>
