## CARTA DE TRAMITE

Escuela: Carmen N. Peraza Toledo (John Whittier) Código: (11411)

Municipio: Hatillo Fecha de: 13-Jan-20  
Inspección

## OCULAR INSPECTION CHECKLIST

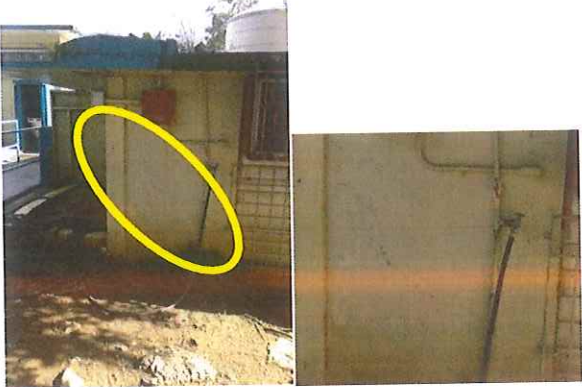
Edificio: 1 Descripción:	No se observaron daños en el edificio. Si se observan serios problemas de humedad en el techos y deficiencias en el drenaje del terreno. Existen grietas en las paredes de bloques, que aunque son preexistentes, ameritan evaluación, antes de que se remedien con un simple empañetado.  <u>NO RELACIONADO AL EVENTO SISMICO</u>

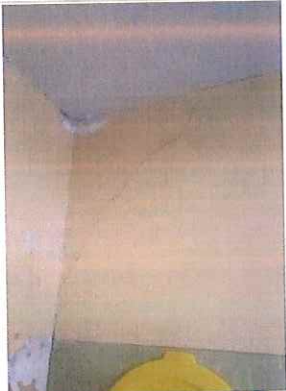
Grieta en el comedor en pared de bloques. Amerita observación y futura evaluación. Esta área tiene muchas grietas preexistentes que requieren atención y una evaluación más detallada de la estructura para asegurar que cualquier reparación que se haga sea la adecuada y no una cosmética.

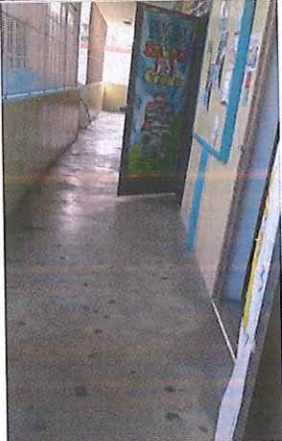
Edificio: 2 Descripción:	No se observaron daños en el edificio. Problemas de humedad.  <u>NO RELACIONADO AL EVENTO SISMICO</u>

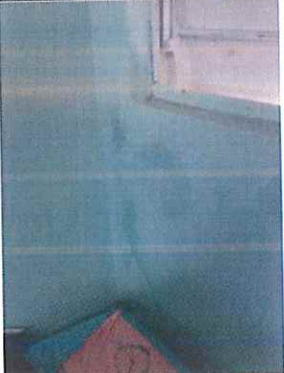
No se observaron daños en el edificio.  <u>NO RELACIONADO AL EVENTO SISMICO</u>

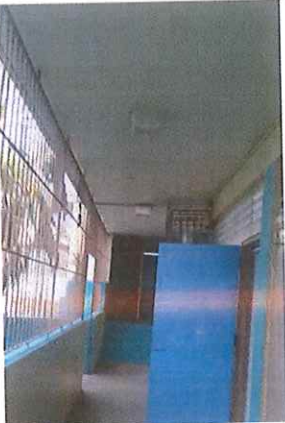
Edificio:	3		
Descripción:	No se observaron daños estructurales.

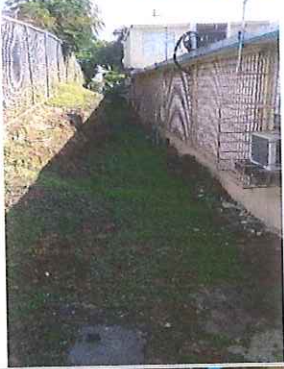
<u>NO RELACIONADO AL EVENTO SISMICO</u>		
Edificio:	4		
Descripción:	No se observaron daños estructurales. No obstante, se recomienda evaluar los problemas de humedad y drenaje sobre el terreno.

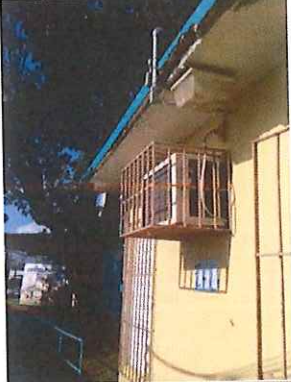
<u>NO RELACIONADO AL EVENTO SISMICO</u>		
Edificio:	5		
Descripción:	No se observaron daños estructurales. Hay problemas de humedad severos en el salón, desprendimiento de plafón de techo, pero lo que nos trae una inquietud es que se indica que el salón fue construido sobre un pozo séptico, el cual se encuentra en desuso. Esto último requiere de una evaluación más detallada.

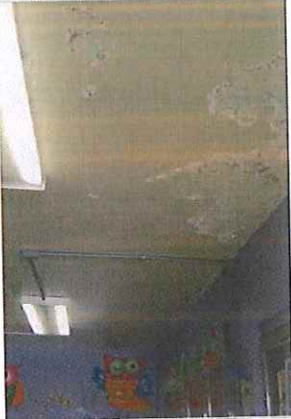
<u>NO RELACIONADO AL EVENTO SISMICO</u>		
	Problemas de humedad.

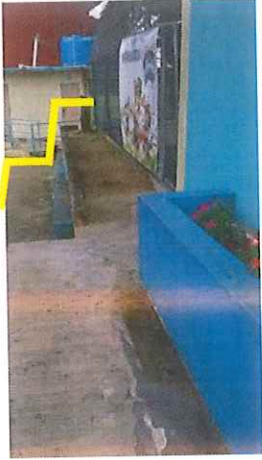
<p>A causa de la diferencia en altura entre el pasillo que da acceso al área de juegos por el exterior, se requiere la construcción de barandas para brindar seguridad a los niños y sus acompañantes.</p> <p><b><u>NO RELACIONADO AL EVENTO SISMICO</u></b></p>
