CARTA DE TRAMITE

Escuela: **Botijas I**

Código: **(12716)**

OCULAR INSPECTION CHECKLIST

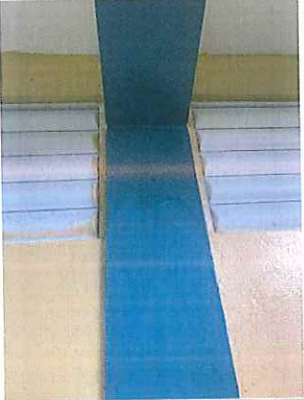
Edificio: 1	Descripción: No se observaron daños.	 
Edificio: 2	Descripción: Grieta en una de las columnas

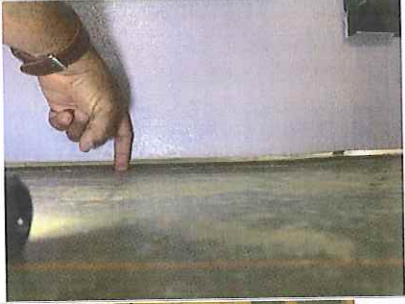
Edificio: 3	Descripción: Grieta entre pared construida y la losa de piso.

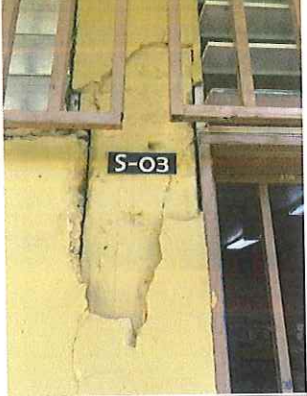
Edificio: 4	Descripción: Grietas existentes en columnas en estructura

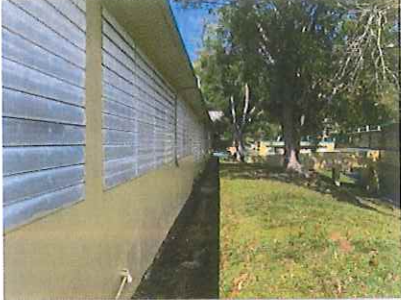
Edificio: 5	
--------------------	--

Descripción:	No se observaron daños.

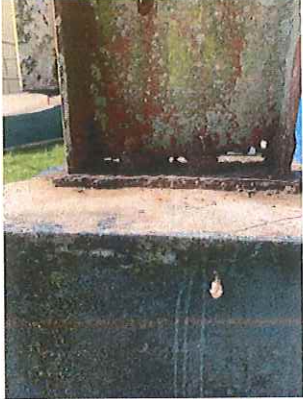
Descripción:	Se observaron daños significativos en el edificio. Base de acero de corroída en muy mal estado en la cancha bajo techo.	
Edificio:	8

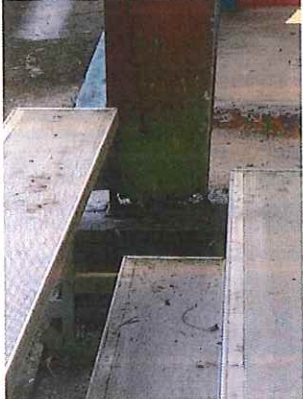
Descripción:	Conexión y base de acero de la cancha de baloncesto techada. Base corroída en cancha bajo techo.
