CARTA DE TRAMITE

Departamento de Educación Dr. Eligio Hernández Pérez Secretario de Educación		
Hora: 12:00pm	Código:	20784
Escuela: Jesús T. Piñero	Fecha de Inspección:	15 de enero de 2020
Municipio: Caguas		
Abrir Escuela (Verde)	1	
Abrir Parcialmente la Escuela (Amarillo)		
No Abrir la Escuela (Rojo)

-			
Α.	GENERAL INFORMATION		
1.	Street Address of the School:	Bo. La Barra	
_	City: Caguas	State: Puerto Rico Zip:	
2.	School Name:	Jesús T. Piñero	
3.	Date of inspection:	January 15, 2020	#C ***

Jesús T. Piñero School Photos

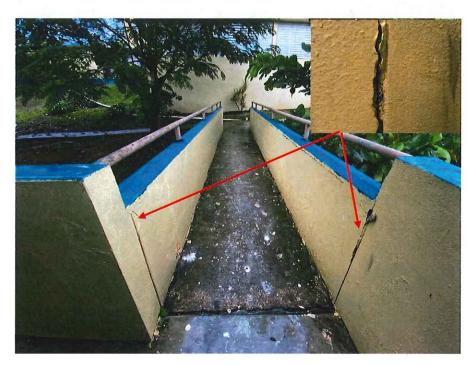
Photo 1: Crack at both sides of the bridge

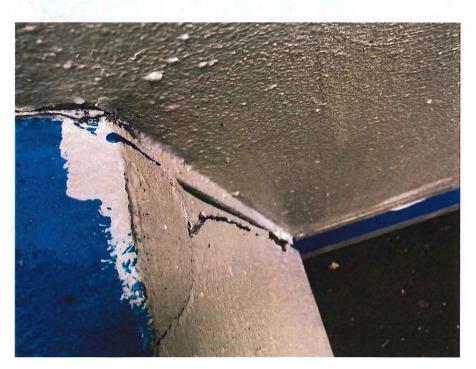
Photo 2: Crack at the side of the bridge

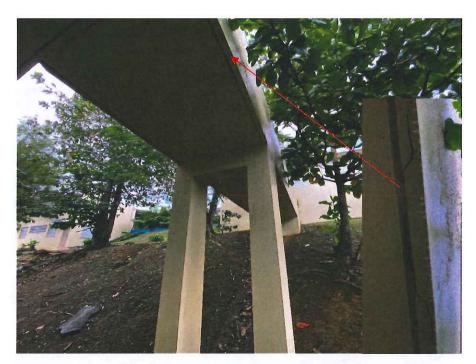
Photo 3: Crack under the bridge

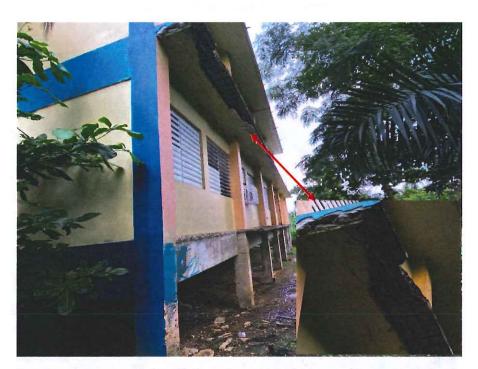
- -One building has short columns but no cracks were observed.
- -Exposed eave reinforcing bars
- -Director indicated that if he cannot use some building, he has 4 rooms available, which were inspected and do not show any damage.

Photo 4: Exposed eave reinforcing bars

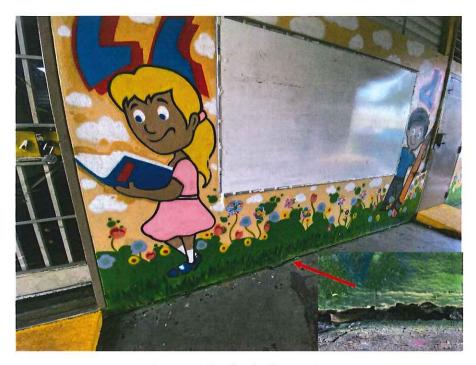
Photo 5: Crack on floor/wall intersection

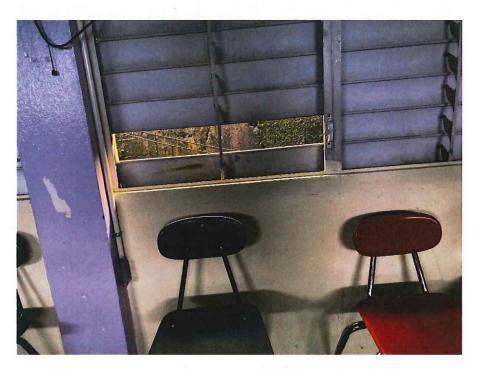
Photo 6: Damaged window

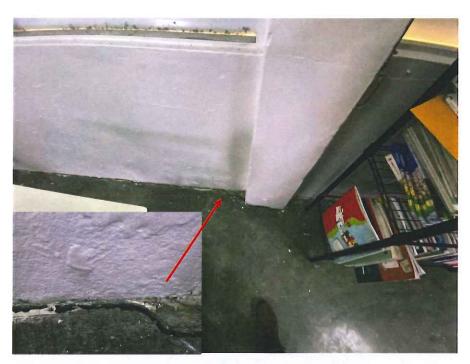
Photo 7: Crack floor/wall intersection

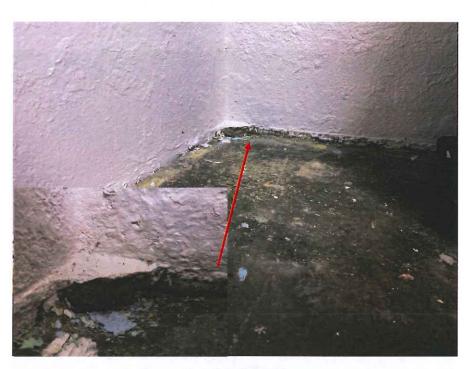
Photo 8: Undercut slab

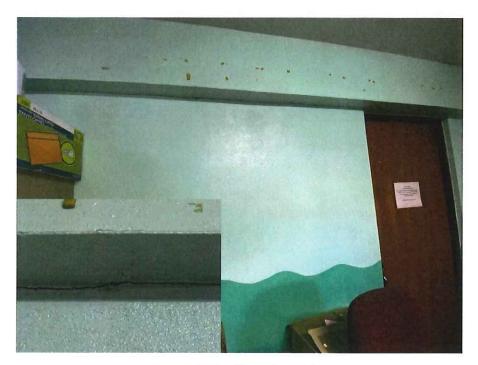
Photo 9: Crack wall/beam intersection
