Hoja de Trámite

Escuela: LUIS MUÑOZ RIVERA Codigo: 20834

OCULAR INSPECTION CHECKLIST

G. RECOMENDACIÓN AL SECRETARIO

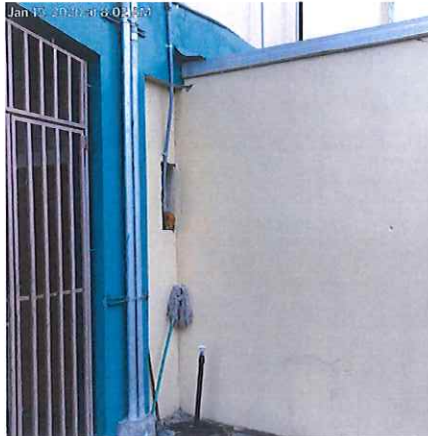
Grieta en empate de estructura principal con estructura accesorio

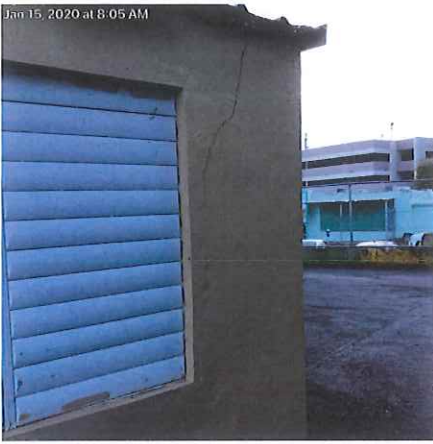
ISSUE # 9	ISSUE Grieta en esquina pared superior e inferior ventana.

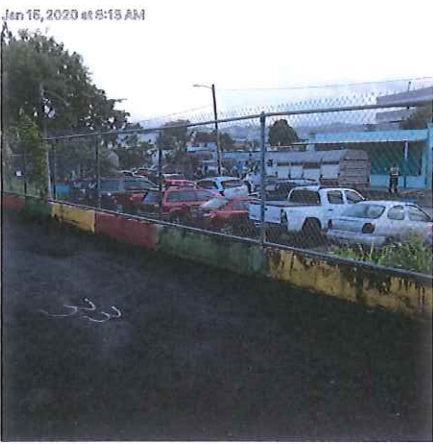
ISSUE # 12	ISSUE Grietas en pared de verja de metal eslabonado

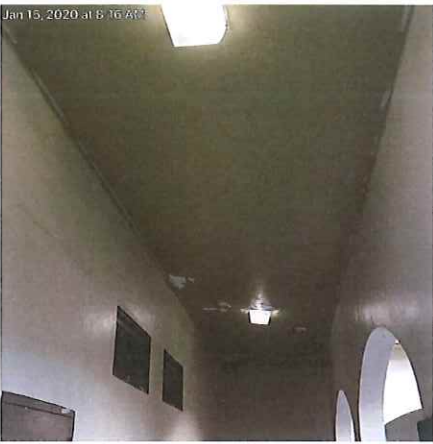
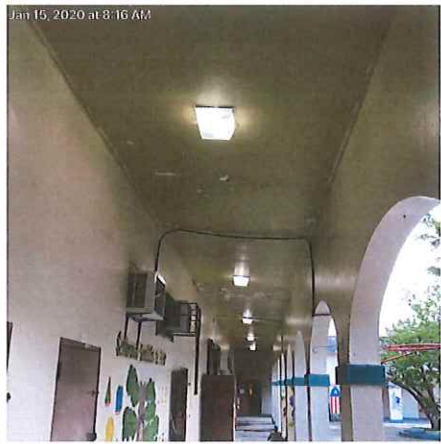
ISSUE # 13	ISSUE Filtración en techo

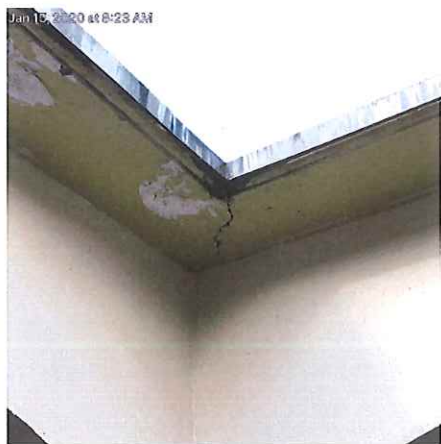
ISSUE #	ISSUE Grieta en techo. Condición previo al evento sísmico. Se recomienda atención inmediata	  <p>Jan 15, 2020 at 8:21 AM</p>

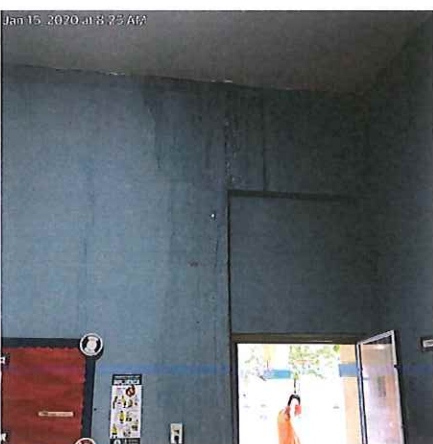
ISSUE # 15	ISSUE Humedad en pared

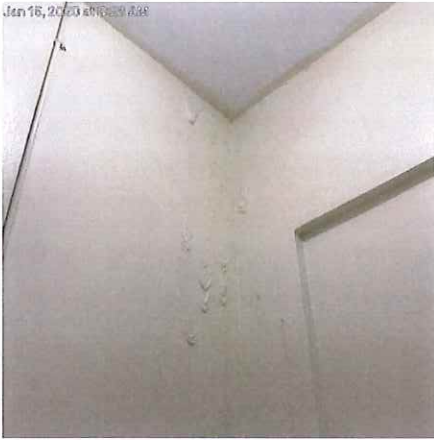
ISSUE # 16	ISSUE Humedad en paredes

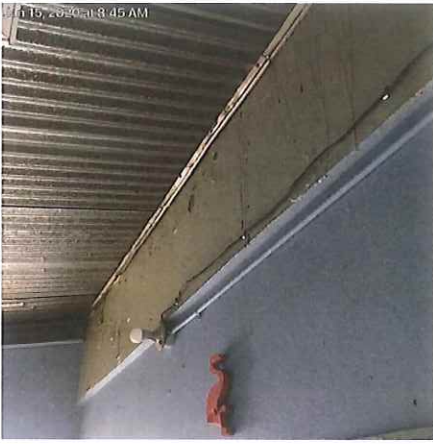
ISSUE # 20	ISSUE Humedad en pared entre biblioteca y ofic trabajadora social

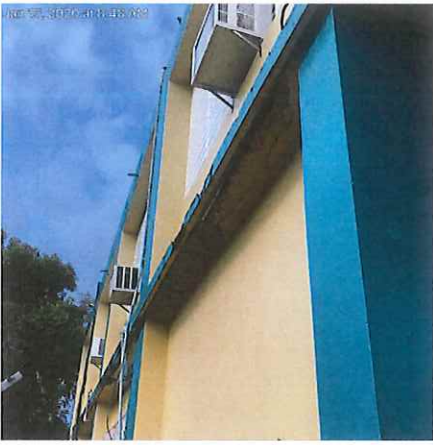
ISSUE # 21	ISSUE Varillas expuestas. Requiere atención

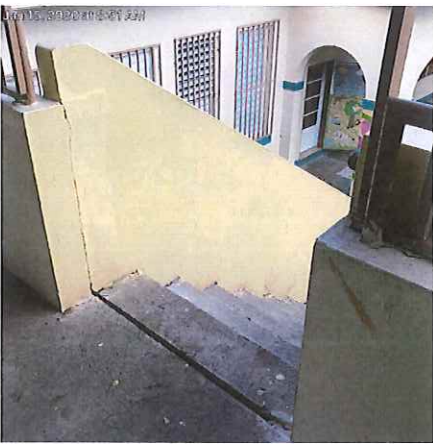
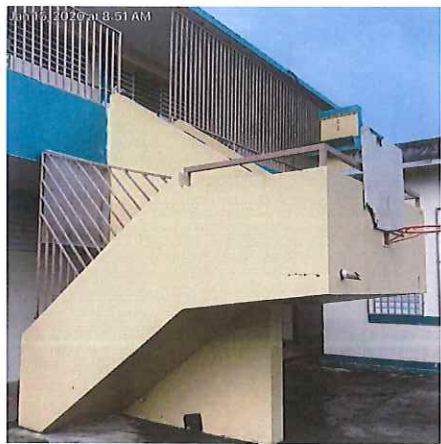
ISSUE #	ISSUE Grietas en empate escalera. Condición previa al sismo. Estructuras actúan separadas

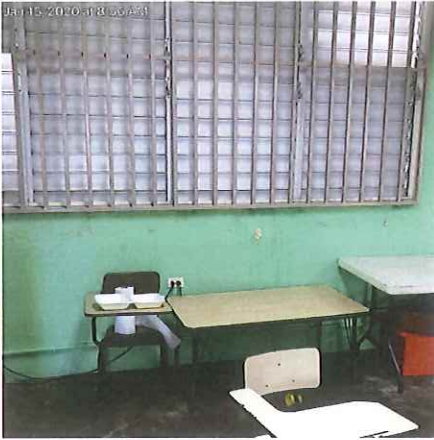
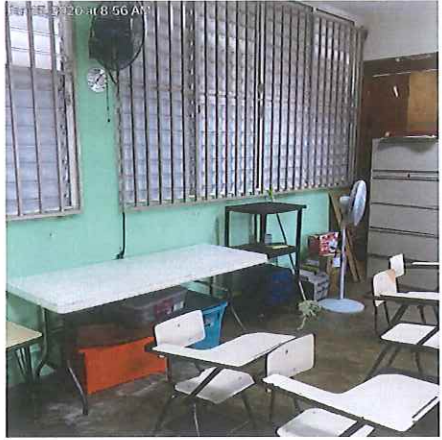
ISSUE # 24	ISSUE Reflejo humedad en pared

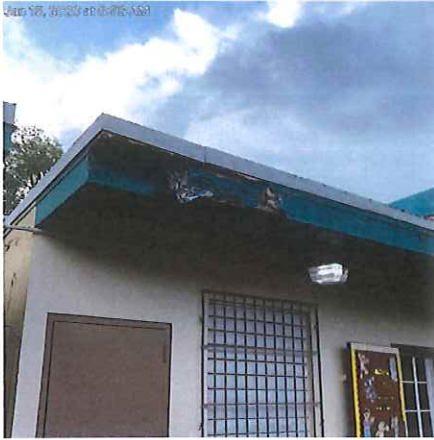
ISSUE # 25	ISSUE Desprendimiento de empañetado y madera comprometida

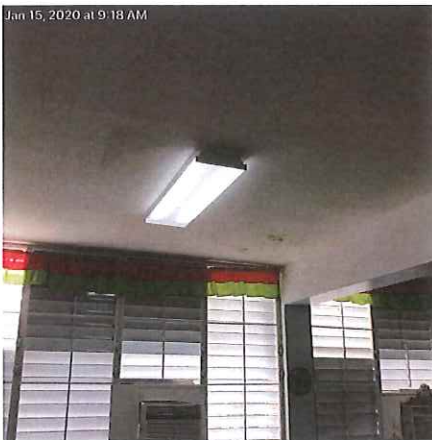
ISSUE # 30	ISSUE Humedad en techo

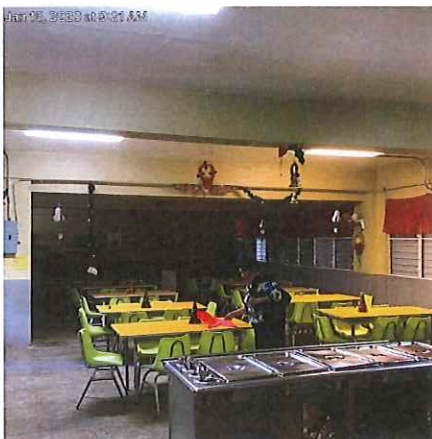
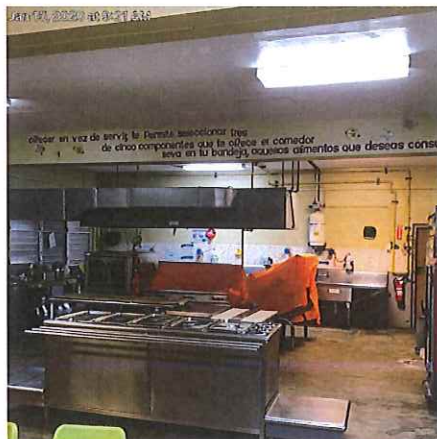
ISSUE # 31	ISSUE Condición actual. Equipos funcionales

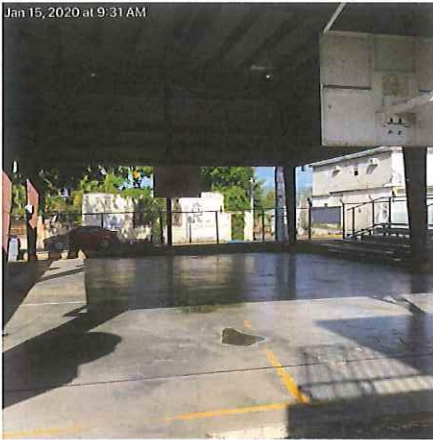
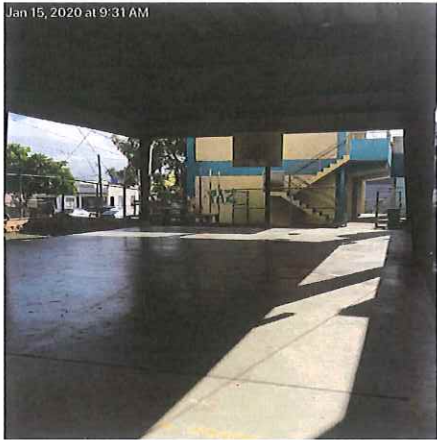
ISSUE # 32	ISSUE Algunas tuercas de pernos en columnas están corroídas. Se sugiere atención	 	 
FLOOR Cancha			
ROOM	COMMENT		
SHEET			
STATUS INCOMPLETE			
ASSIGN TO	RESOLUTION DATE

1. Cancha - Tuercas en pernos corroídos. Limitar acceso hasta su reparación. Tomar provisión para áreas aledañas
2. Edif A - Corregir grieta en techo
3. Comedor - Reparar techo de acero previo a su uso. Limitar acceso hasta reparación
4. Edif B - Pasillo frente salón 10. Remover empañetado previo a su uso. Coordinar para reparar.
5. Edif B - Detras Baños. Reparar varillas expuestas
6. Edif B - Pasillo Almacén. Reparar viga y empañetado
7. Edif C, Salones 19 y 18. Remover empañetado previo a su uso
