CARTA DE TRAMITE

Escuela: **Carmen Benítez**

Código: **(30841)**

OCULAR INSPECTION CHECKLIST

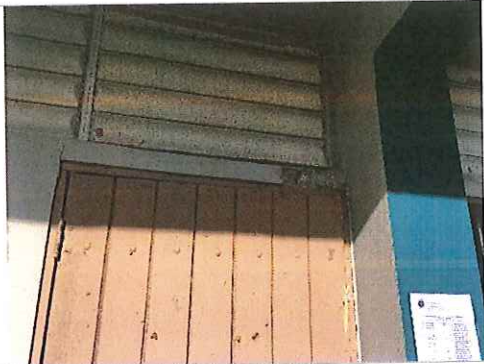
Descripción	<p>Salón # 14</p> <p>Se observó desprendimiento de hormigón en mocheta de puerta en el salón # 14. En nuestra opinión, no representan riesgo de seguridad.</p>	
Edificio:	B

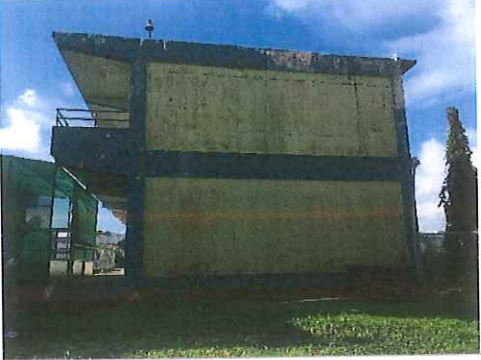
Descripción	<p>Pared lateral exterior</p> <p>Se observaron grietas en empañetado. En nuestra opinión, no representan riesgo de seguridad.</p>

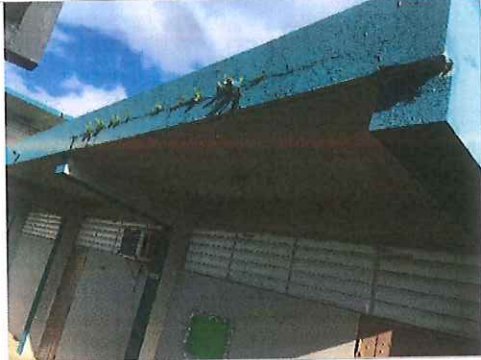
Edificio: Descripción	<p>B1</p> <p>Parapeto</p> <p>Se observó grieta en empañetado. En nuestra opinión, no representa riesgo de seguridad.</p>

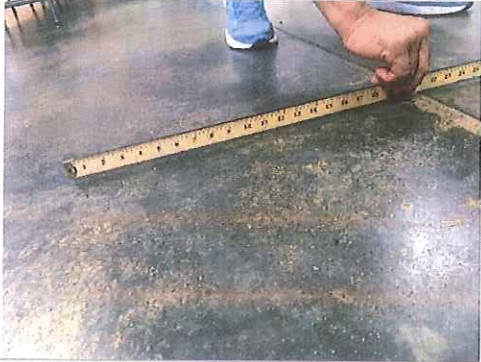
Descripción	<p>Piso</p> <p>Se observó desnivel en losa de piso. Se recomienda que NO se utilice este edificio hasta que se evalúen y corrijan todos los defectos señalados.</p>

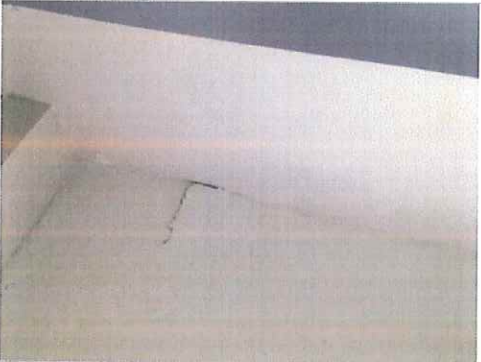
Edificio:	F	
Descripción	<p>Pared interior</p> <p>Se observaron grietas pronunciadas en pared en el salón # 51. Se recomienda que NO se utilice este edificio hasta que se evalúen y corrijan todos los defectos señalados.</p>

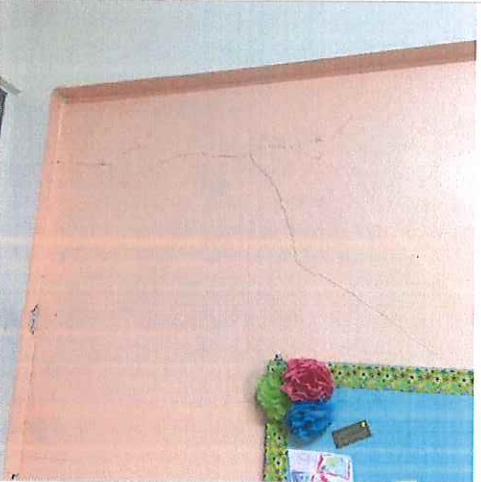
Edificio:	F	
Descripción	<p>Pared interior</p> <p>Se observaron grietas pronunciadas en pared en el salón # 52. Se recomienda que NO se utilice este edificio hasta que se evalúen y corrijan todos los defectos señalados.</p>

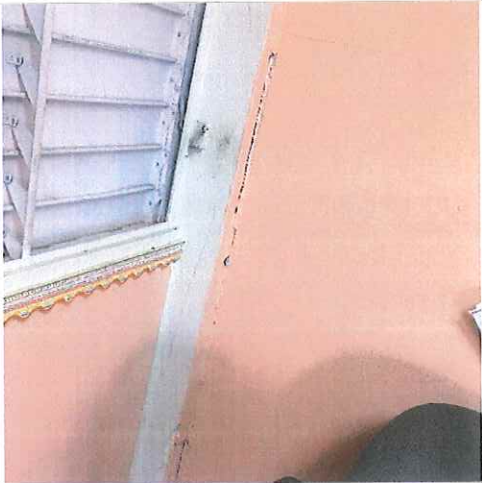
Descripción	<p>Pared interior</p> <p>Se observaron grietas pronunciadas en pared en el salón # 52. Se recomienda que NO se utilice este edificio hasta que se evalúen y corrijan todos los defectos señalados.</p>

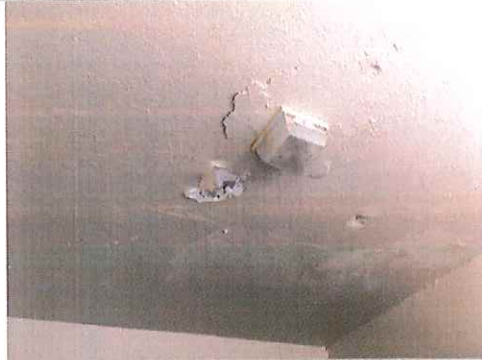
Edificio:	F	
Descripción	<p>Baños de niñas</p> <p>Se observó empañetado caído en plafón.</p> <p>Se recomienda que NO se utilice este edificio hasta que se evalúen y corrijan todos los defectos señalados.</p>

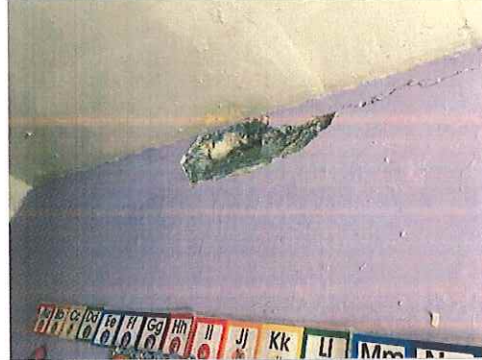
En adición a las áreas indicadas, recomendamos que los salones #35 y #36 del edificio E, #44 del edificio G y el # 70 del edificio C no se utilicen por existencias de grietas pronunciadas y desprendimientos de empañetados.

Edificio:	E	
Descripción	<p>Pared Interior – Salón #35</p> <p>Se observó empañetado caído y hormigón desprendido en pared divisoria entre los salones 35 y 36.</p> <p>Se recomienda que NO se utilicen estos 2 salones hasta que se evalúen y corrijan los defectos señalados en los mismo</p>

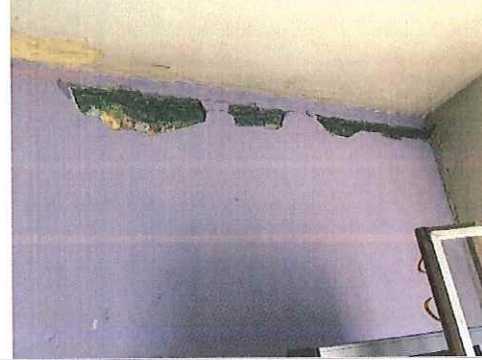
Edificio:	E	
Descripción	<p>Pared Interior – Salón #35</p> <p>Se observó empañetado caído en pared divisoria entre los salones 35 y 36.</p> <p>Se recomienda que NO se utilicen este edificio hasta que se evalúen y corrijan todos los defectos señalados en los mismo</p>

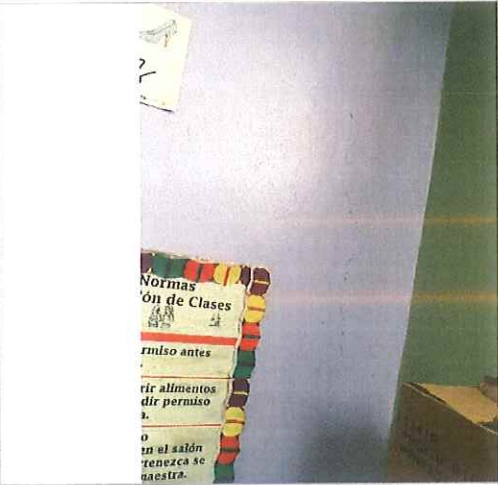
Descripción	<p>Pared Interior – Salón #41</p> <p>Se observaron grietas en empañetado. En nuestra opinión, no representan riesgo de seguridad.</p>

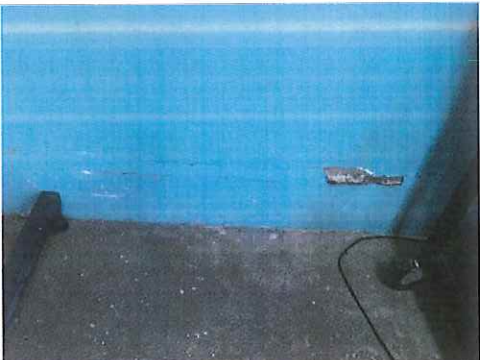
Edificio:	D	
Descripción	<p>Pared Interior – Salón #41</p> <p>Se observó empañetado desprendido. En nuestra opinión, no representan riesgo de seguridad.</p>

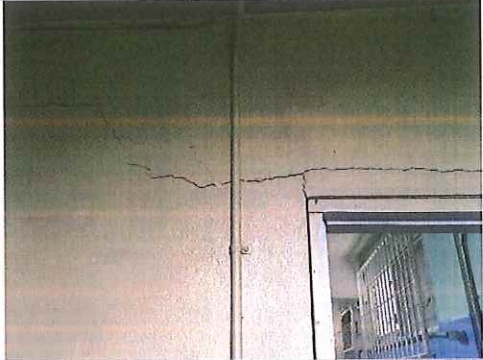
Edificio:	G	
Descripción	<p>Pared interior – Salón #44</p> <p>Se observaron grietas pronunciadas en pared en el salón # 44. Se recomienda que NO se utilice el mismo, hasta que se evalúe y corrija este defecto.</p>

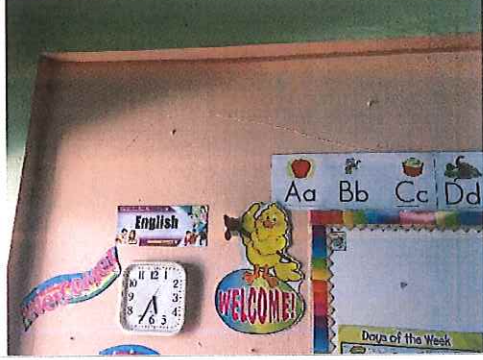
Edificio:	C	
Descripción	<p>Pared Interior – Salón #65</p> <p>Se observaron grietas en empañetado. En nuestra opinión, no representan riesgo de seguridad.</p>

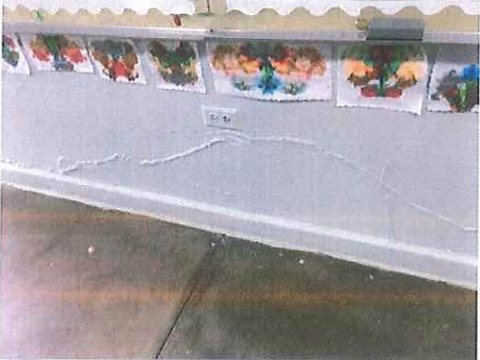
Descripción	<p>Pared Interior – Salón #64</p> <p>Se observaron grietas en empañetado. En nuestra opinión, no representan riesgo de seguridad.</p>

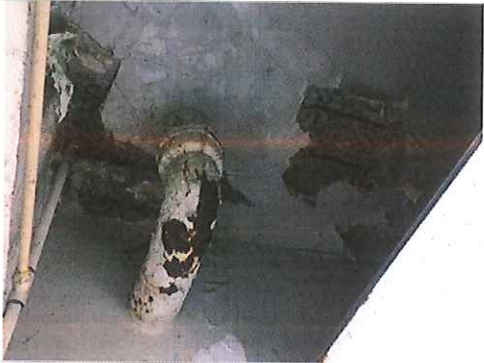
C	
Descripción	<p>Plafón – Área #70</p> <p>Se observó desprendimiento empañetado de plafón y varillas expuestas. Se recomienda que NO se utilice esta área, hasta que se evalúen y corrijan estos defectos.</p>

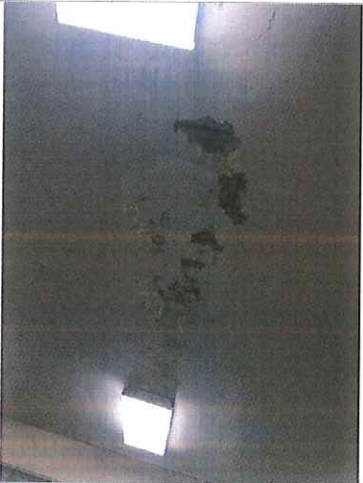
C	
Descripción	<p>Plafón – Salón #60</p> <p>Se observó desprendimiento empañetado de plafón y varillas expuestas. En nuestra opinión, no representan riesgo de seguridad.</p>

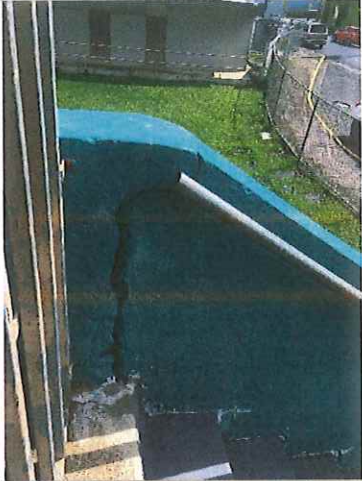
Descripción	<p>Escaleras</p> <p>Se observó grieta pronunciada en muro de escaleras. Se recomienda que NO utilizar la misma, hasta que se evalúe y corrija este defecto.</p>

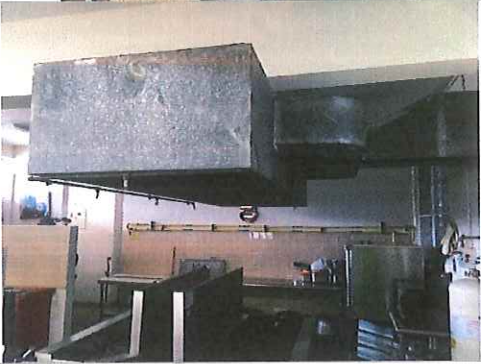
Descripción	<p>Campana Comedor</p> <p>No se sintió olor a gas.</p>

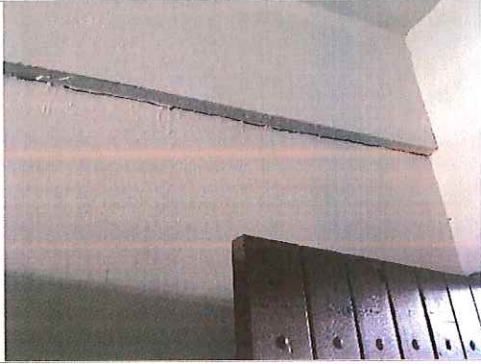
Edificio	B	
Descripción	<p>Cuarto de Neveras del Comedor</p> <p>Se observó grieta profunda en unión de pared con viga en este cuarto. Se recomienda que NO se utilice este espacio hasta que se evalúe y corrija este defecto.</p>

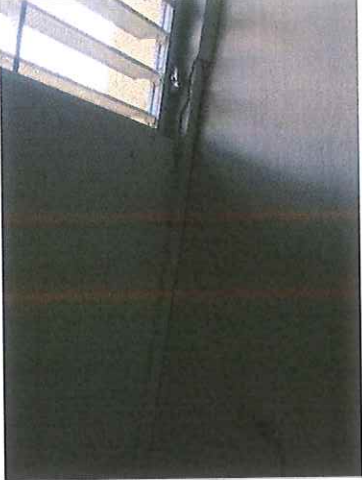
Descripción	Cuarto de Neveras del Comedor Se observó grieta profunda en unión de pared y columna en este cuarto. Se recomienda que NO se utilice este espacio hasta que se evalúe y corrija este defecto.

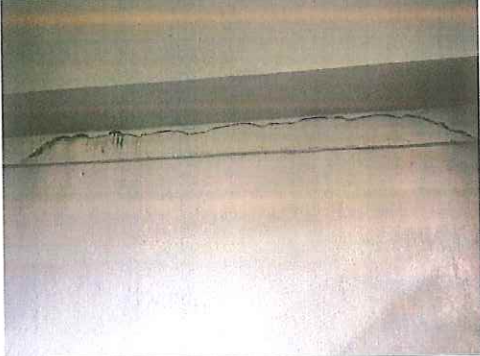
Edificio	B	
Descripción	Salón #12 Se observó empañetado desprendido en pared interior. En nuestra opinión, no representan riesgo de seguridad.
