CARTA DE TRAMITE

Escuela:	James Garfield	Código:	40915
Municipio:	Cabo Rojo	Fecha de Inspección:	17-enero-2020

OCULAR INSPECTION CHECKLIST

G. RECOMENDACIÓN AL SECRETARIO

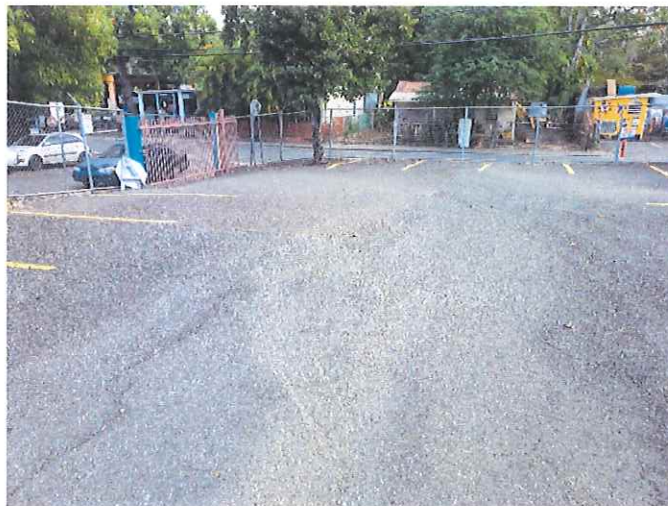
- Patterns of cracking, not attributed to the seismic events, were noted on ground surface.

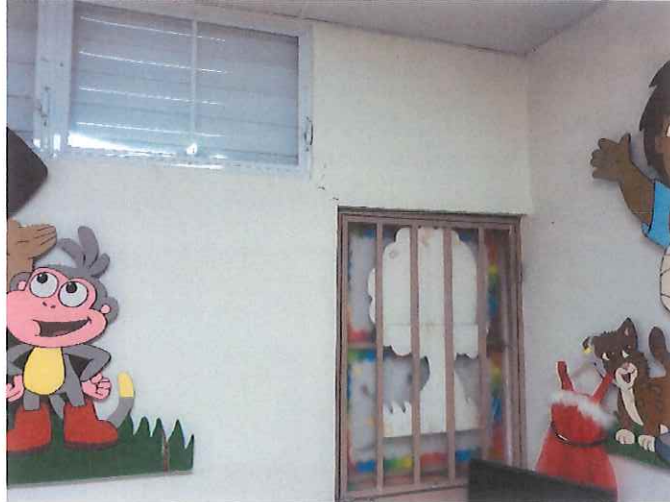
- Cracks on window and door openings were noted in the library and autism classrooms but these defects are not attributed to the ground motion events prior to our site visit. In an interview with the school director and personnell, they confirmed that these cracks were present prior to the ground motion events.

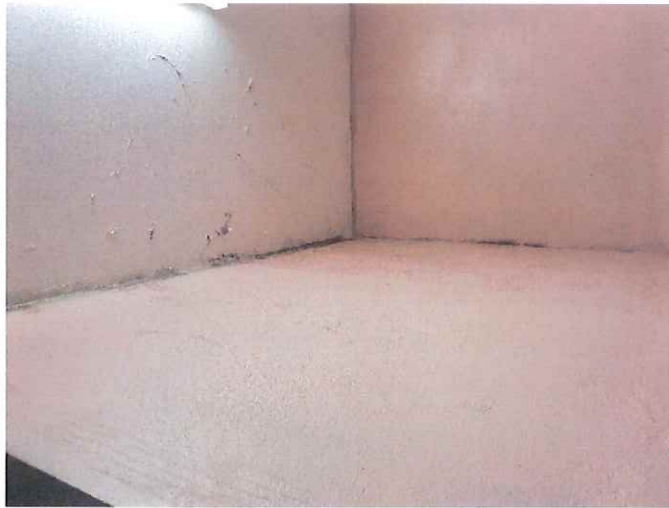
- Evidence of water infiltration from roofing was persistent in every building but not attributed to the ground motion events. Due to this defects, some spalling and delimitation of concrete was observed on interior ceiling. This might represent a falling object hazard and it is recommended to be repaired.

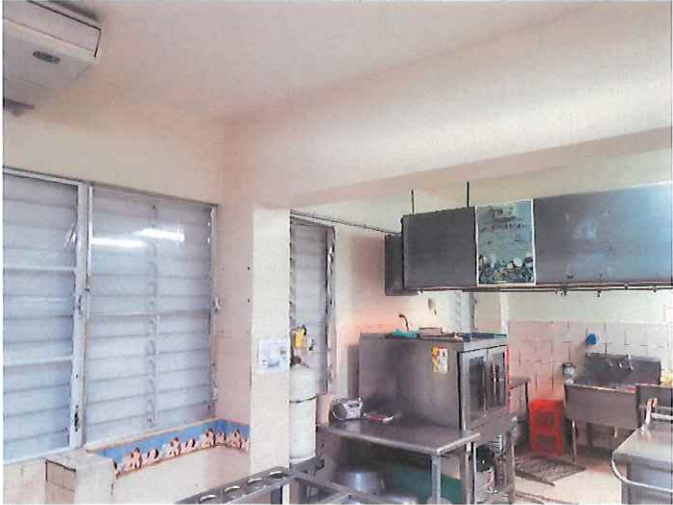
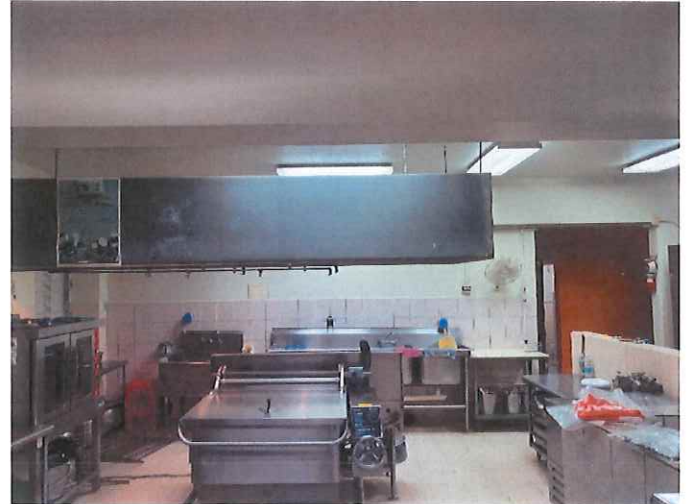
* No damage was noted on dining room, however, the exhaust hood is not properly restrained.

- The exhaust hood on the dining room is not properly restrained and this might represent a hazard during a strong ground motion event. It is recommended to be restrained.

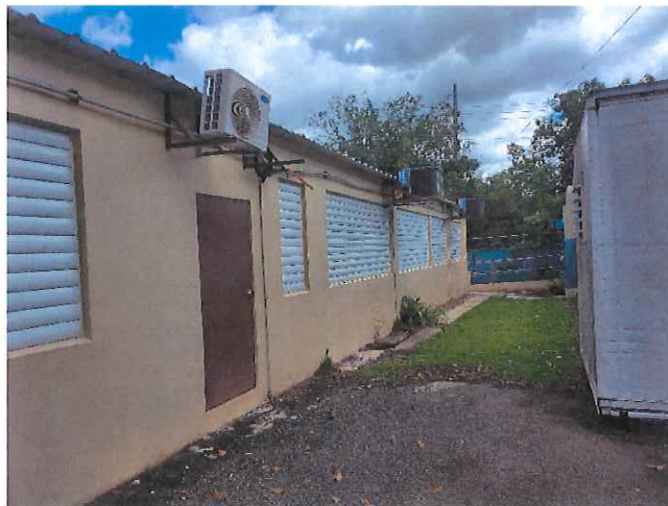
- All condensers and equipment externally attached are recommended to be properly restrained.
