# CARTA DE TRAMITE

Escuela:	Pedro N. Colberg	Código:	40980
Municipio:	Cabo Rojo	Fecha de Inspección:	17-enero-2020

Inspección Visual: Escuela Pedro Nelson Colberg  
Carretera PR-102, Sector Pueblo Nuevo, Cabo Rojo  
Código: 40980  
Directora: Vanessa Álvarez Montalvo  
Fecha de Inspección: 17 de enero de 2020  
Hora Entrada: 9:30AM / Hora Salida: 4:30PM  
Año de Construcción de la escuela: 1953 (aprox.)

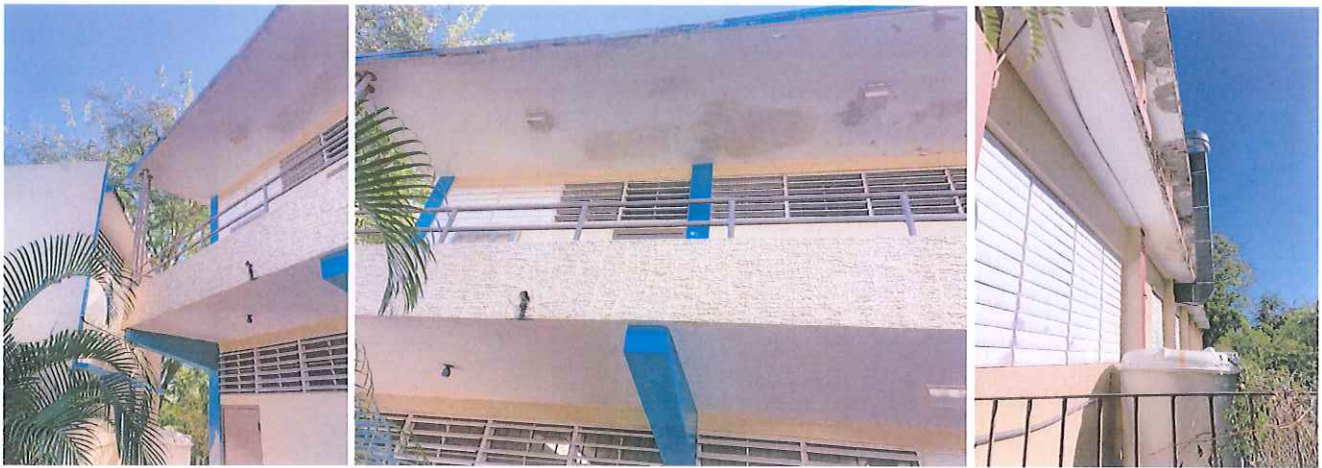
- Deflexión observada en techo del pasillo (techo del pasillo esta soportado con 3-tubos de metal en cada extremo). En la parte posterior(externo) se observó pintura despegada, área dañada con refuerzo expuesto en el alero (al lado de la campana de extractor).

Fotos: Deflexión en techo pasillo del segundo piso

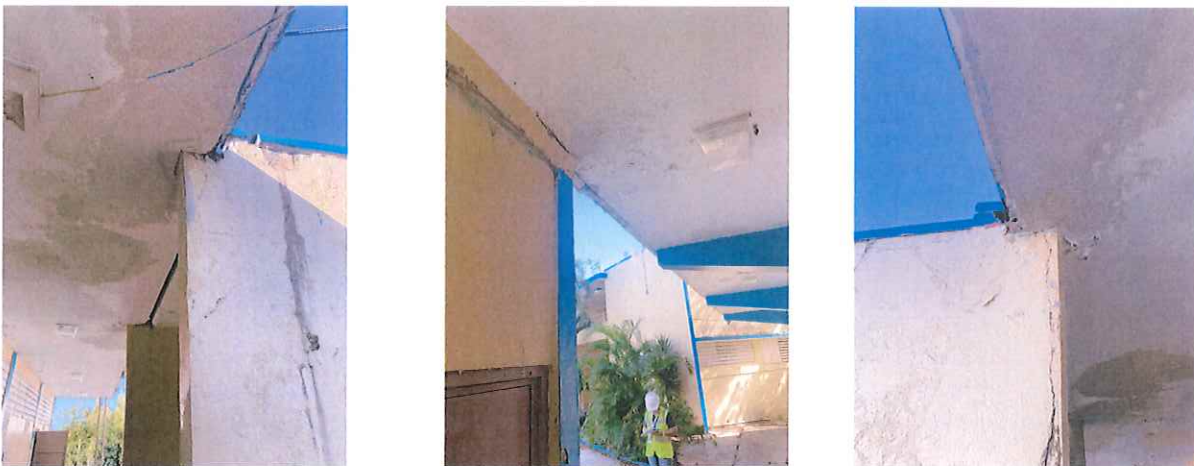
- Grietas observadas entre techo del pasillo del segundo piso y conexión con la estructura de escaleras. En adición, se observaron manchas de humedad del techo.

Fotos: Conexión entre techo y estructuras de escaleras.

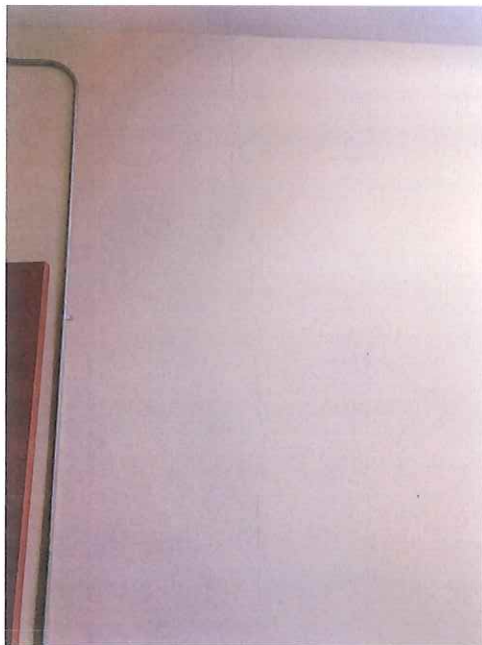
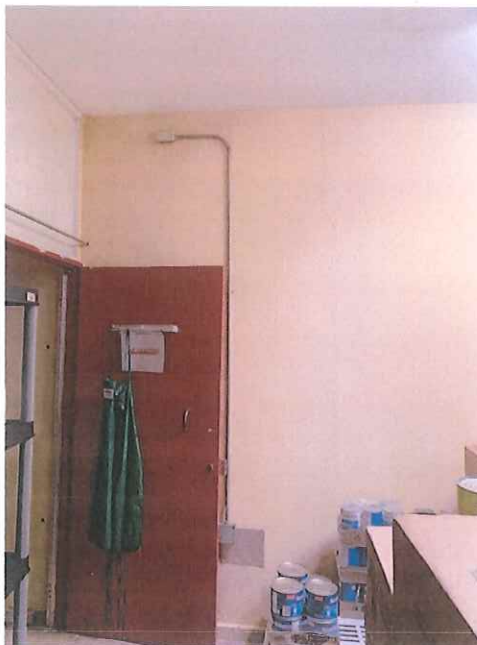
- Se observó una grieta en la pared transversal del área del almacén del comedor (desde el techo hasta mas de la mitad de la pared). Esta grieta no se refleja al otro lado de la pared.

Fotos: Grieta en área del almacén del comedor.

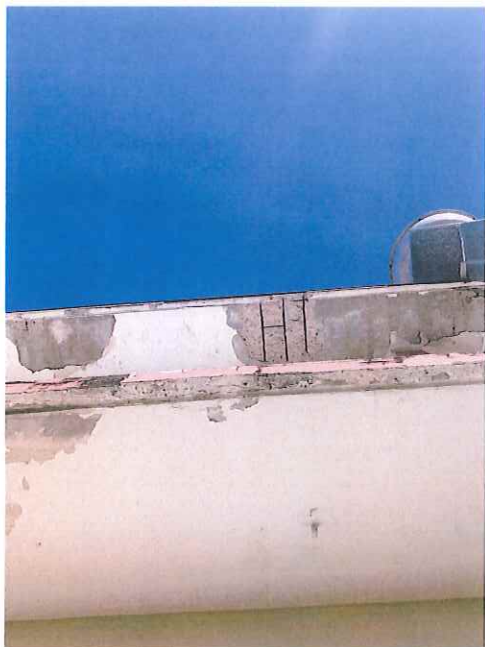
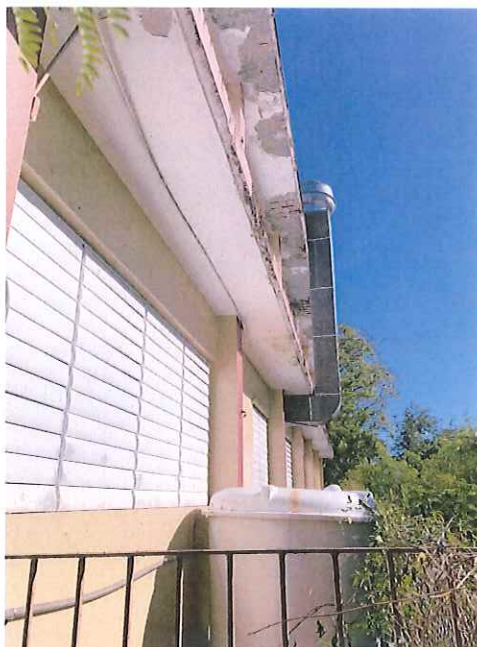
- En la parte posterior (externo) se observó pintura despegada en el alero. Se observó un área del alero en la estructura de las escaleras dañado (varilla expuesta).

Fotos: Condición del alero en parte posterior del edificio.

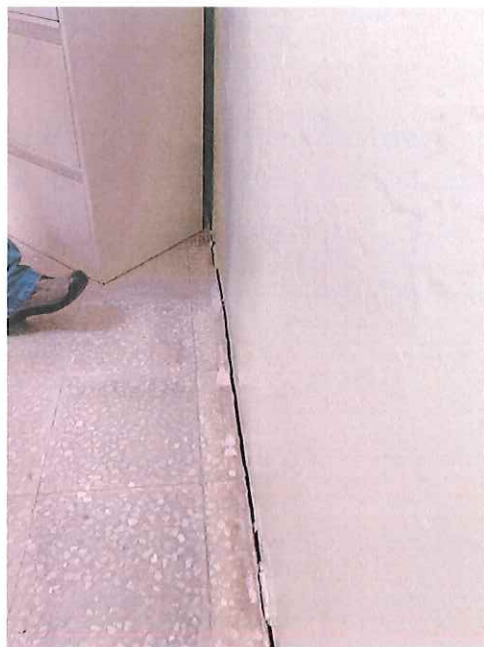
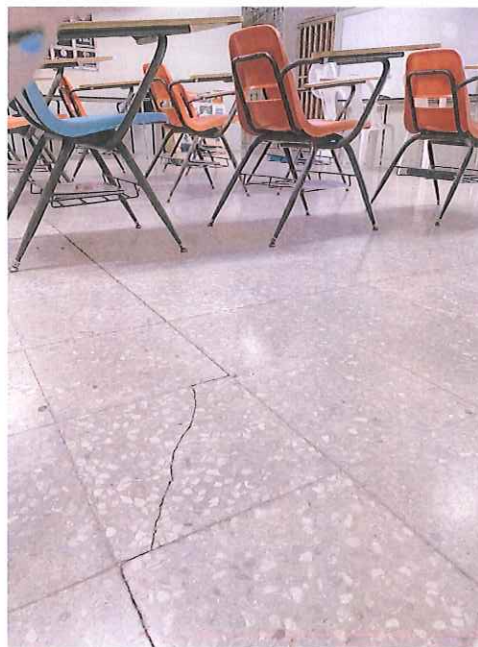
Observaciones generales: Dentro de ambos salones, se observaron una separación entre piso y pared posterior. Varias grietas entre las losetas de piso. Tratamiento de techo despegado en el borde del techo(pasillo). Pintura deteriorada o dañado alrededor del edificio. Separación entre pared exterior y piso. Grietas menores en techo y paredes, áreas con pintura o empañetado despegado en pared y techo. Varias grietas en áreas de marcos de ventanas. Estos daños aparentan no estar relacionados al evento sísmico. Además, se observaron deficiencias de columna corta lo que representa una vulnerabilidad en el caso de un movimiento telúrico. Por el año de construcción de la escuela (1953- lo cual no se diseñaban con código de terremotos) esta estructura no fue diseñada bajo los códigos actuales, lo cual la hace vulnerable en eventos sísmicos.

Fotos: Separación de loza de piso y pared y grieta en losetas.

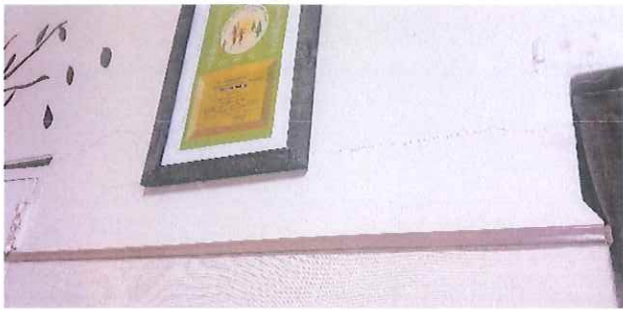
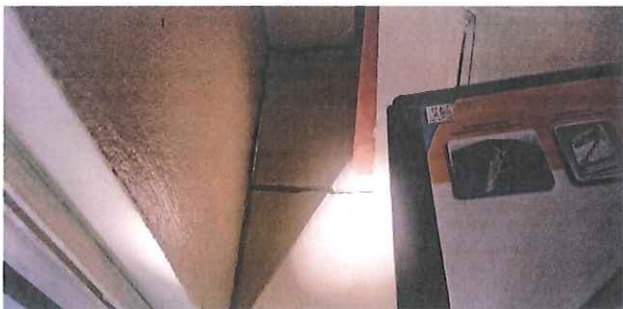
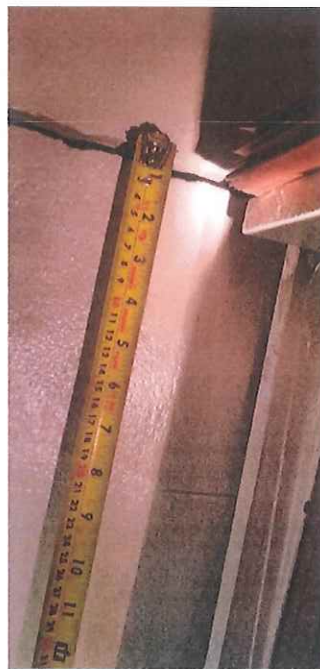
Se observaron varias grietas en paredes de la oficina de la directora y área de almacén. La grieta dentro del almacén es pronunciada (al menos 0.5" de ancho). También se observó una separación de pared y viga y grieta horizontal en la pared.

Fotos: Grietas en paredes de oficina.

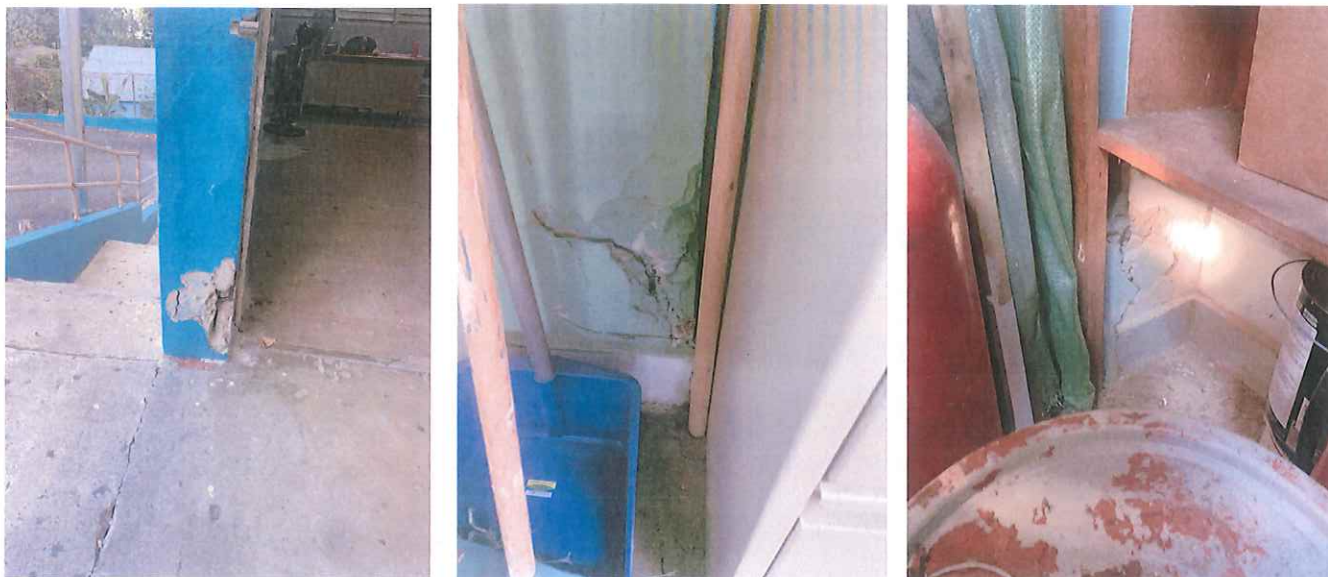
Se observaron varias columnas deterioradas en el primer piso del edificio. Estos daños en las columnas (y deformaciones) se observan dentro y fuera del salón, en al menos 3 columnas.

Fotos: Base de columnas en el primer piso deterioradas.

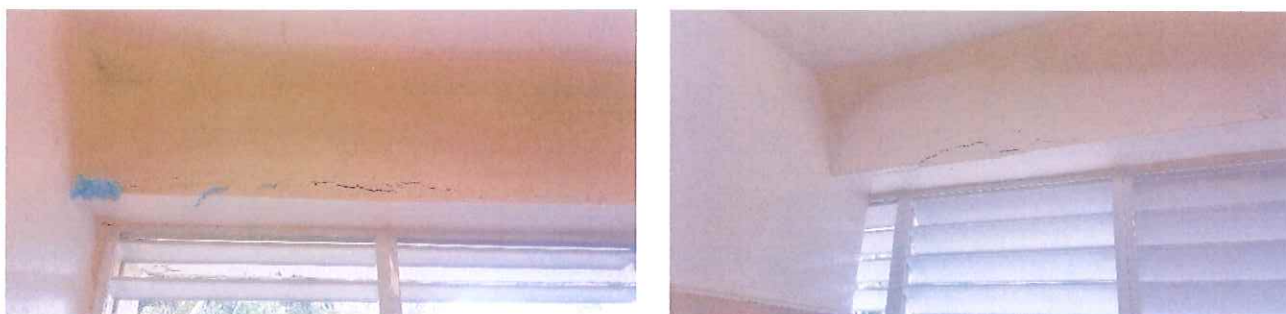
Se observaron grietas horizontales en la viga (encima de las ventanas) de los baños.

Fotos: Grietas horizontales en vigas (baños).

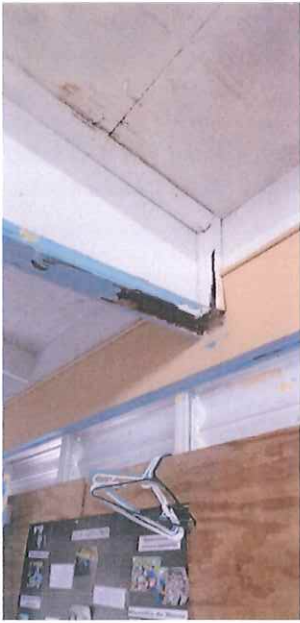
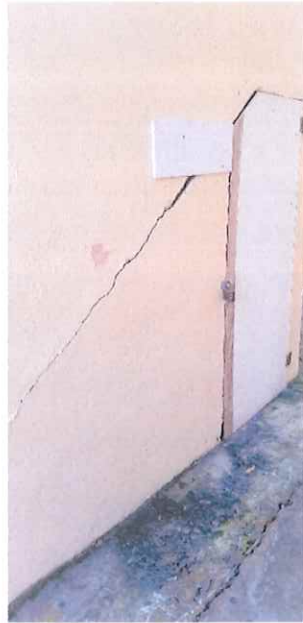
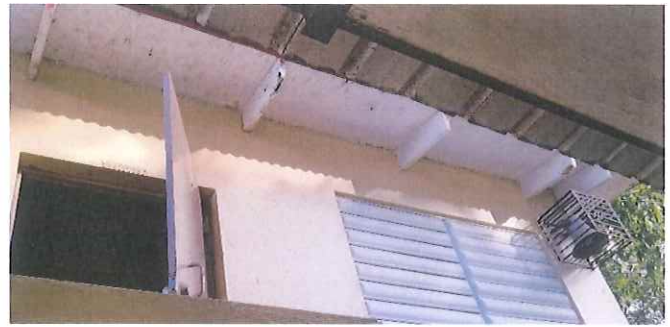
Se observó la escalera de acceso al 2ndo nivel con grieta pronunciada. También se observaron deficiencias en el techo y vigas de madera del segundo nivel.

Fotos: Deficiencias en segundo piso y grieta en escalera.
