CARTA DE TRAMITE

Escuela:	Antonio Acarron	Código:	41020
Municipio:	Cabo Rojo	Fecha de Inspección:	18-enero-2020

OCULAR INSPECTION CHECKLIST

Inspección Visual: Escuela Antonio Acarrón Correa
Carretera PR-102, Cabo Rojo
Código: 41020
Principal: Barbara Gregory Dávila
Fecha de Inspección: 18/enero/2020
Construcción: 2008-2009
Inauguración: 2010

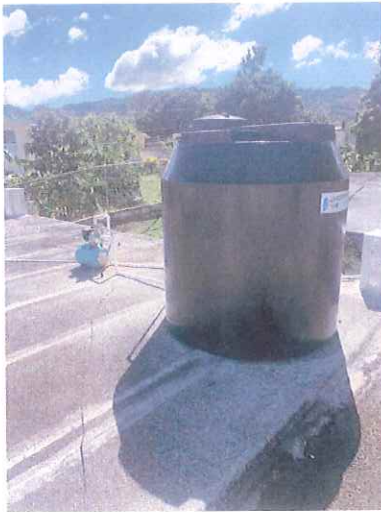
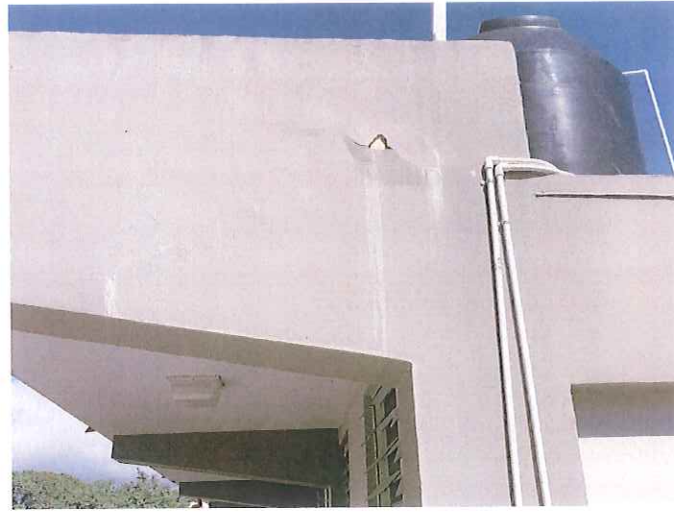
NOTA: Se observó cisterna de agua instalada en el techo, cerca del alero y sin anclajes. Se recomienda relocalizar cisterna en lugar más seguro.

Fotos: Cisterna en techo de comedor

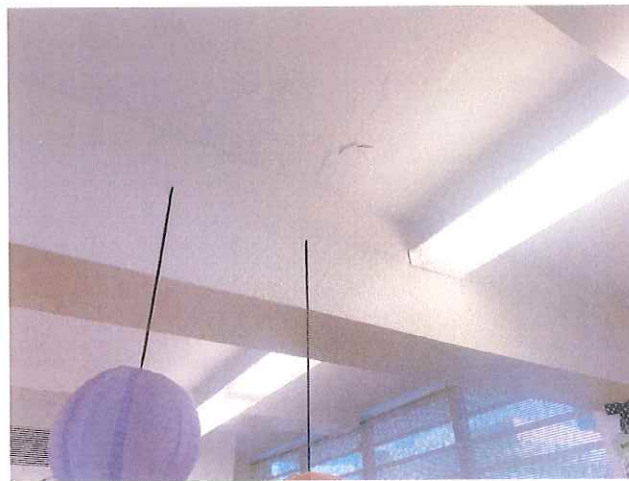
Fotos: Edificio 8 (salon 01)

Edificio de un nivel, en hormigón. Se observaron grietas leves en paredes, marcos de puertas y ventanas. Se observaron áreas en el techo de pintura y empañetados despegados. Paredes exteriores con áreas de pintura dañada. Se observaron varias grietas leves en paredes exteriores. Estos daños no aparentan estar relacionados al evento sísmico.

NOTA: Se recomienda reparar el techo interno del salón, debido a las áreas de empañetados despegados.

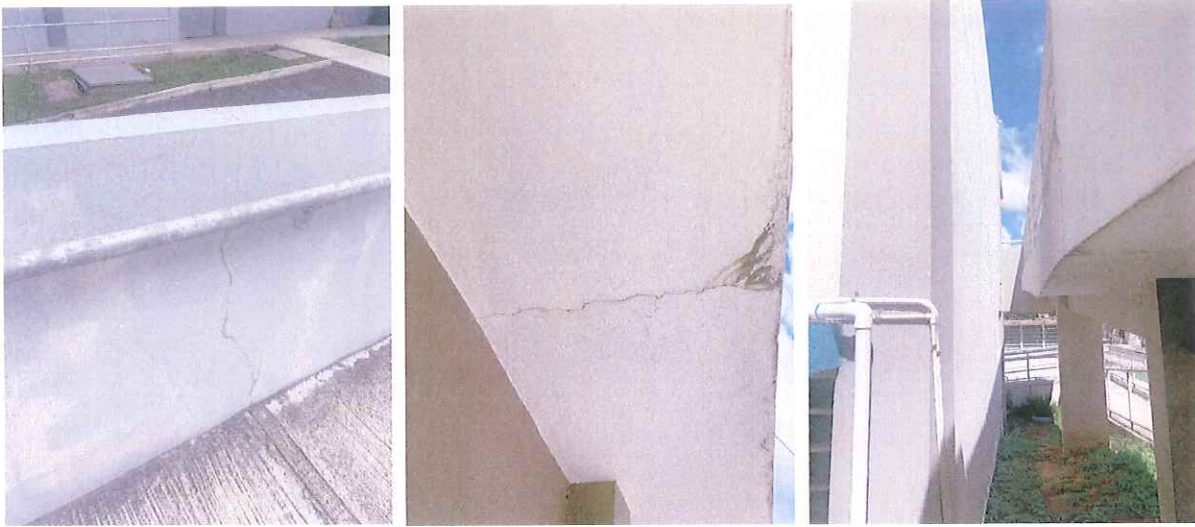
- b. Pórtico de entrada a la escuela - se observó separación entre techo del pórtico y edificio #1 (junta) y varias grietas en el área de la junta. Estructura de techo esta soportada por varias columnas, no se observaron daños en el techo o columnas. Estos daños no aparentan estar relacionados al evento sísmico.
 - c. Cancha de Baloncesto – no se observaron daños en cancha y área de asientos.
 - d. Rampa de impedidos – se observaron varias grietas en las paredes de la rampa (al este del Edificio #1). Grietas no son recientes, pero estas se proyectan a cada lado de la pared y piso. También se observó separación entre la junta del pasillo y la rampa.
- NOTA:** Se recomienda hacer reparaciones en junta y grietas en la rampa para evitar daños en caso de eventos futuros.

Fotos: Grietas en rampa de impedidos.

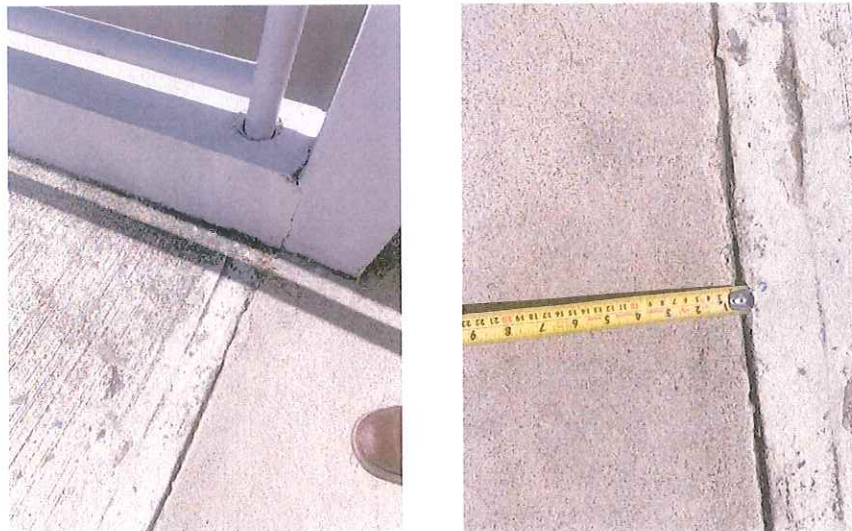
Fotos: Separación junta de rampa y pasillo.
