A.	GENERAL INFORMATION		
1.	Street Address of the School:	PR #10 km. 52.2	
	City: Utuado	State: P.R. Zip:	00641
2.	School Name:	Escuela Superior Vocacional Anton

3.	Date of Inspections	January 10, 2020	
4.	Inspector's Name: Adolfo Bonilla Ro		
B.	BUILDING SITE INSPECTION		
5.			
	Utility Service Safety:		
and to cho	FANT—Immediately following an earthquake, check the entire it, turn off the gas at the meter where it enters the house. Lo gas has been shut off, vacate the building and contact the	ocate and repair leaks before turning one book o	nell of gas. If gas odor is n. If the gas odor persists
IMPORT	TANT-Before entering a damaged, vacant building verify that ther a manual valve or a seismically-activated gas shut-off v	at cas is off. Chack the age meter for damage or	nd position of main gas

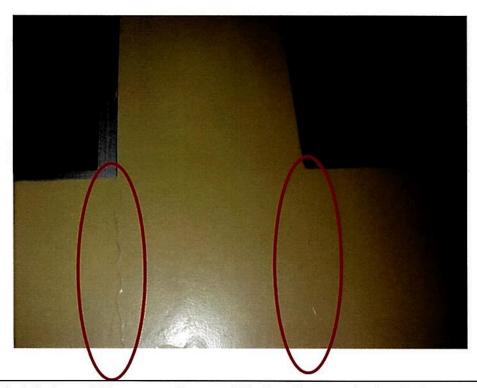
Typical "hair crack" between column and block wall at exterior façade (aprox 35%), concentrated in the EAST two story concrete building

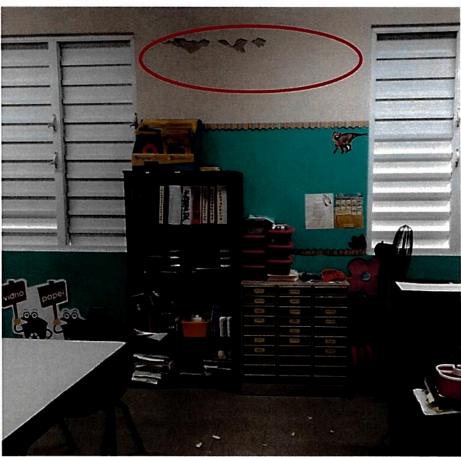
Typical "hair crack" at windows corners in the interior walls

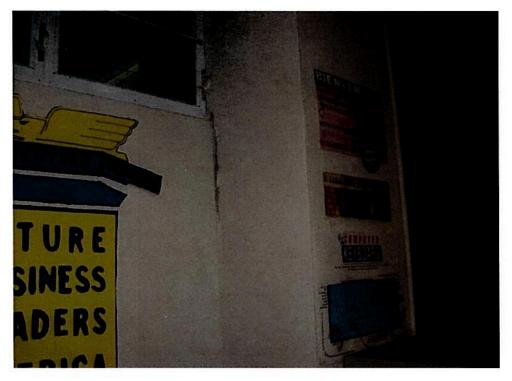
Typical "hair crack" at windows corners in the interior walls. Cement plaster in local areas detached deposited the waste in the floor.
