GENERAL EARTHQUAKE DAMAGE INSPECTION CHECKLIST

- 1. **Street Address of the School:** PR-876 esq. Calle Bartolo Andino
 City: Trujillo Alto State: Puerto Rico Zip: 00924
- 2. **School Name:** Petra Zenon De Fabery
- 3. **Date of inspection:** January 17, 2020
- 4. **Inspector's Name:** Carlos A. Sanchez

Escuela Petra Zenon De Fabery – Trujillo Alto	Visit Date: Jan-17-2020
Constructed ~ 1985	Const. Area: Middle & H. School ~56,600sf Int. Court: ~8,400sf
	Const Area: Vocational Bldg.: ~36,700sf
Maria de los Angeles Rivera O'Farrell	Director
-	AEP Supervisor
Maigualida Yopez	Maestra de Ciencias
Observations by: Carlos A. Sanchez Gallardo, P.E.

School: **Petra Zenon de Fabery**
 City: Trujillo Alto
 Date: Jan-17-2020

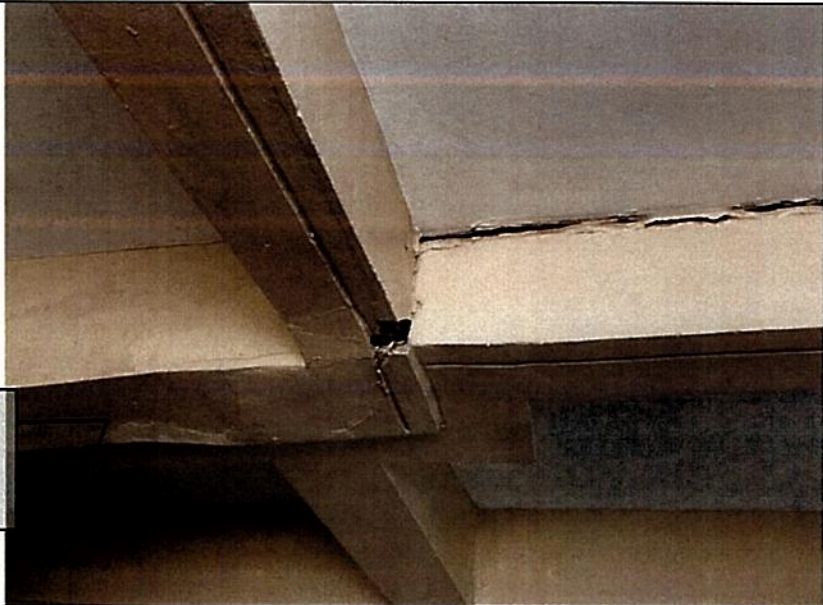
CMU Walls with Stair
Step Cracks at this
area

Picture 1 – Differential settlement condition at the SE Stairs area noticeable at the building expansion joint (opening), adjacent CMU walls cracking, floor elevation difference and ceiling separations and cracks at the stairs and building joint.

No se apreciaron daños obvios a causa del terremoto. Sin embargo se recomienda
1) atender situación de posible asentamiento diferencial en la escalera sureste vs. el edificio modulo sur para evitar posible "pounding" entre ambas, 2) No utilizar el comedor y area pasillo al otro lado de las paredes agrietadas en forma tipo escalera,
3) Cerrar (no usar) la rampa de impedidos hasta no remover el material dañado, reparar la baranda y que se evalúe mejor su daño estructural si el caso.

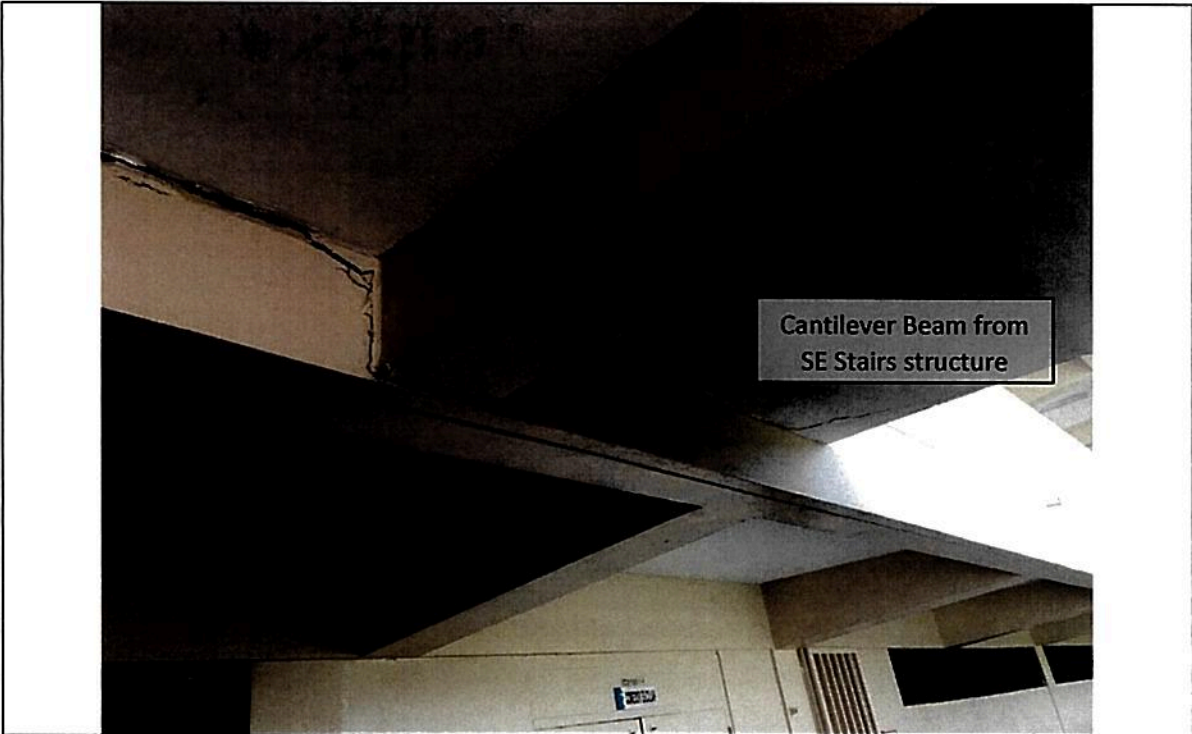
Cantilever Beam from
SE Stairs structure

Picture 2 – Differential settlement condition at the SE Stairs area noticeable at the building expansion joint (opening), adjacent CMU walls cracking, floor elevation difference and ceiling separations and cracks at the stairs and building joint.

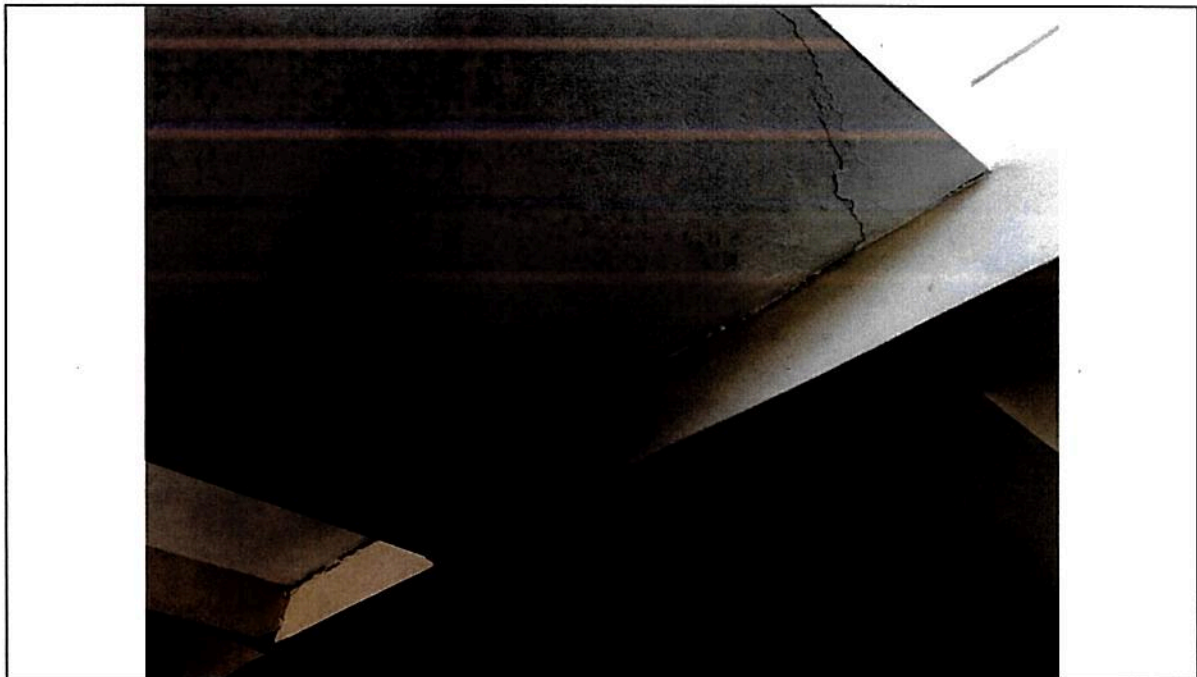
Picture 3 – Differential settlement condition at the SE Stairs area noticeable at the building expansion joint (opening), adjacent CMU walls cracking, floor elevation difference and ceiling separations and cracks at the stairs and building joint.

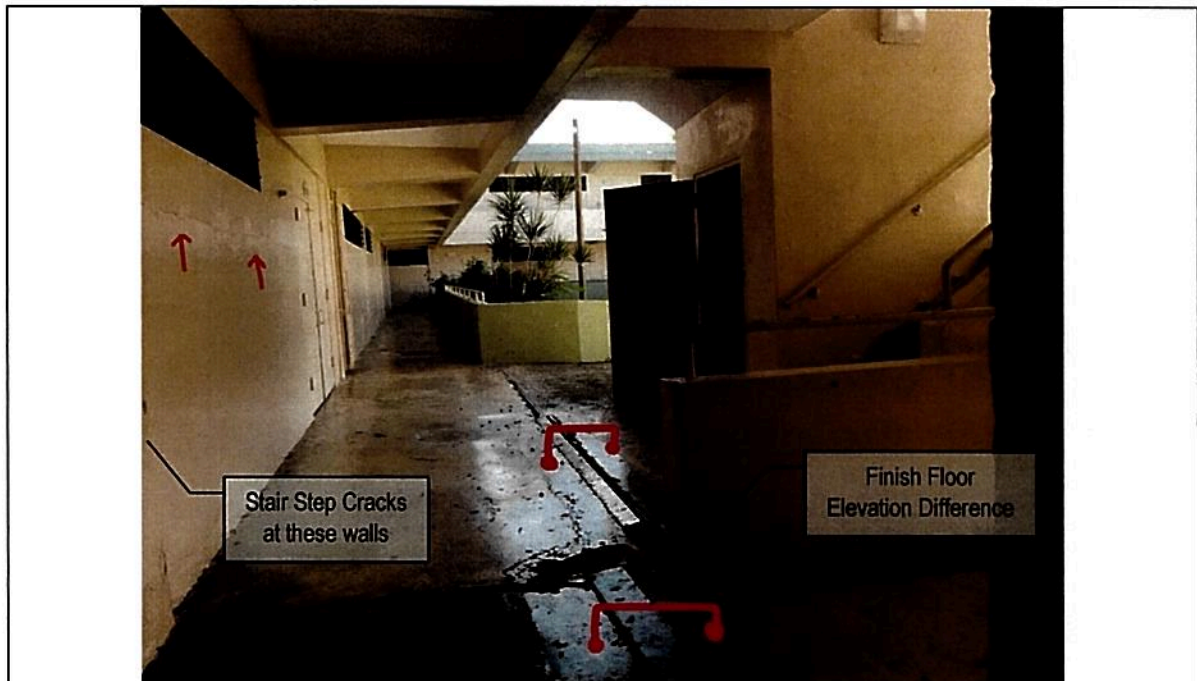
Picture 4 – Differential settlement condition at the SE Stairs area noticeable at the building expansion joint (opening), adjacent CMU walls cracking, floor elevation difference and ceiling separations and cracks at the stairs and building joint.

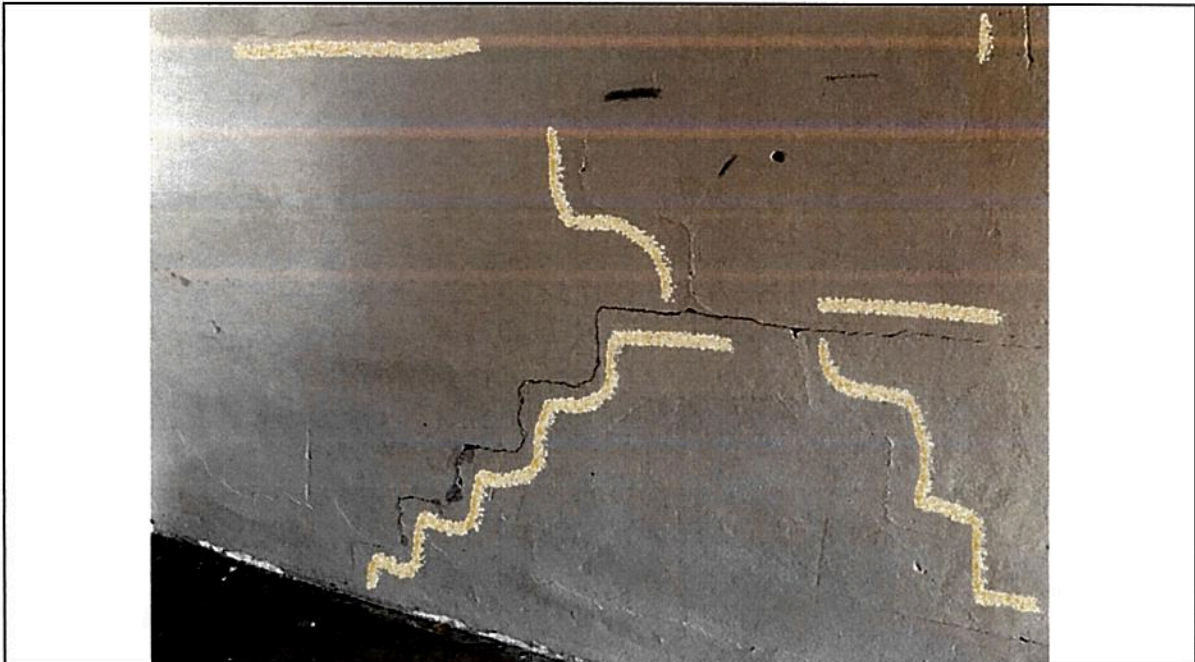
Picture 5 – Stair step cracks at least at two CMU walls segments in the vicinity of the SE building expansion joint (dining hall/corridor wall) – Image shows corridor side

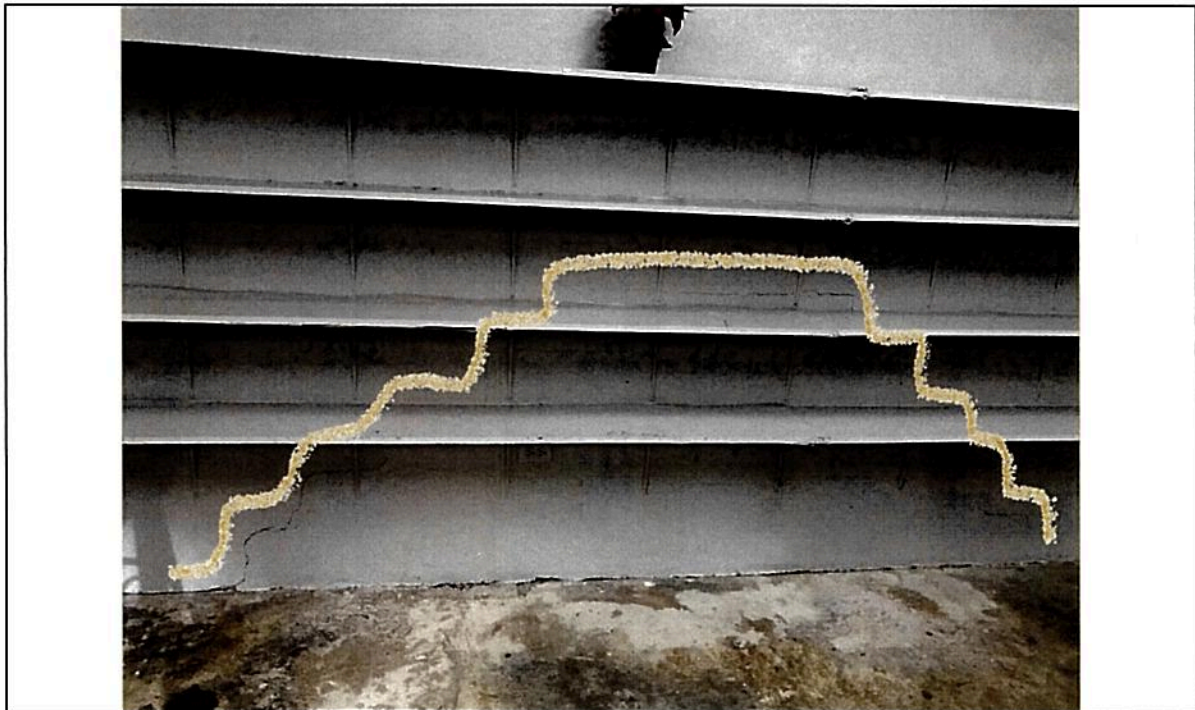
Picture 6 – Stair step cracks at least at two CMU walls segments in the vicinity of the SE building expansion joint (dining hall/corridor wall) – Image shows dining hall side

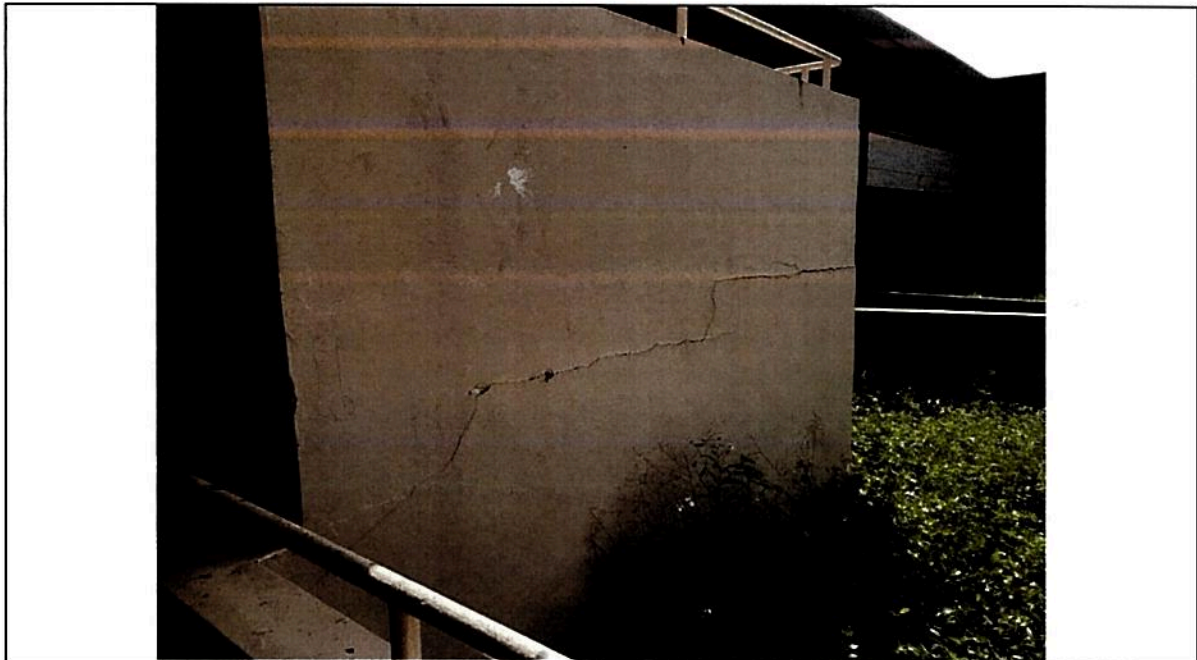
Picture 7 - CMU wall base below SE Stairs to enclose and form a storage closet appears to be settling. There is a horizontal separation gap between the stair's structure (at intermediate landing) and the top of the CMU wall.

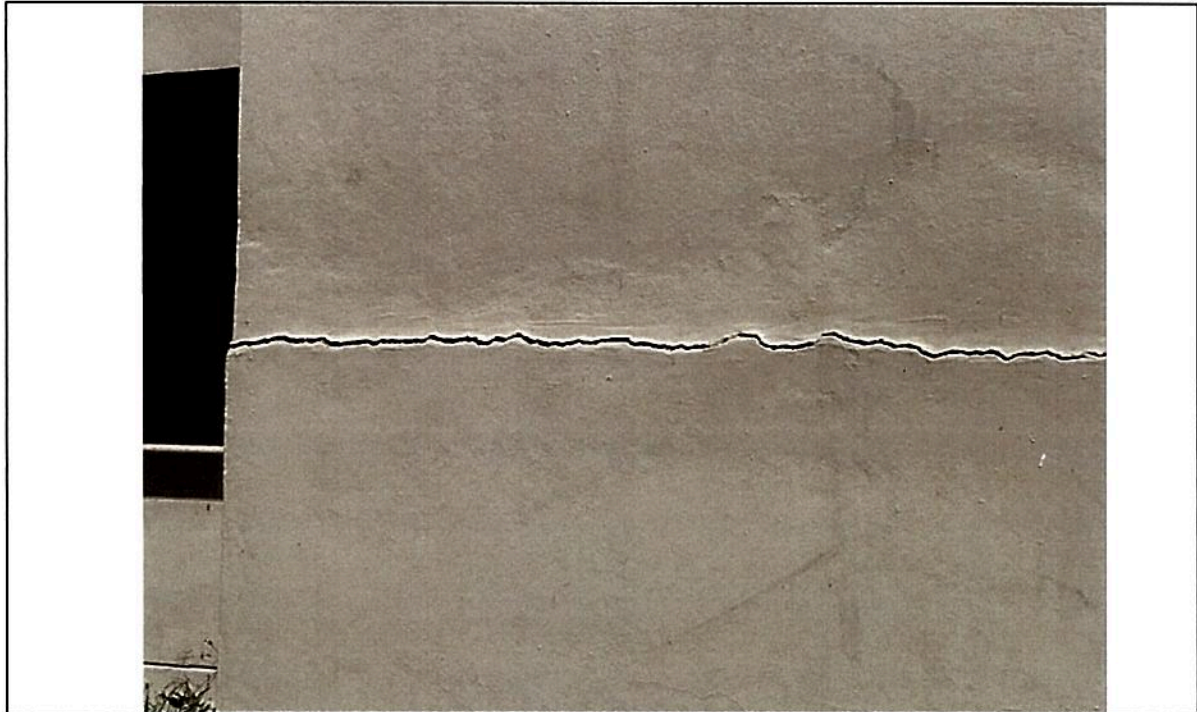
Picture 8 - CMU wall base below SE Stairs to enclose and form a storage closet appears to be settling. There is a horizontal separation gap between the stair's structure (at intermediate landing) and the top of the CMU wall.

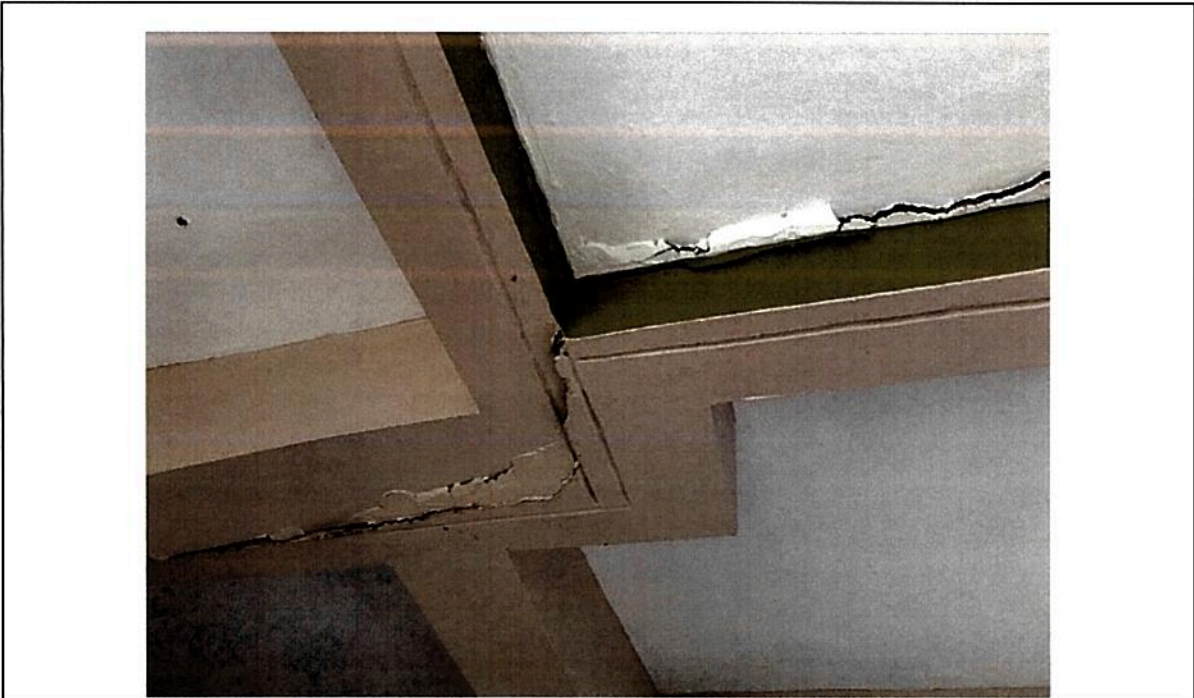
5	Separations at building expansion joints (between bldg. modules) causing cement plaster finish to crack, break and fall.	Many cases with opened gaps that have cracked and loosened the plaster on those joints (falling debris hazard on ceiling cases)	9/10/11
6	Handicap Ramp reinforced concrete wall broken section by a falling tree during H. Maria. Strong impact along the long axis of the ramp by the tree.	The ramp independent structure should be further evaluated	12
7	Division wall stair step cracks at walls in classroom (ciencia ambiental) and small office (educacion especial) both on level 3		13

Picture 9 - Open construction joints between building modules (Cracked and loose plaster)

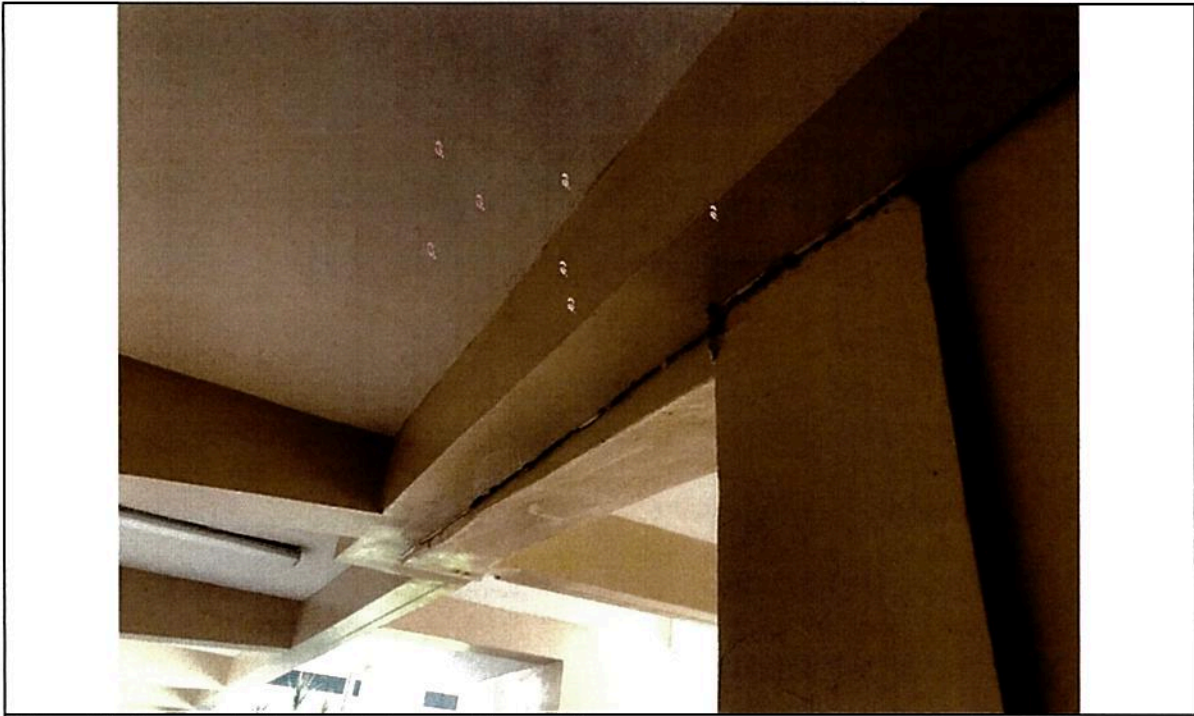
Picture 10 - Open construction joints between building modules

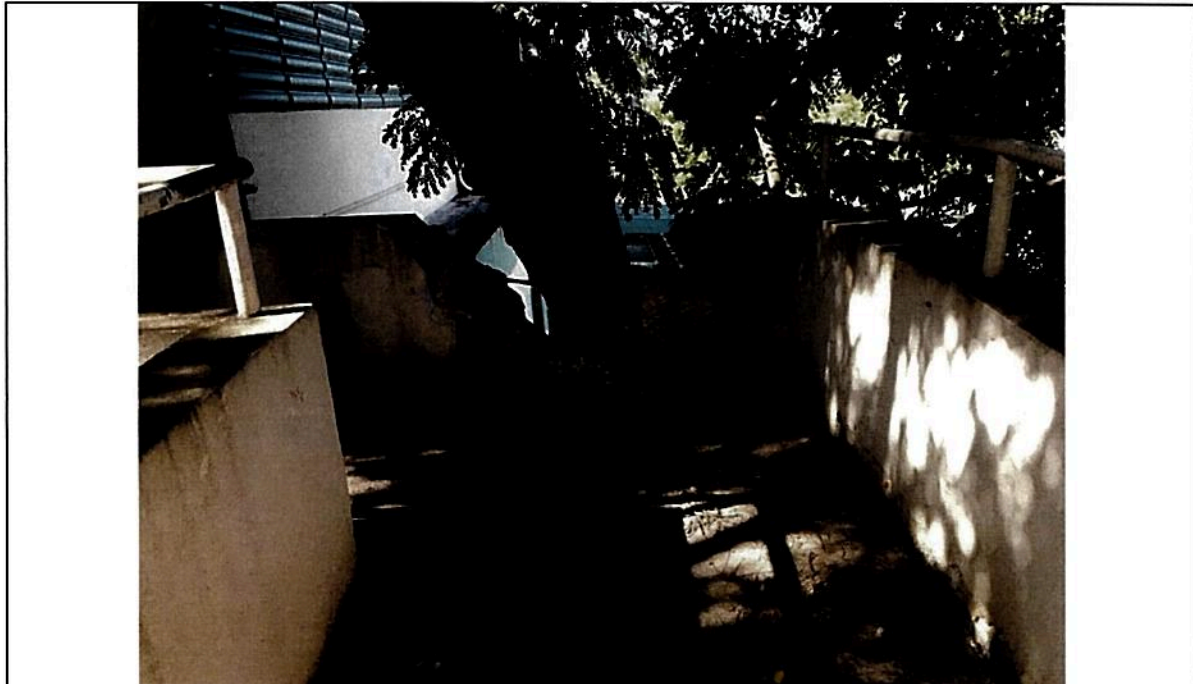
Picture 12 – Handicap Ramp reinforced concrete wall broken section by a falling tree during H. Maria. Strong impact along the long axis of the ramp by the tree.

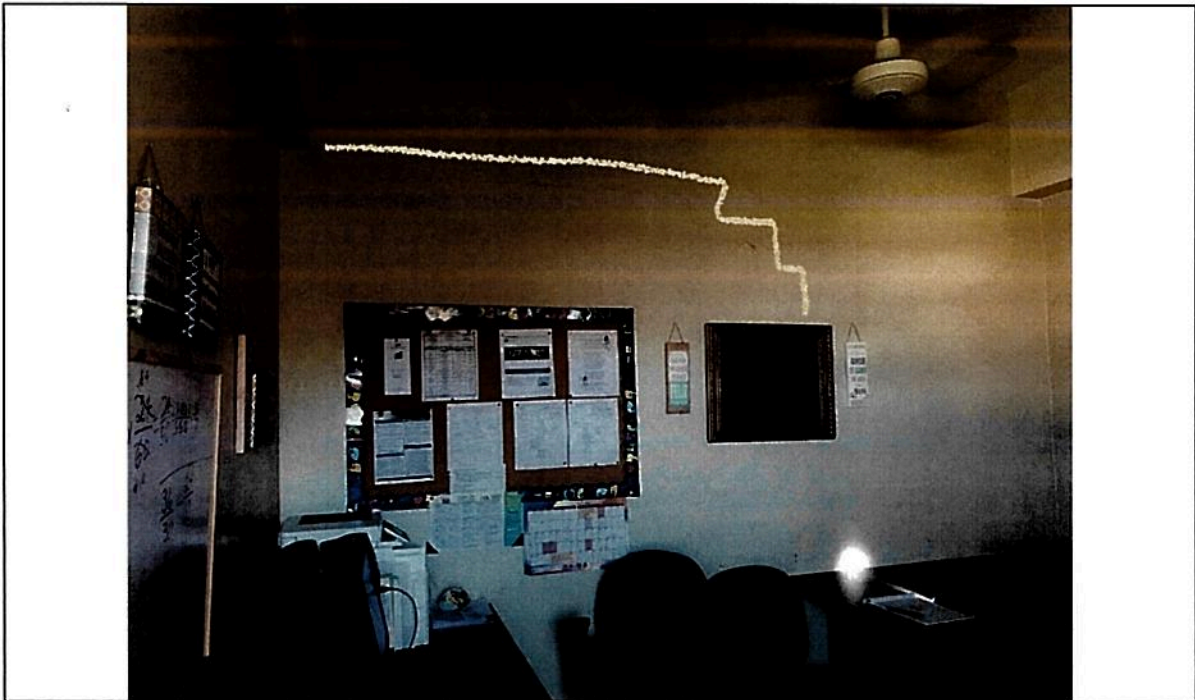
Picture 13 - Division wall stair step cracks at walls in classroom (ciencia ambiental) and small office (educacion especial) both on level 3

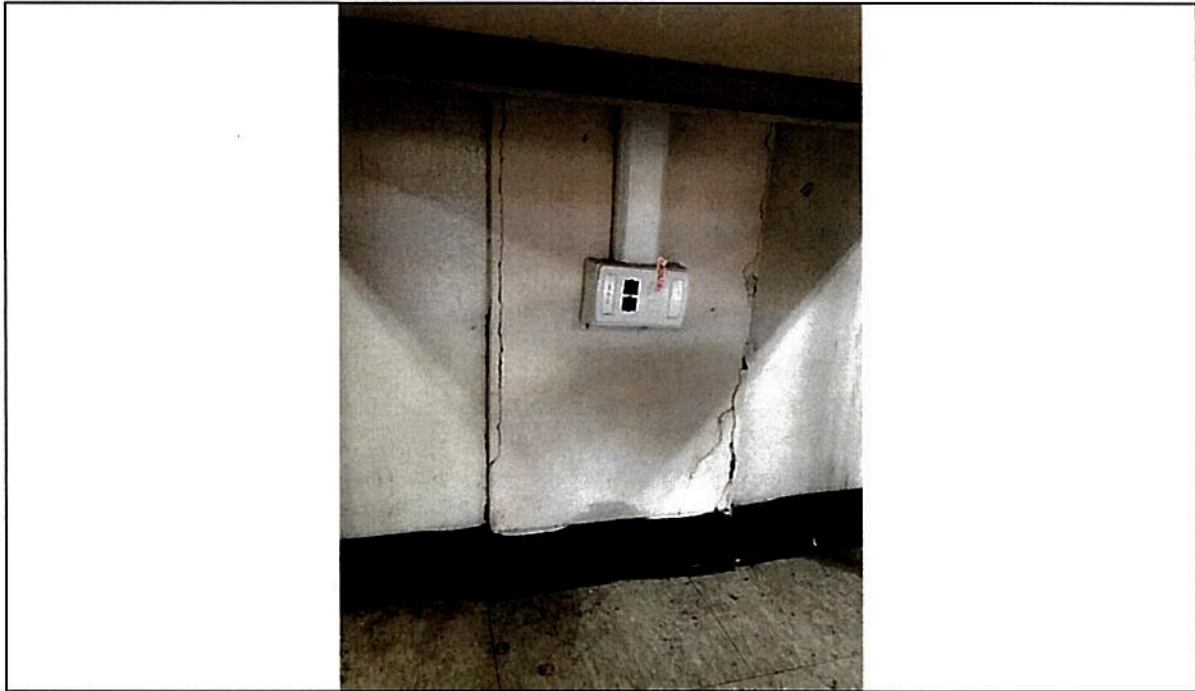
Picture #14 - Concrete Delamination or Spalling at borders of elements or local areas

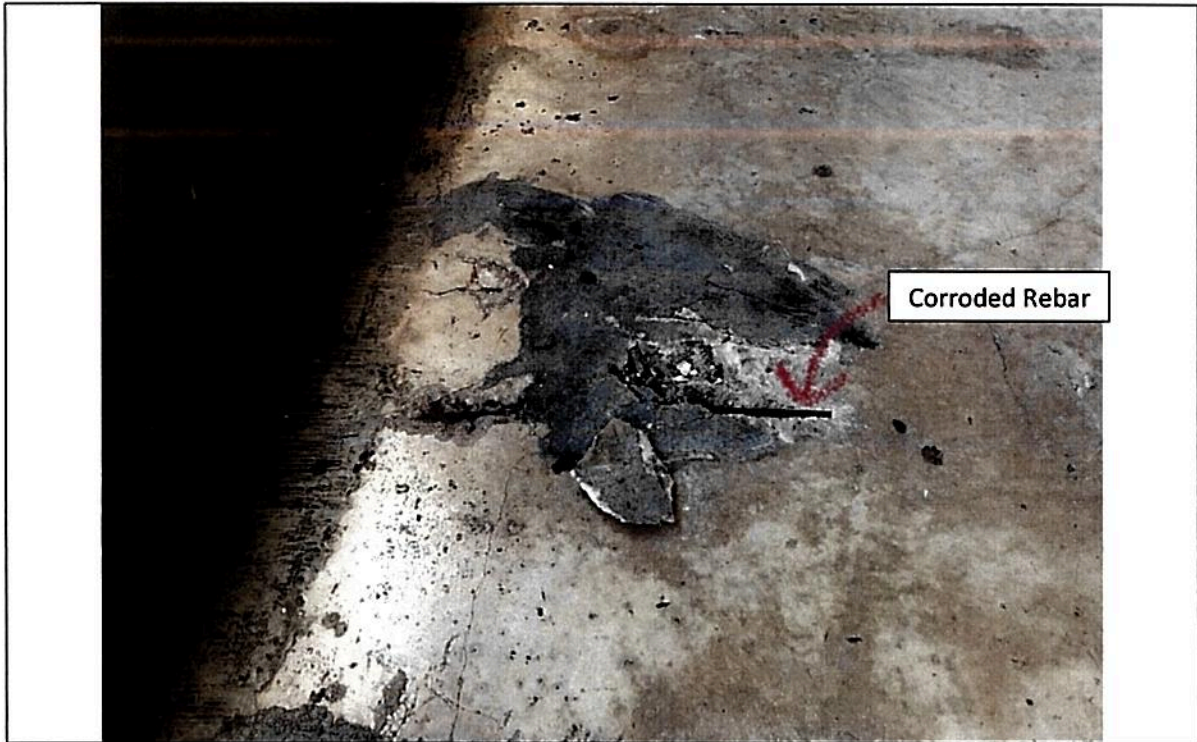
Picture #15 - Concrete Delamination or Spalling at borders of elements or local areas

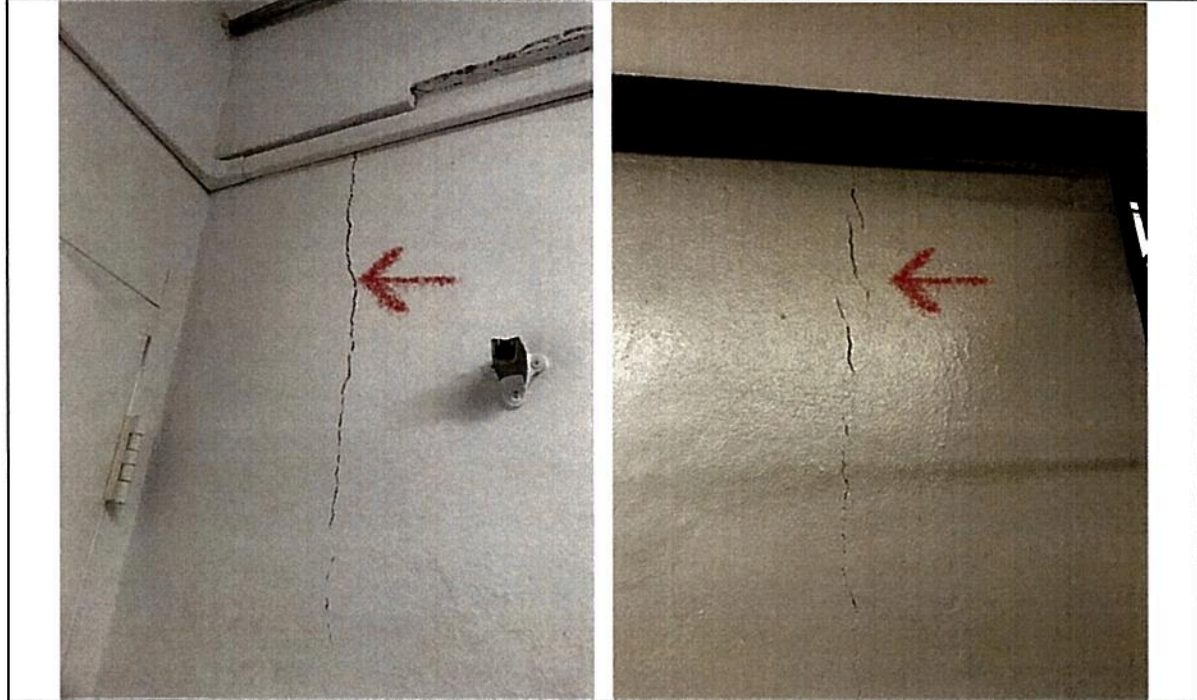
Picture 16 - Vertical cracks in exterior site CMU wall fence and building CMU walls

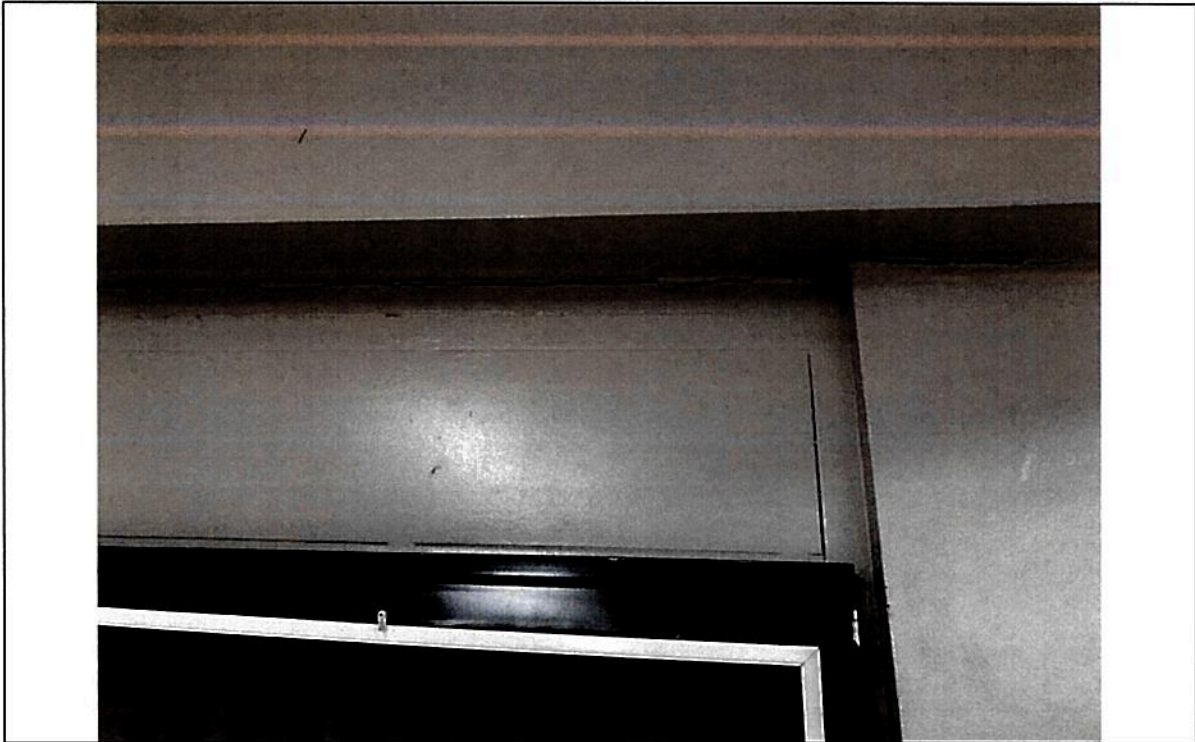
Picture 17 - Horizontal separations or cracks at division walls joints with ceiling slab, beams, or other horizontal component

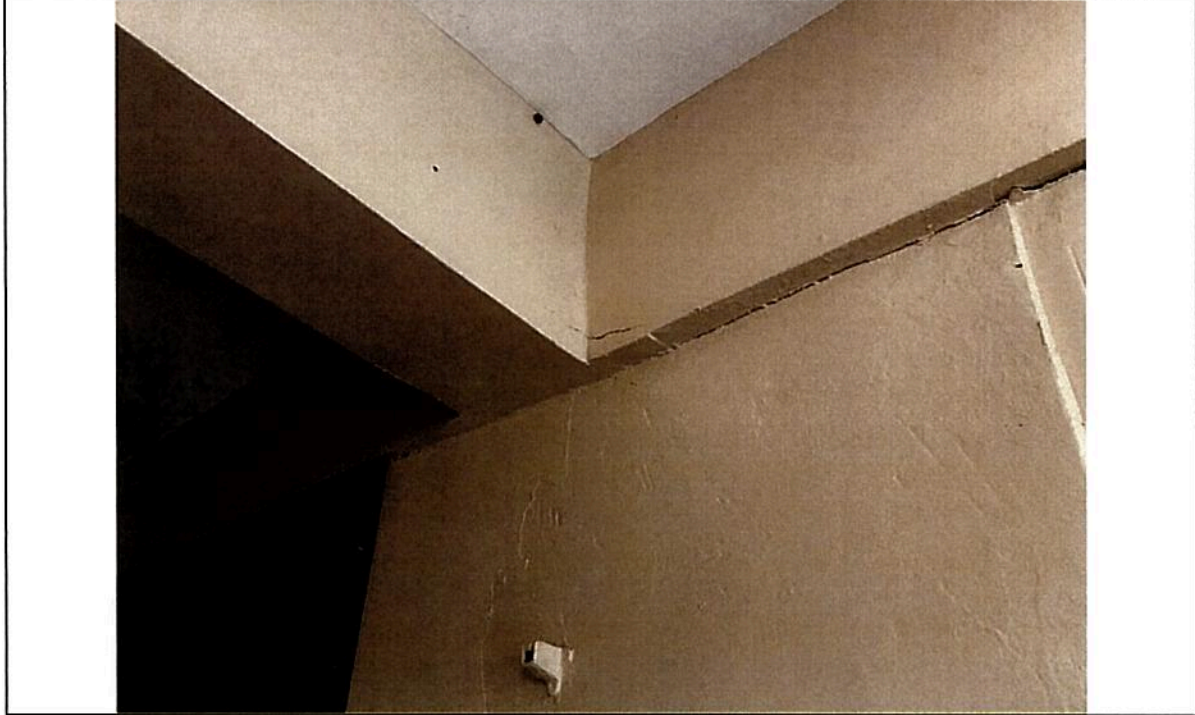
Picture 18 - Horizontal separations or cracks at division walls joints with ceiling slab, beams, or other horizontal component

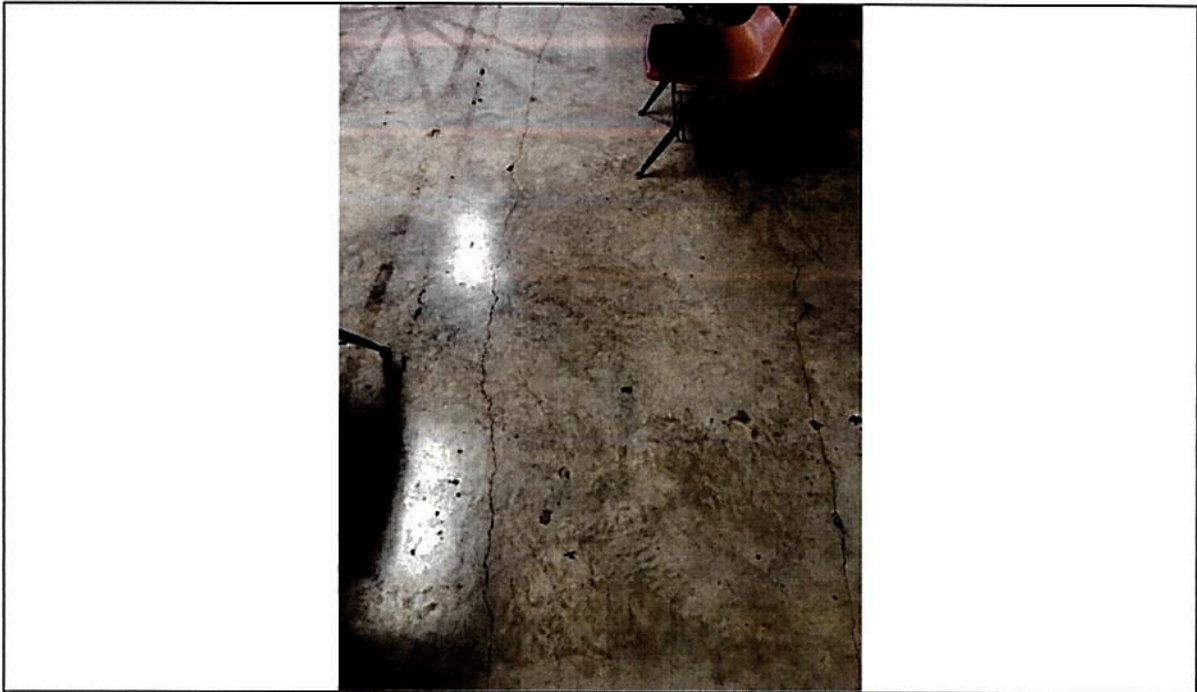
Picture 19 - Slab cracks random patterns and long cracks perpendicular to the corridors in various classrooms (both levels)
