## CARTA DE TRAMITE

Escuela: **Gabriela Mistral**

Código: **(61382)**

## OCULAR INSPECTION CHECKLIST

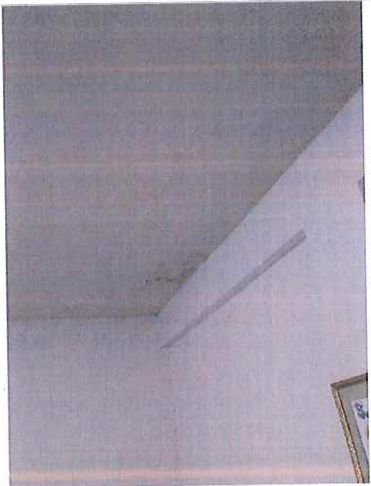
Descripción:	Aquí se observa una grieta en el plafón paralela a la pared, también podemos observar problemas de humedad. Esto es en el salón de la Facultad. Personal de la escuela nos notificó que en esta área (debido al paso del Huracán María) habían caído sobre esta estructura dos árboles grandes y que entendían había afectado el techo. Aparentemente llevaron a cabo unos trabajos, pero las filtraciones continúan según indicó el personal de la escuela.	
Edificio:	Principal Administración

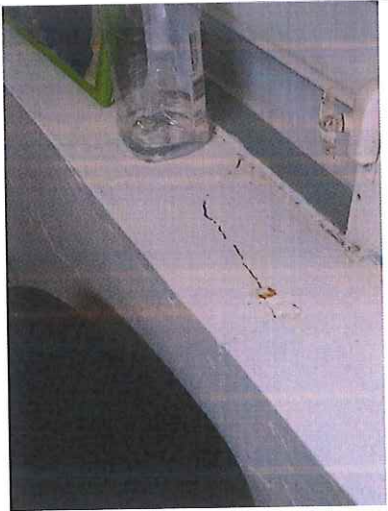
Descripción:	Grieta superficial en mocheta de ventana. Localizada en el Salón de la Facultad.

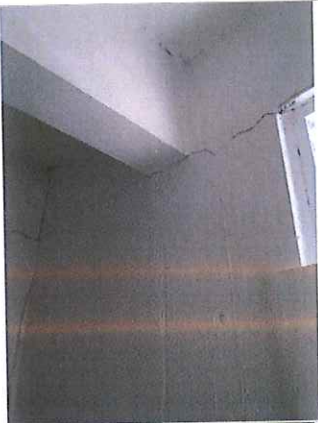
Edificio:	Principal Salones Sociales	
Descripción:	Aquí se puede observar grieta en la junta entre la pared de y la viga de la estructura. La misma no se observó que pasara a la parte de afuera, en el momento de la inspección visual. Aun así, recomendamos se lleve a cabo una evaluación más detallada de la condición. Personal de la escuela nos notificaron que esta condición era preexistente a los sismos.

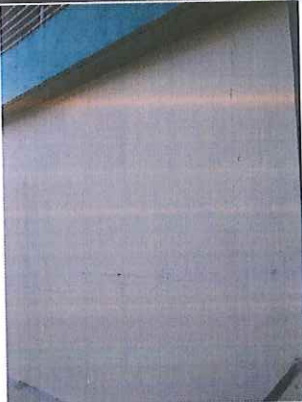
Edificio:	Edificio Principal	
Descripción:	En la foto podemos observar las grietas superficiales en el empañetado en la junta con la columna y también otras en forma de escalones las cuales demarcan la unión de los bloques. Cabe señalar que el personal de la escuela nos indicó que las mismas eran preexistentes a los temblores. Esta área se encuentra en el primer piso al final del edificio a mano derecha.

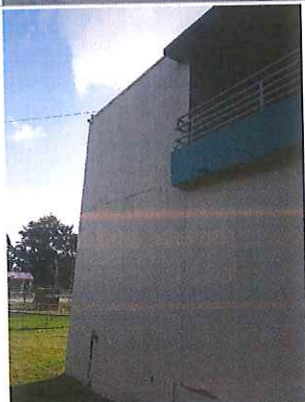
Edificio:	Edificio Principal	
Descripción:	En la foto podemos observar una grieta superficial relacionada a la unión de la pared descrita en la foto anterior; además de la unión con la pared del segundo piso. Personal de la escuela nos indicaron que las mismas eran preexistentes a los eventos de los sismos.

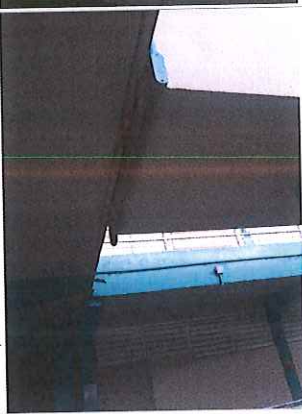
Edificio:	Edificio Principal	
Descripción:	La foto incluida muestra la junta entre la rampa de acceso al segundo piso y el piso del pasillo, la cual se observa desmejorada. Se recomienda, reparar la misma con el mantenimiento adecuado.

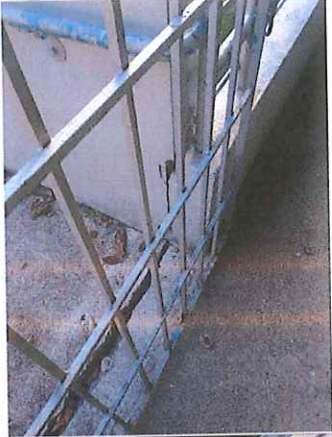
Edificio: Descripción:	Edificio Principal La foto muestra la junta de la rampa de acceso y el pasillo desde el segundo piso. Esta es la misma de la foto anterior, la cual se recomienda reparar.

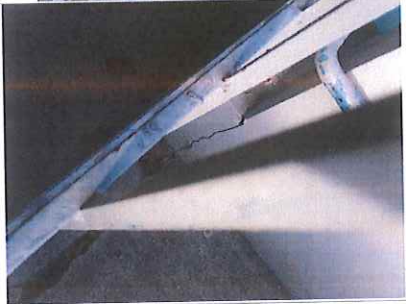
Edificio: Descripción:	Edificio Principal Otra foto de la condición descrita en las dos fotos anteriores. Según nos notificara el personal de la escuela, esto es una condición preexistente al evento de los sismos.

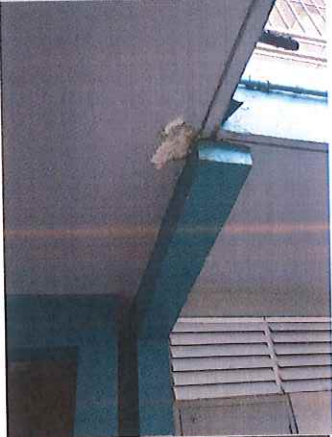
Edificio: Descripción:	Principal En la foto podemos apreciar un desprendimiento del empañetado del plafón, la misma se encuentra en la estructura principal entre el edificio frontal y el que queda a mano izquierda. Se recomienda cotejar la junta entre ambas estructuras y reparar la misma.

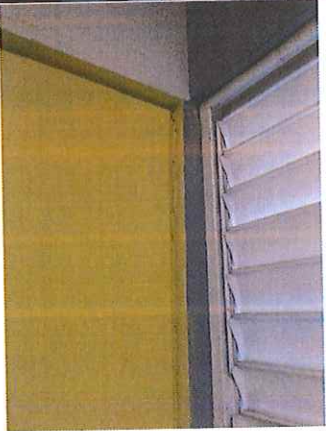
Edificio: Descripción:	Principal Lado Izquierdo En la foto se identifica una grieta vertical en la junta de la pared con la columna. La misma se encuentra en el salón 16 de Inglés, en el primer piso.

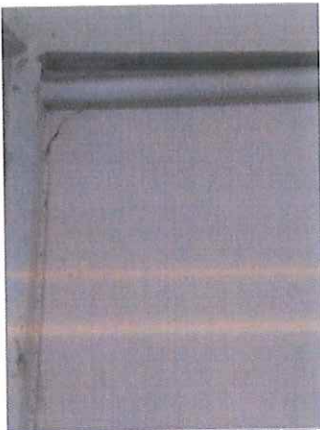
Edificio:	Principal Lado Izquierdo	
Descripción:	En la foto se puede observar una grieta en la junta de la pared con la columna y la viga. La misma se encuentra en el Salón 17 de matemáticas, localizado en el primer nivel.

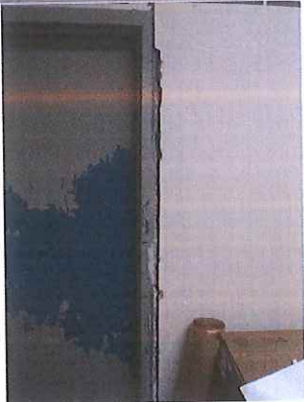
Edificio:	Principal Lado Izquierdo	
Descripción:	En el mismo Salón 17 de matemáticas se identificó la reparación de la mocheta de la puerta, en el lado de adentro del salón, en el primer nivel.

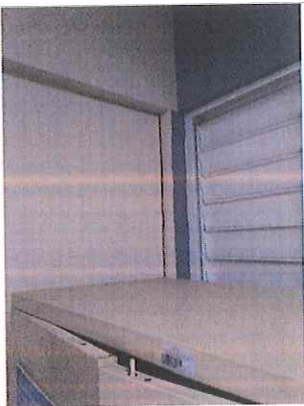
Edificio:	Principal Lado Izquierdo	
Descripción:	En la foto se identifica grieta en la junta de la pared con viga y columna. La misma se encuentra en el Salón 20 de español de 12. Al igual que todas las demás el personal de la Escuela nos indicó que éstas eran preexistentes al evento, en el primer nivel.

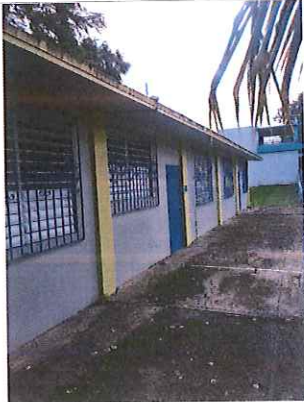
Edificio:	Comedor	
Descripción:	La foto muestra la estructura del comedor desde el exterior. Cabe señalar que la inspección visual en la estructura del comedor se llevó a cabo desde el exterior debido a que no se tuvo acceso al interior del mismo.

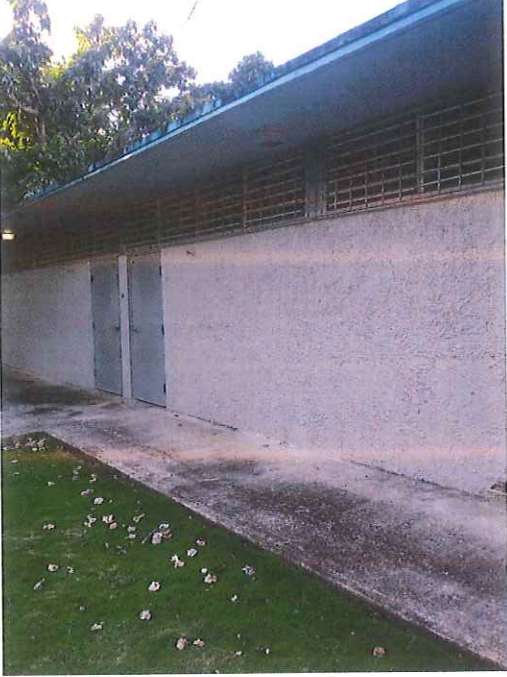
Edificio:	Edificio Salones Un Nivel

Descripción:	La inspección ocular de la estructura se llevó a cabo solo en el exterior. Solo obtuvimos acceso a la mitad de la estructura (un pequeño almacén que se encuentra a la derecha y un salón al lado de dicho almacén); en ambos casos no se observó ningún daño a causa de los sismos.	
Edificio:	Edificio de dos niveles

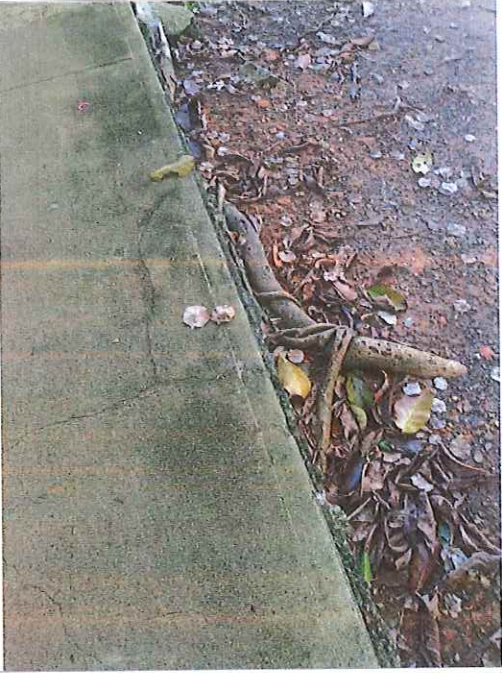
Descripción:	Se identificaron grietas en la superficie del pasillo de los salones. También se observaron raíces de un árbol cercana a la estructura metiéndose por debajo de la misma.
