CARTA DE TRAMITE

Escuela: **Trina Padilla de Sanz**

Código: **(61440)**

GENERAL EARTHQUAKE DAMAGE OCULAR INSPECTION CHECKLIST

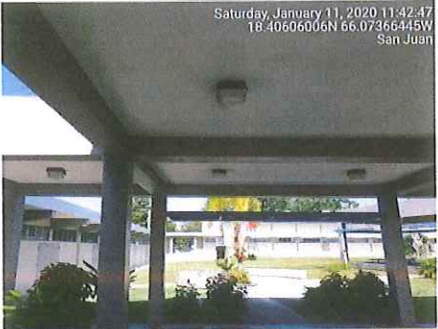
Edificio:	1	
Descripción:	No se observaron daños.

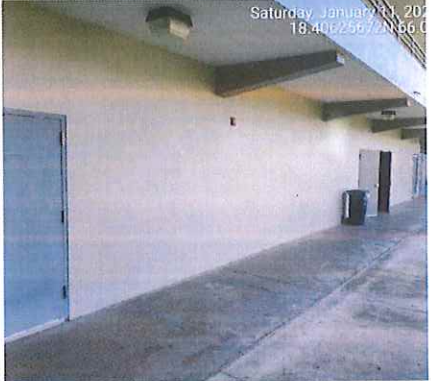
Edificio:	2	
Descripción:	No se observaron daños.

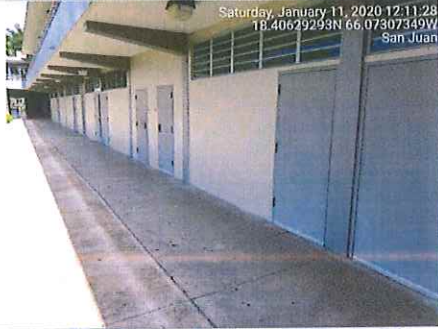
Edificio:	3	
Descripción:	No se observaron daños.

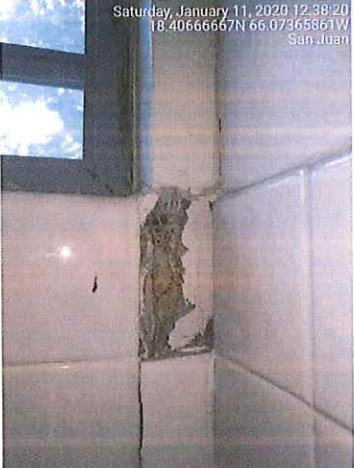
Las Estructuras Núm. 1, Núm. 2, Núm. 3, Núm. 5, Núm. 6, Núm. 7, Núm. 8; Núm. 9 y Núm. 10 no presentan daños causados por los eventos sísmicos. En cambio, la Estructura Núm. 4 presenta daños. (Ver Anejo). La inspección realizada a la facilidad se limita a una inspección visual para documentar cualquier daño causado por los eventos sísmicos registrados. El informe preparado no constituye una opinión profesional sobre el cumplimiento con códigos de seguridad, diseño u construcción.

Edificio:	4	
Descripción:	En la foto se puede apreciar grietas, posiblemente por causas del efecto de columna corta.

Se debe entender que este informe está basado solamente en una inspección ocular de las facilidades con el propósito de observar en las escuelas la presencia de daños significativos causados por los eventos sísmicos registrados hasta la fecha de este informe. La determinación de la adecuación estructural de las escuelas y su cumplimiento con los códigos aplicables de diseño o construcción, al igual que el desarrollo de recomendaciones para la rehabilitación de las facilidades, requerirá una evaluación detallada.

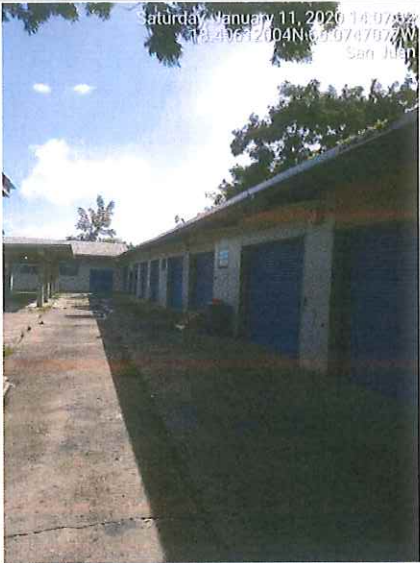
Edificio:	8

Descripción:	No se observaron daños.	
Edificio:	9

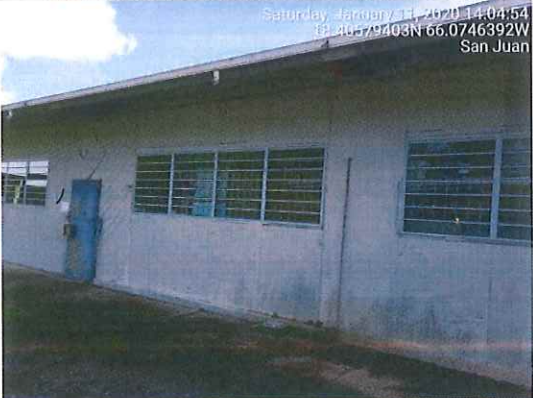
Descripción:	No se observaron daños.	
Edificio:	10

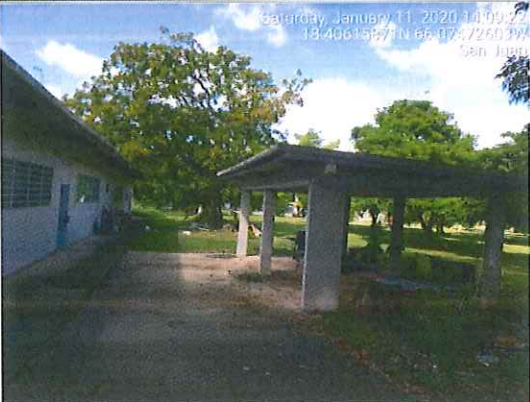
Descripción:	No se observaron daños.
