CARTA DE TRAMITE

Escuela: Luis Muñiz Suffront

Código: (61457)

OCULAR INSPECTION CHECKLIST

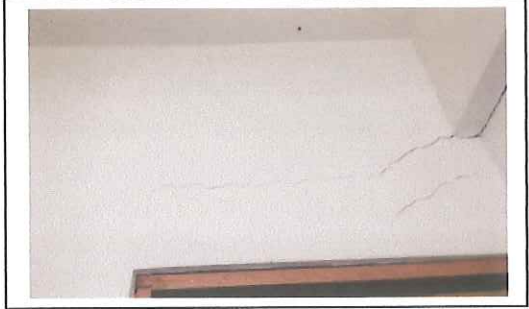
Edificio:	Edificio no. 1- Edificio escuela salones dos niveles y oficinas No Apto para abrir

Descripción:	<ul style="list-style-type: none"> 1- Varios salones sin llave y Grietas en paredes internas 2- Varias paredes con grietas 	
Edificio:	Edificio no. 2- Edificio Biblioteca Apto para abrir

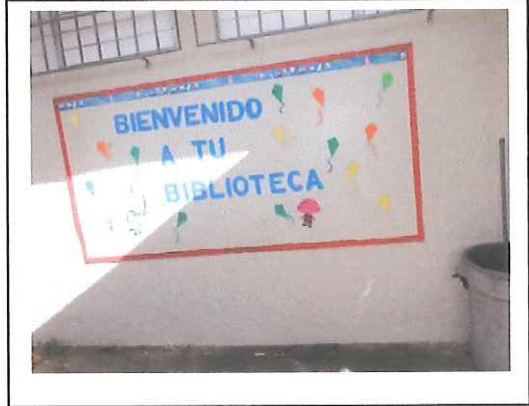
Descripción:	<ul style="list-style-type: none"> 1- No se observaron daños 	
Edificio:	Edificio no. 3- Edificio Comedor- Cerrado No apto para abrir

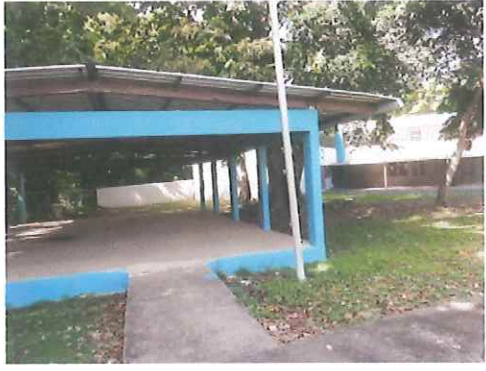
Edificio:	Gazebo

Descripción:	Apto para abrir 1- No se observaron daños	
Edificio:	Exterior- Techo de Aceras	 
Descripción:	No apto para abrir 1- Techos de metal doblados en las aceras
