CARTA DE TRAMITE

Escuela: **Republica de Brasil**

Código: **(61515)**

Informe de inspección ocular de daño en la Escuela República de Brasil
Calle 48 Esq. 9, Reparto Metropolitano , San Juan P.R 00921

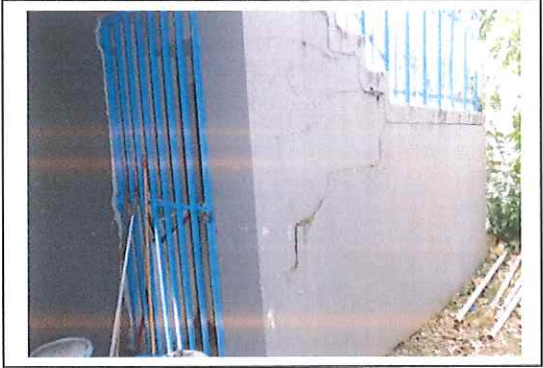
Edificio:	Edificio no.1: Edificio Escuela de dos niveles y oficina (Concreto con techo en cemento)

Descripción:	<ul style="list-style-type: none"> • Se observaron daños mínimos en el interior de los salones y oficinas • Se observaron grietas significativas en columna, de la escalera debe ser re-evaluada • Humedad de agua del techo, sin tratar para humedad. 	
Edificio:	Edificio no. 2- Edificio escuela salones Apto para abrir

- Se observaron grietas significativas en columna, de la escalera debe ser re-evaluada
 - Humedad de agua del techo, sin tratar para humedad.
- 2- Edificio no.2: Edificio Escuela de un nivel

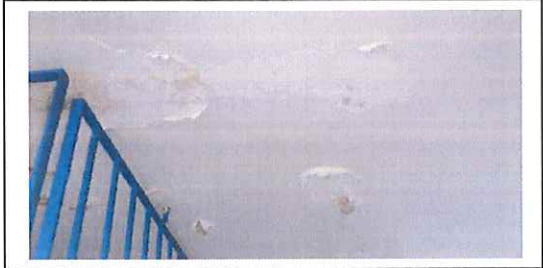
Descripción:	<ul style="list-style-type: none"> • No se observaron daños. 	
Edificio:	Edificio no. 3- Edificio Biblioteca

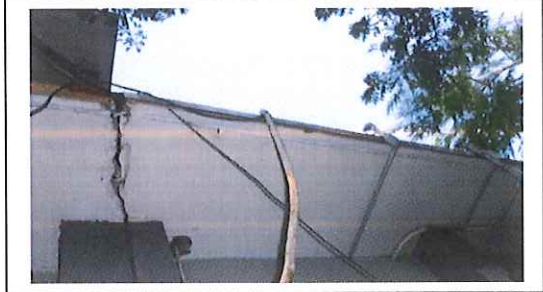
Descripción:	<p>No apto para abrir</p> <p>Edificio se desplazo en columna</p>	
Edificio:	Edificio no. 4- Edificio escuela salones Apto para abrir

- Humedad de agua del techo y humedad
 - Grietas menores en techo existentes
- 3- Edificio no.3: Biblioteca
 - Se observaron daños significativos en columna

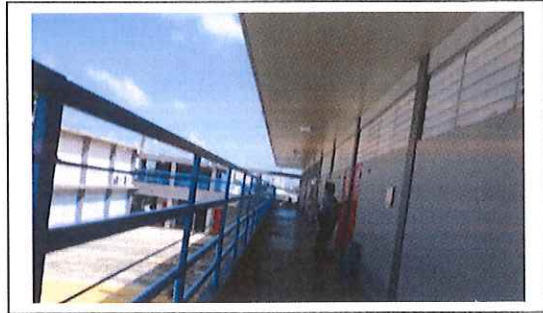
Descripción:	<ul style="list-style-type: none"> • No se observaron daños.

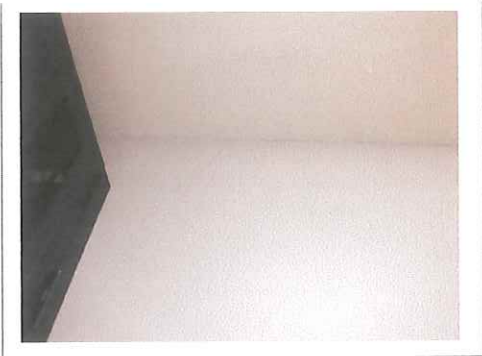
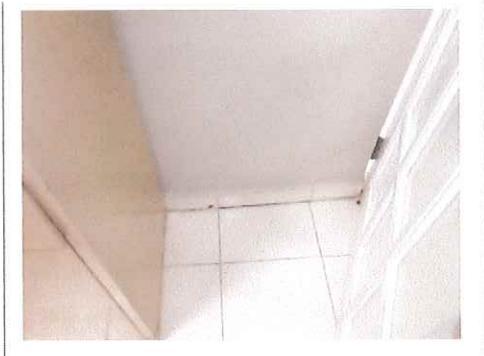
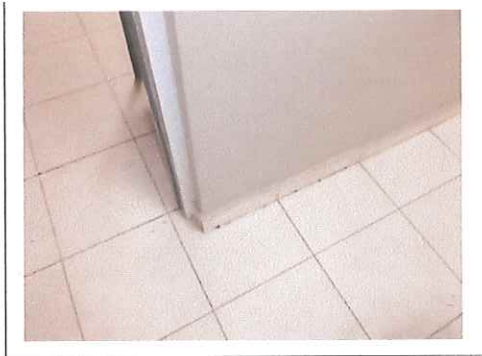
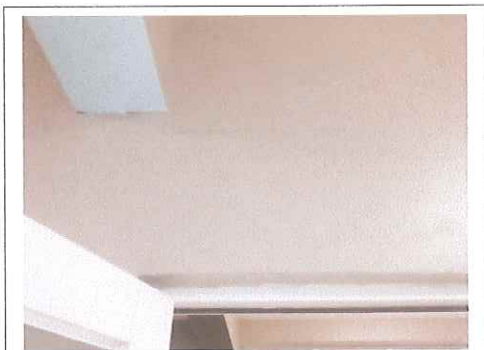
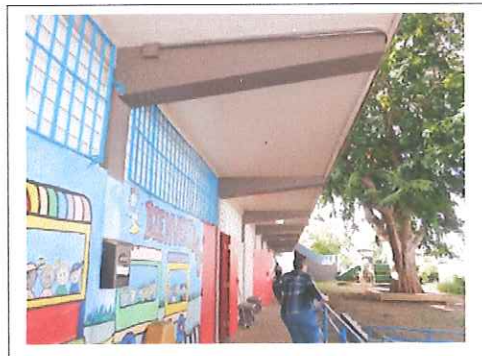
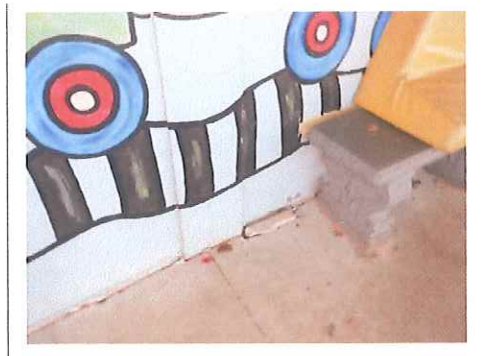
1- Edificio no.1

- 1- Edificio no.1: Edificio Escuela de dos niveles y oficina
(Concreto con techo en cemento)
 - Se observaron daños mínimos en el interior de los salones y oficinas

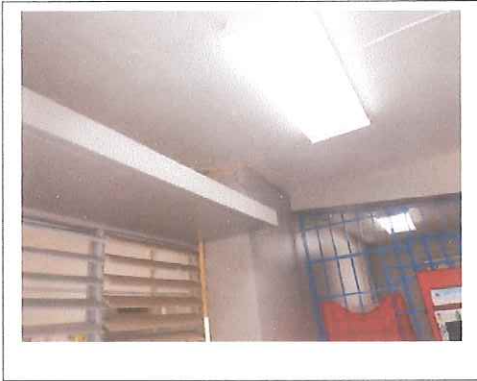
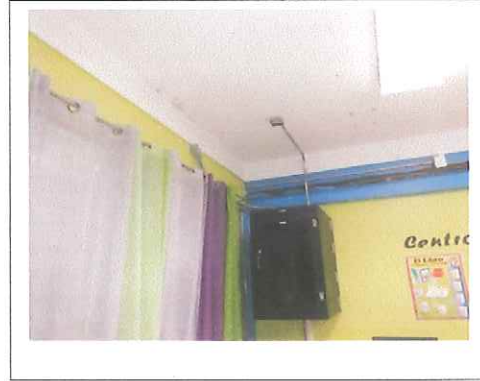
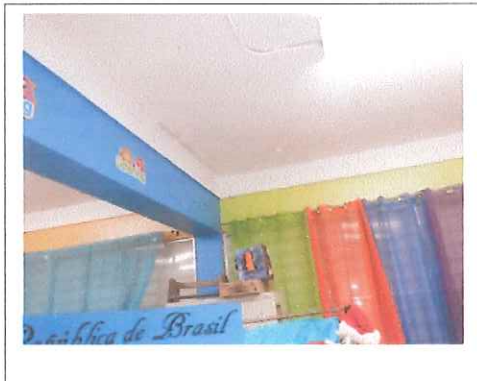
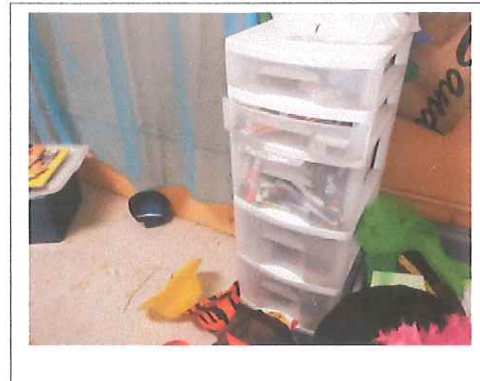
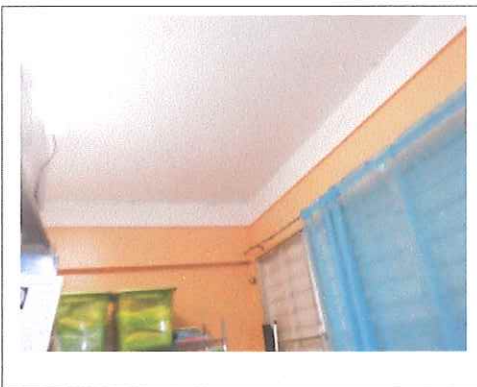
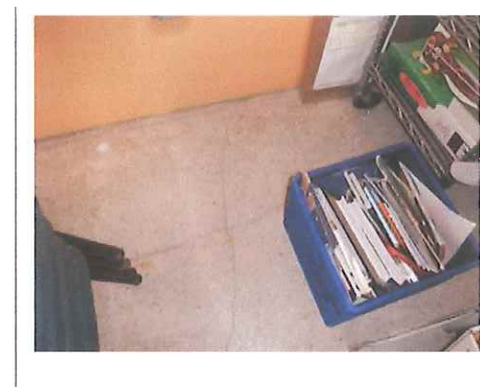
3- Edificio no.3Biblioteca

- 1- No se observaron daños significativos de grietas en la verjas perimetral de la escuela.
- 2- Se observó el desplazamiento de la columna en edificio no. 3 de la Biblioteca .

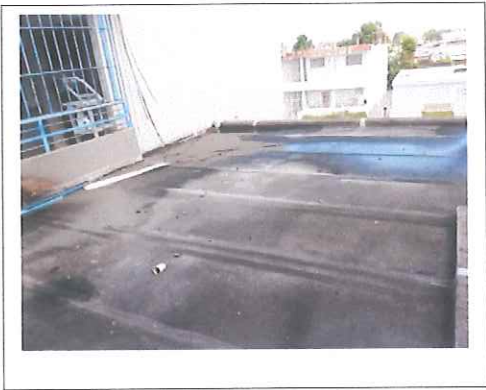
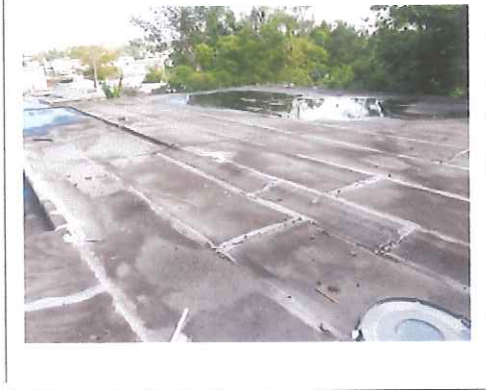
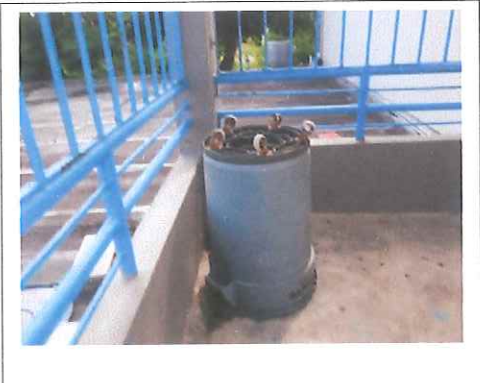
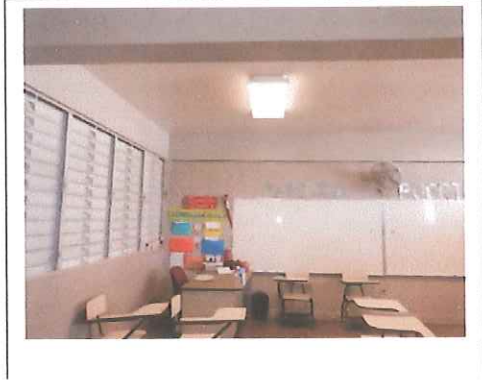
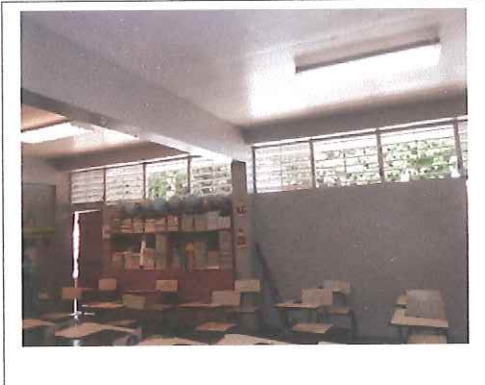
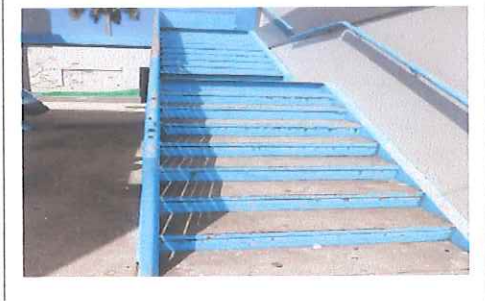
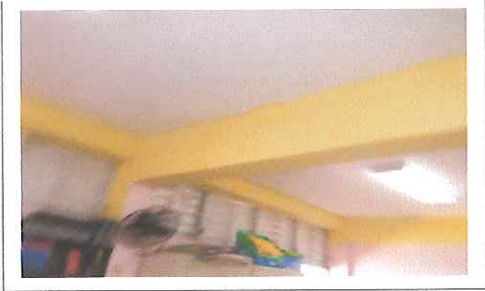
4- Edificio no.4

- 4- Edificio no.4.: Edificio Salones 2 niveles
 - Humedad de agua del techo, no tratado para humedad
 - Grietas y paredes existentes no significativa
- 5- Edificio no.5: Edificio Comedor y almacén

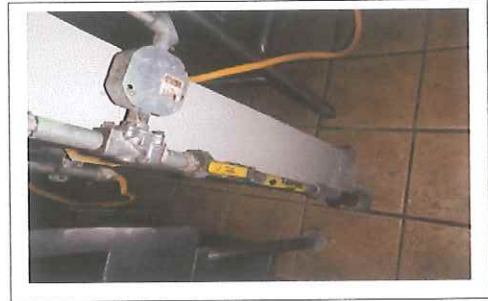
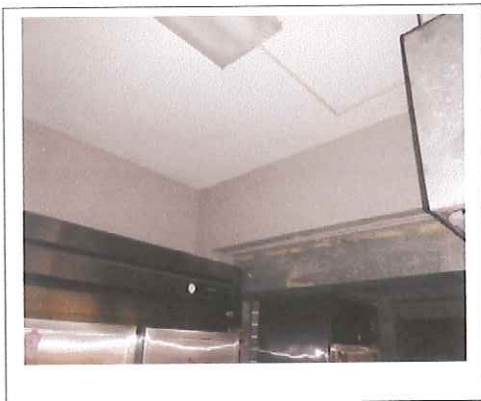
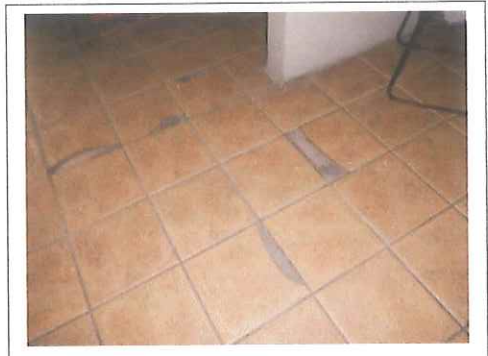
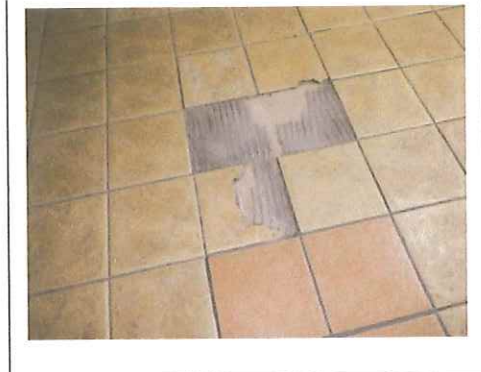
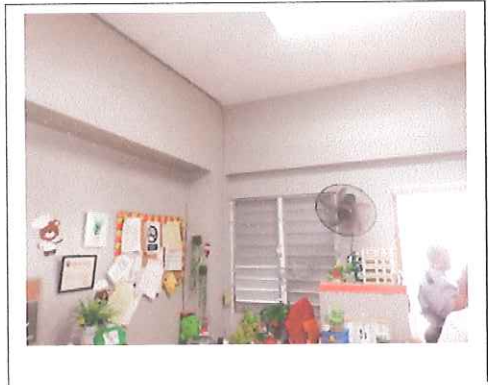
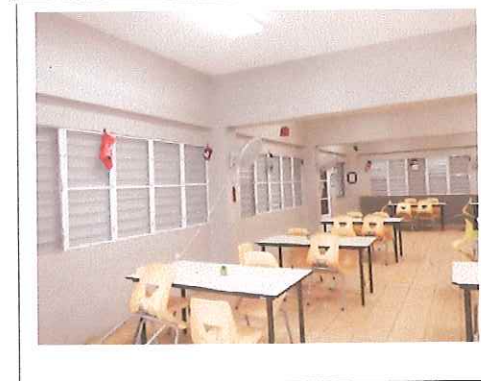
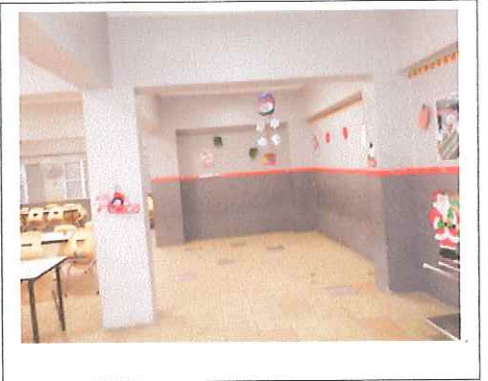
5- Edificio no.5

- Humedad de agua del techo, no tratado para humedad
 - Grietas menores en techo y paredes existentes
- 6- Edificio no.6: Edificio Salones, Kinder
 - Humedad de agua del techo, y humedad
