## CARTA DE TRAMITE

Escuela: **Rafael Hernández Marín**

Código: **(61549)**

## OCULAR INSPECTION CHECKLIST

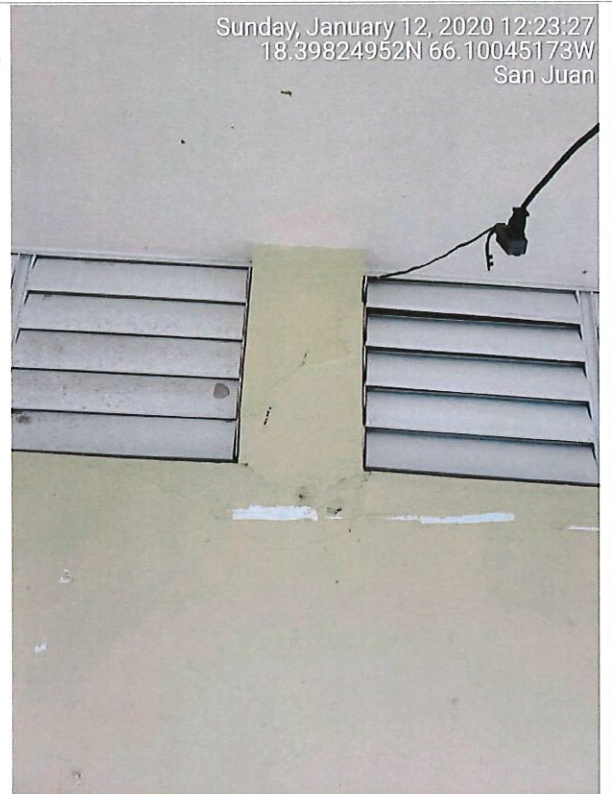
Edificio:	1
Descripción:	Se observaron grietas y fallas por causa del efecto de columna corta.

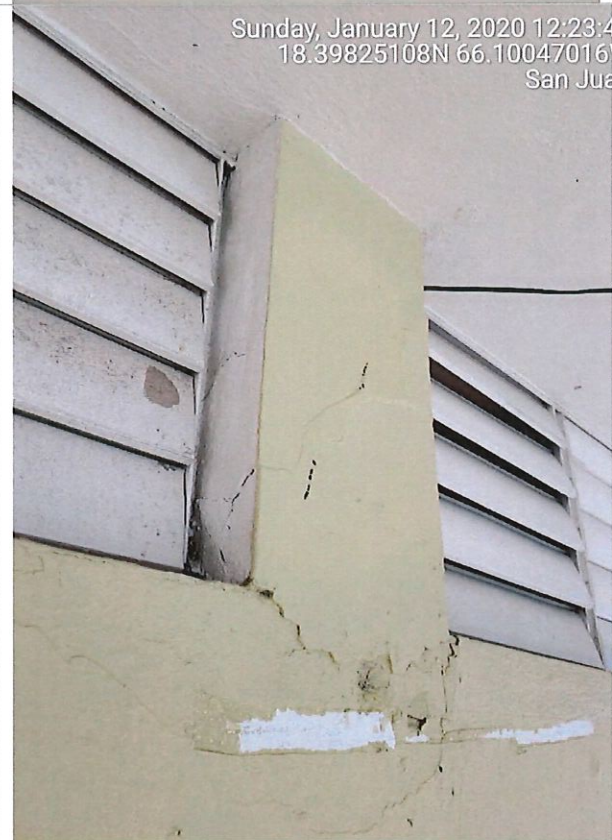
Edificio:	1
Descripción:	Se observaron grietas y fallas por causa del efecto de columna corta.

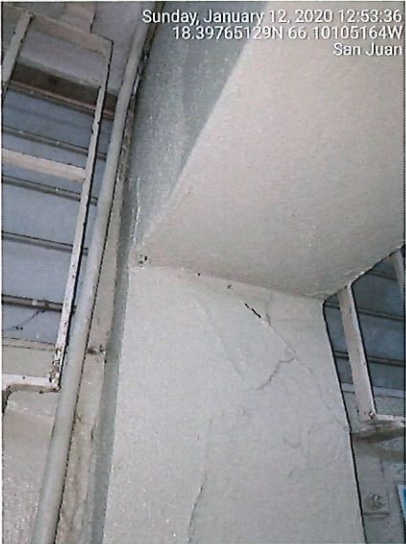
Edificio: 1		Sunday, January 12, 2020 12:53:36 18.39765129N 66.10105164W San Juan
Descripción: Se observaron grietas y fallas por causa del efecto de columna corta.

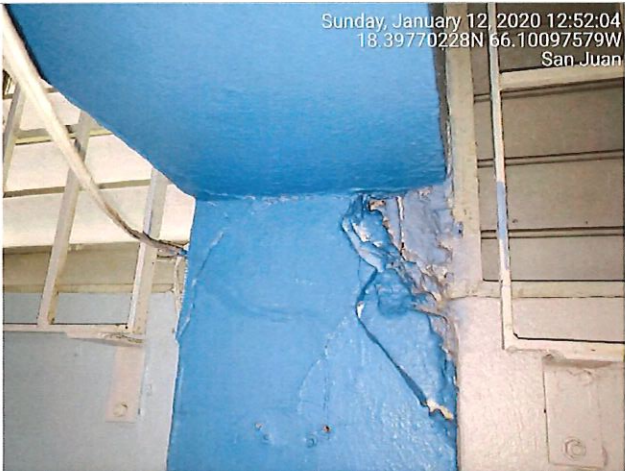
Edificio: 1		Sunday, January 12, 2020 12:52:04 18.39770228N 66.10097579W San Juan
Descripción: Se observaron grietas y fallas por causa del efecto de columna corta.
