CARTA DE TRAMITE

Escuela: Imbery Código: (10744)

Municipio: Barceloneta Fecha de: 13-Jan-20
Inspección

OCULAR INSPECTION CHECKLIST

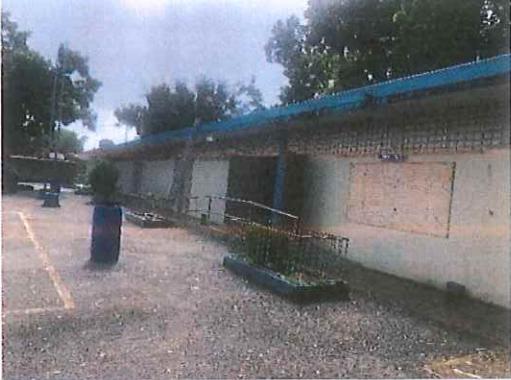
| Edificio: | 1 | |

| Descripción: | Vista de la estructura núm. 1. No se observaron daños. | |

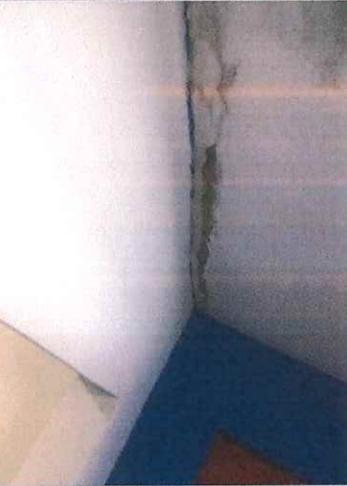
| Edificio: | 1 – Oficina del Director | |

| Descripción: | En la foto se observa filtración en el techo (condición existente). | |

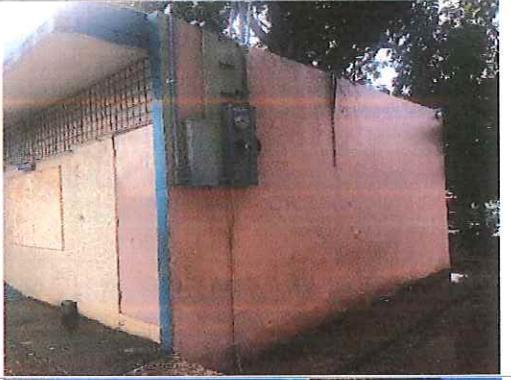
| Edificio: | 2 | |

| Descripción: | Vista de la estructura núm. 1. | |

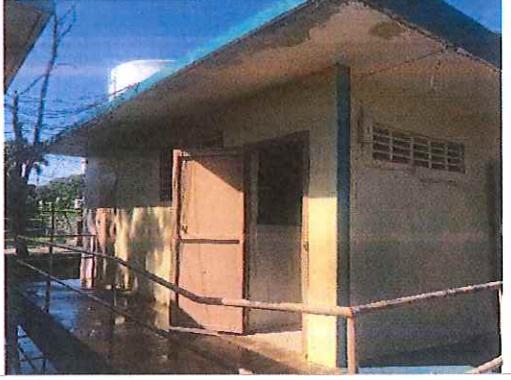
| Edificio: | 2 | |

| Descripción: | Vista de la estructura núm. 2. No se observaron daños. | |

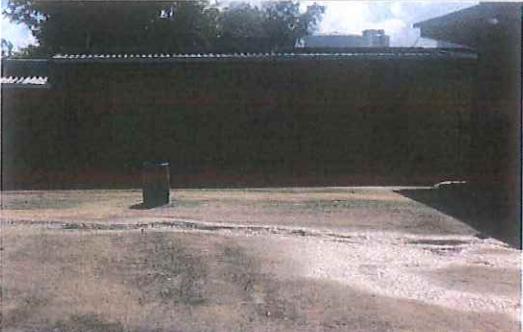
| Edificio: 3 | Descripción: Vista de la estructura núm. 3. No se observaron daños. | |

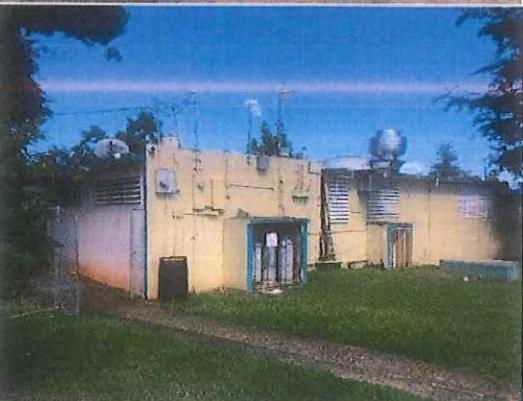
| Edificio: 3 | Descripción: En la foto se observa que el sistema de extracción de la cocina pasa a través de la pared de la estructura | |

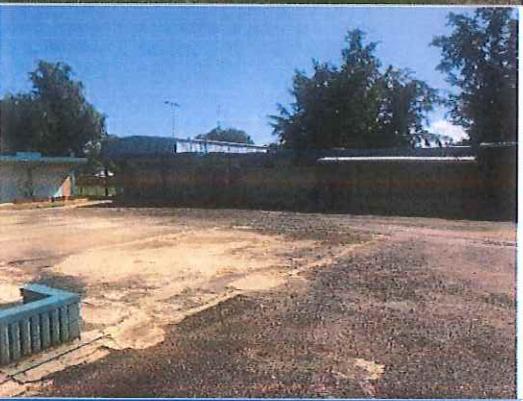
| Edificio: 4 | Descripción: Vista de la estructura núm. 4. No se observaron daños. | |

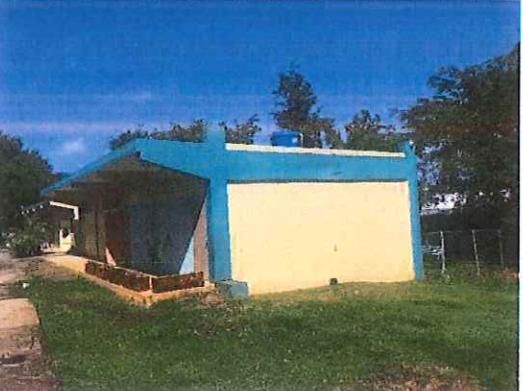
| Edificio: 5 | Descripción: Vista de la estructura núm. 5. No se observaron daños. | |

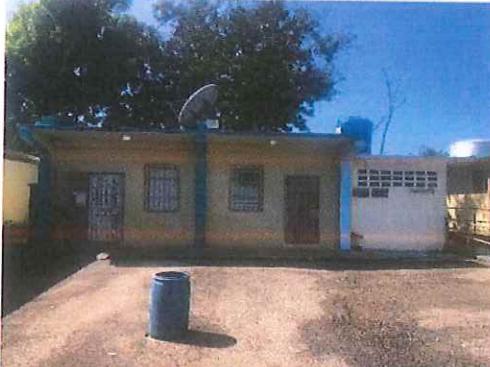
| Edificio: 6 | Descripción: Vista de la estructura núm. 6. No se observaron daños. | |

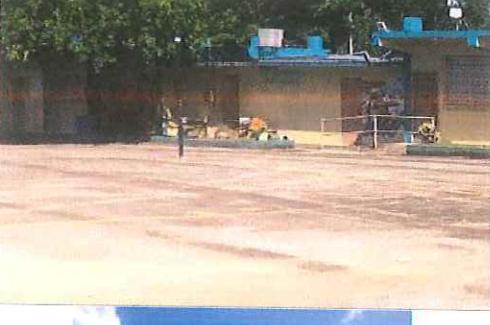
| Edificio: 7 | Descripción: Vista de la estructura núm. 7. No se observaron daños. | |

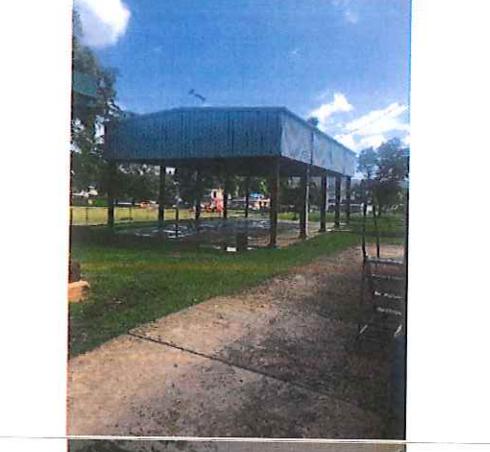
| Edificio: 8 | Descripción: Vista de la estructura núm. 8. No se observaron daños. | |

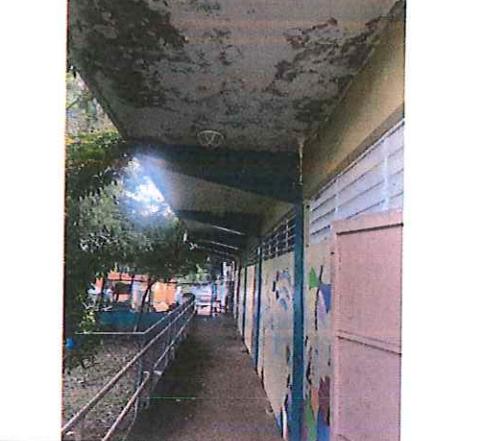
| Edificio: 9 | Descripción: Vista de la estructura núm. 9. No se observaron daños. | |

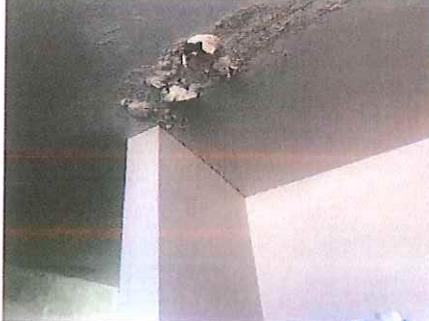
| Edificio: | 9 - Salón | |

| Descripción: | En la foto se observa que se ha abierto la junta entre la pared divisoria y la losa de techo. Aparenta estar anclada y estable. | |
