OCULAR INSPECTION CHECKLIST

1. Street Address of the School: State Road PR-2 km 93.4 Membrillo Ward
City: Camuy PR State: Puerto Rico Zip: 00627
2. School Name: Ralph W. Emerson
3. Date of inspection: January 13, 2020 10:00 AM
4. Inspector's Name: Jván D. Hernández González, PE-MEM

ANEJO A

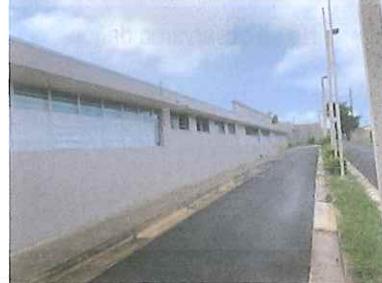
Edificio:	1

Descripción:	No se observaron daños.		
Edificio:	2

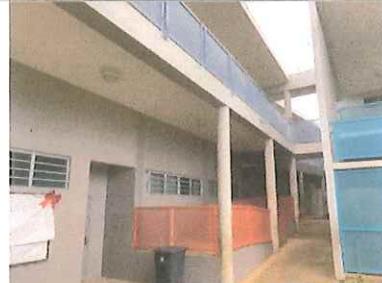
Descripción:	No se observaron daños.		
Edificio:	3

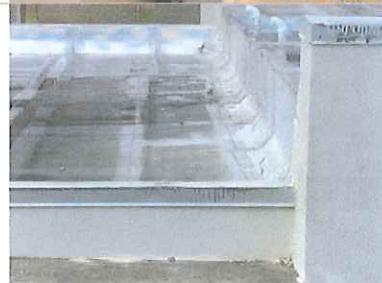
Descripción:	Se observaron daños significativos en el edificio.		
Edificio:	4

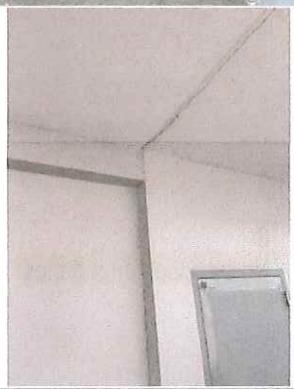
Descripción:	No se observaron daños.

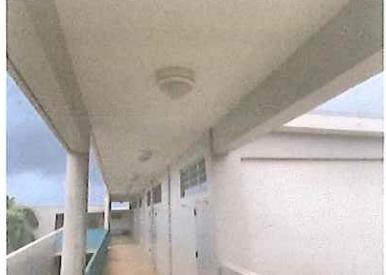
Descripción: No se observaron daños.

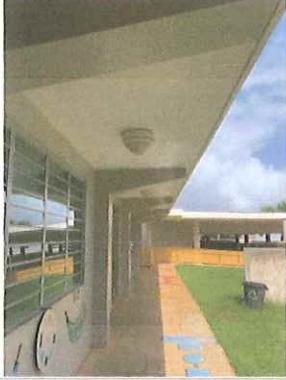
Edificio:	6

Descripción:	No se observaron daños.		
Edificio:	7

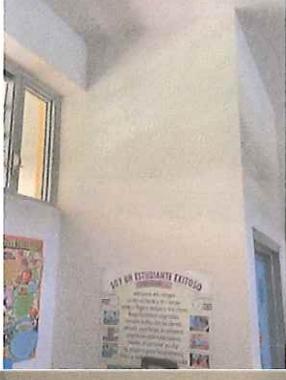
Descripción:	Se observaron daños significativos en el edificio.		
Edificio:	8

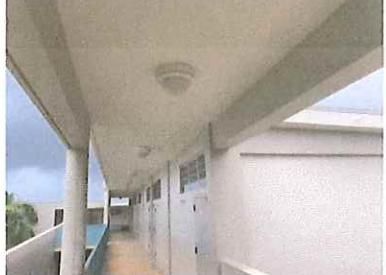
Descripción:	No se observaron daños.
