CARTA DE TRAMITE

Escuela: **Antonio Velez Alvarado**

Código: **(12187)**

Informe de inspección ocular de daño en la Escuela Antonio Vélez Alvarado
Carretera 2 Km 46.1 Bo. Pugnado, Manatí, PR 00674

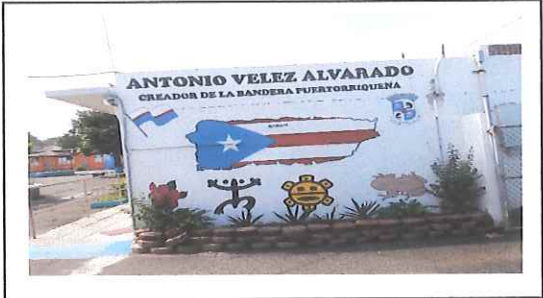
Edificio:	5- Edificio no.5: Edificio Salones, Baños , Almacén, Biblioteca, Oficinas)

Descripción:	<ul style="list-style-type: none"> ● Humedad de agua del techo, no tratado para humedad ● Grietas menores en techo y paredes existentes 	
Edificio:	6- Edificio no.6.: Edificio Salones, Educación Especial

- Grietas menores en techo y paredes existentes
- 5- Edificio no.5: Edificio Salones, Baños , Almacén, Biblioteca, Oficinas)
 - Humedad de agua del techo, no tratado para humedad

- Grietas menores en techo y paredes existentes
- 6- Edificio no.: Edificio Salones, Educación Especial
 - Humedad de agua del techo, no tratado para humedad

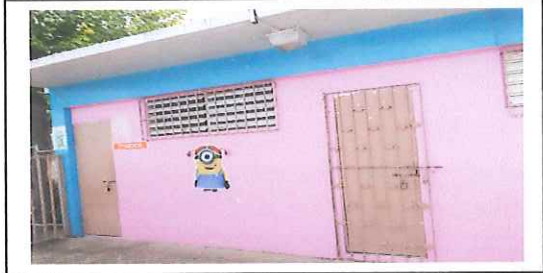
Descripción:	<ul style="list-style-type: none"> ● Humedad de agua del techo, no tratado para humedad ● Grietas menores en techo y paredes existentes 	
Edificio:	7- Edificio no.7: Edificio Escuela de un nivel (Concreto con techo en cemento) (Salón 1-2)

- Grietas menores en techo y paredes existentes

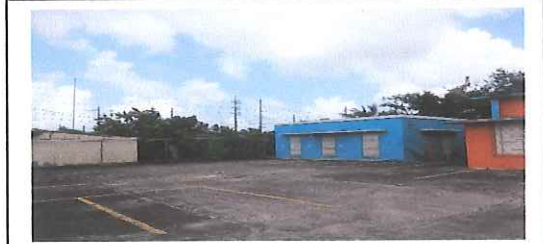
Descripción:	<ul style="list-style-type: none"> ● No se observaron daños significativos en el interior de los salones ● Humedad de agua del techo, sin tratar para humedad 	
Edificio:	8- Edificio no.8: Edificio Escuela de un nivel (Concreto con techo en cemento) (Salón 1-1)

- 1- Edificio no.7: Edificio Escuela de un nivel
(Concreto con techo en cemento) (Salone1-2)
 - No se observaron daños significativos en el interior de los salones
 - Humedad de agua del techo, sin tratar para humedad.
- 2- Edificio no.8: Edificio Escuela de un nivel
(Concreto con techo en cemento) (Salon 1-1)
 - No se observaron daños significativos en el interior de los salones
 - Humedad de agua del techo, sin tratar para humedad

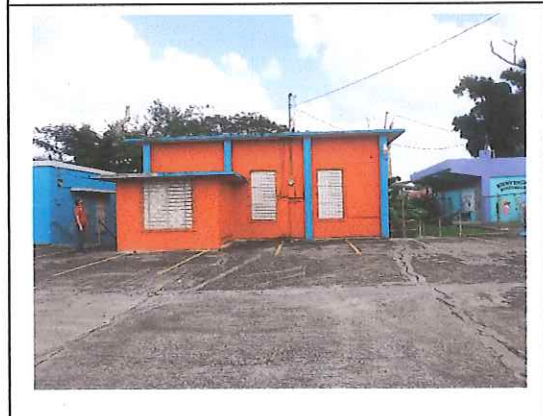
Descripción:	<ul style="list-style-type: none"> ● No se observaron daños significativos en el interior de los salones ● Humedad de agua del techo, sin tratar para humedad

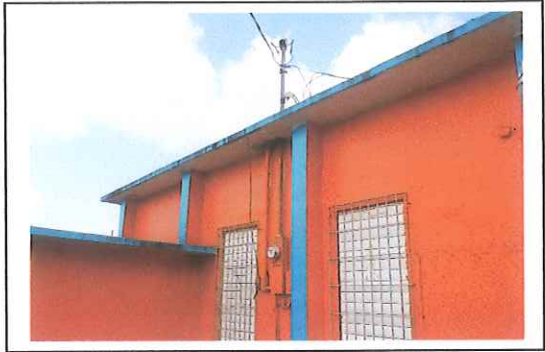
Edificio:	9- Edificio no.9: Edificio Escuela de un nivel – Kínder (Concreto con techo en cemento, Salón Kínder)

Descripción:	<ul style="list-style-type: none"> • . No se observaron daños significativos en el interior de los salones • Humedad de agua del techo, sin tratar para humedad 	
Edificio:	10- Edificio no.10: Edificio Escuela de un nivel -Baños(Concreto con techo en cemento)

- 3- Edificio no.9: Edificio Escuela de un nivel -Kinder
(Concreto con techo en cemento, Salón Kinder)
 - No se observaron daños significativos en el interior de los salones
 - Humedad de agua del techo, sin tratar para humedad

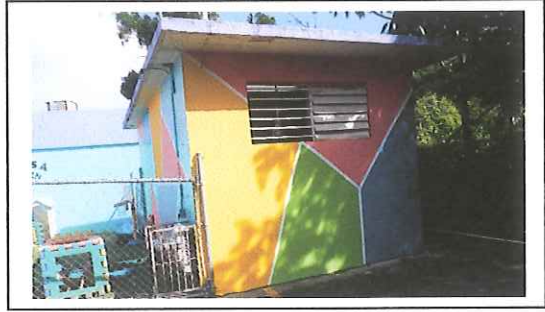
Descripción:	<ul style="list-style-type: none"> • No se observaron daños significativos en el interior de los salones • Humedad de agua del techo, sin tratar para humedad

- 4- Edificio no.10: Edificio Escuela de un nivel -Baños
(Concreto con techo en cemento)
 - No se observaron daños significativos en el interior de los salones
 - Humedad de agua del techo, sin tratar para humedad
