OCULAR INSPECTION CHECKLIST

1. **Street Address of the School:** Urb.Villa Serena Calle Orquídea #2
City: Arecibo **State:** Puerto Rico **Zip:** 00613
2. **School Name:** Elba Luqo Carrión
3. **Date of inspection:** January 10, 2020
4. **Inspector's Name:** Edgardo Hernández-Alvarado

ANEJO A

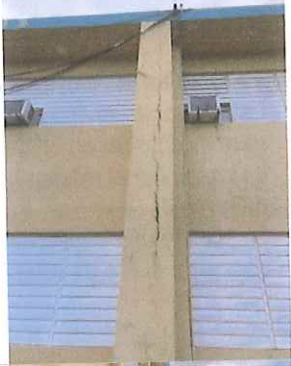
Descripción:	No se observaron daños relacionados con los eventos recientes. Se identificaron grietas preexistentes cónsonas con las previsibles en justas estructurales. Las mismas no presentan evidencia de haberse agravado durante los temblores registrados en el referido periodo y sus réplicas.		
Edificio:	1 – Salones (Ala Norte) - Exterior

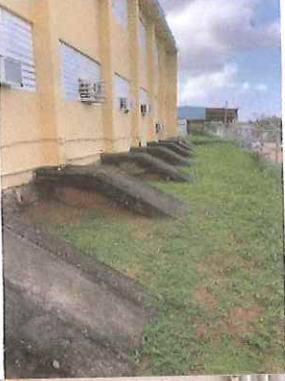
Descripción:	Se observó grave problema de erosión que requiere pronta atención para evitar se exponga la zapata del edificio. En estos momentos se observa expuesta una viga de piso.		
Edificio:	1 – Salones (Ala Norte) - Interior

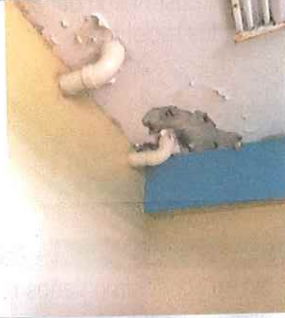
Descripción:	Se observaron daños preexistentes de grietas en paredes de bloques que no aparentan comprometen la integridad estructural de la estructura. Se observó acero expuesto. Estas condiciones requieren trabajos de mantenimiento para su corrección.		
Edificio:	2 – Oficinas de Apoyo - Exterior

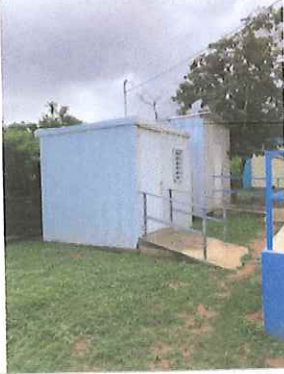
Descripción:	Estas oficinas se encontraban cerradas. Las mismas consisten en unos pequeños contenedores de metal. Por el exterior no se identificaron daños. Se sugiere una inspección ocular previo a comenzar el uso de estas oficinas.

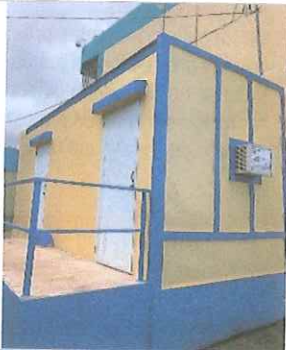
Edificio:	2 – Oficinas de Apoyo - Exterior	
Descripción:	Estas oficinas se encontraban cerradas. Las mismas consiste en un pequeño contenedor de metal. Por el exterior no se identificaron daños. Se sugiere una inspección ocular previo a comenzar el uso de estas oficinas.

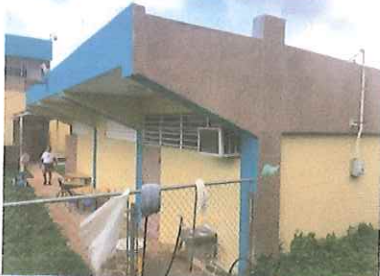
Edificio:	3 – Salón de Clases – (Interior y Exterior)	
Descripción:	No se observaron daños relacionados con los eventos recientes.

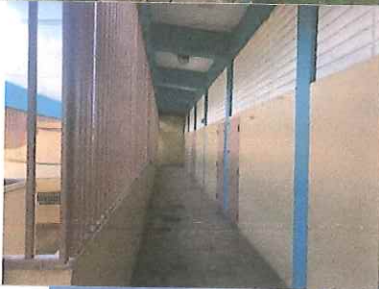
Edificio:	4 – Salones (Ala Sur) – Interior y Exterior	
Descripción:	No se observaron daños relacionados con los eventos recientes.

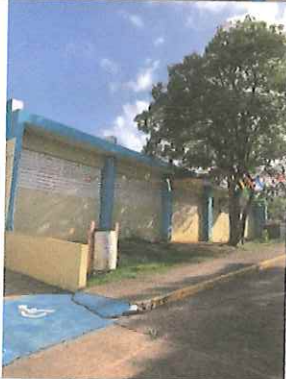
Edificio:	5 – Salón Comedor – Interior y Exterior	
Descripción:	No se observaron daños relacionados con los eventos recientes.

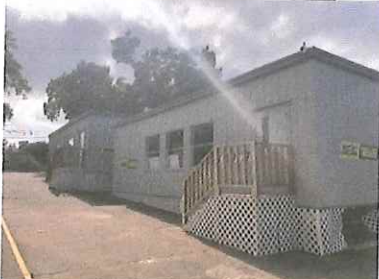
Edificio:	6 y 7 – Salones en Contenedores de Metal	
Descripción:	No se observaron daños relacionados con los eventos recientes. Los soportes en columnas de bloques colocados sin mortero se encontraban en buenas condiciones y no mostraban signos de desplazamiento. Las amarras en metal para evitar el vuelco se encontraban en buenas condiciones y tensadas.
