OCULAR INSPECTION CHECKLIST

1. **Street Address of the School:** Carr. 453, K. 6, H 6, Sect. Soler, Bo. Cibao.
City: Camuy **State:** Puerto Rico **Zip:** 00627
2. **School Name:** Vocacional Agricola Soler
3. **Date of inspection:** January 13, 2020
4. **Inspector's Name:** Edgardo Hernández-Alvarado

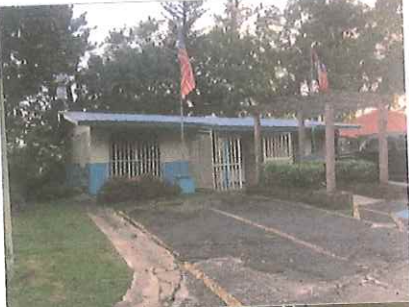
Descripción:	Estructura en Madera. No se observaron daños relacionados con los eventos recientes. Se identificaron grietas preexistentes en el piso y problemas de filtración. Las mismas no presentan evidencia de haberse agravado durante los recientes temblores registrados.	
Edificio:	1 – Oficina

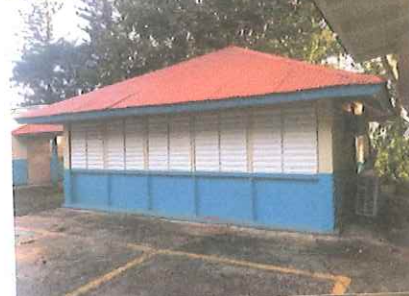
Descripción:	Estructura en Madera. No se observaron daños relacionados con los eventos recientes. Se identificaron grietas preexistentes en el piso y problemas de filtración. Las mismas no presentan evidencia de haberse agravado durante los recientes temblores registrados.	
Edificio:	1 – Baños

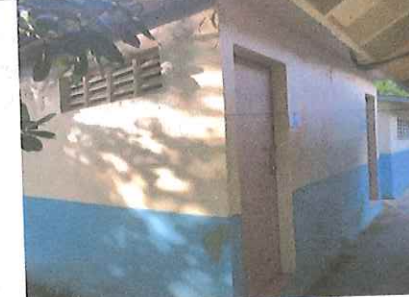
Descripción:	No se observaron daños relacionados con los eventos recientes. Se identificaron grietas preexistentes. Las mismas no presentan evidencia de haberse agravado durante los recientes temblores registrados.	
Edificio:	1 – Baños

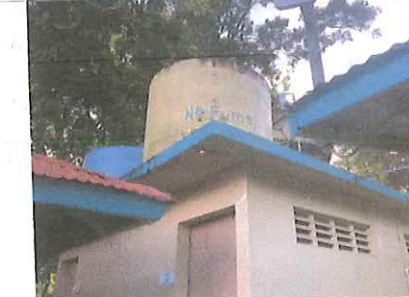
Descripción:	Se observan varias cisternas instaladas sobre el techo de esta estructura. OMEP debe encomendar se realice un análisis estructural para corroborar la capacidad del referido techo para soportar la carga que representan los galones de agua almacenados en dicha cisterna.

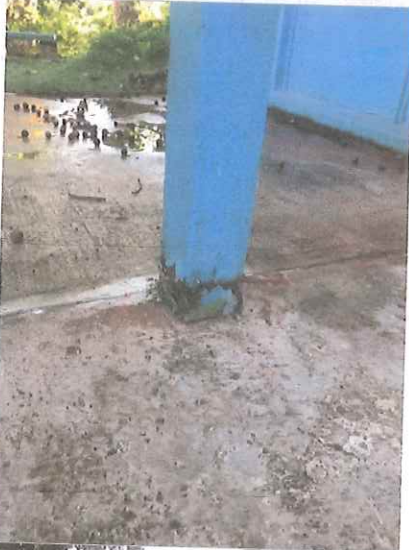
Edificio:	1 – Oficina (Pasillo Exterior Cubierto)	
Descripción:	Estructura en Madera. No se observaron daños relacionados con los eventos recientes. Las columnas del pasillo presentan señales de deterioro. Se recomienda la reparación de las mismas para evitar daños mayores.

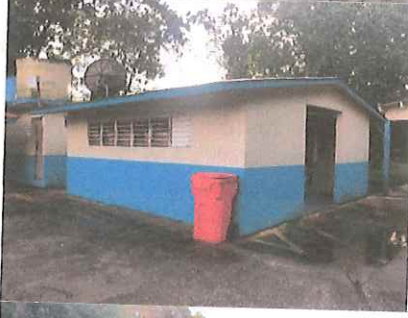
Edificio:	1 – Baños	
Descripción:	No se observaron daños relacionados con los eventos recientes. Se identificaron grietas preexistentes. Las mismas no presentan evidencia de haberse agravado durante los recientes temblores registrados.

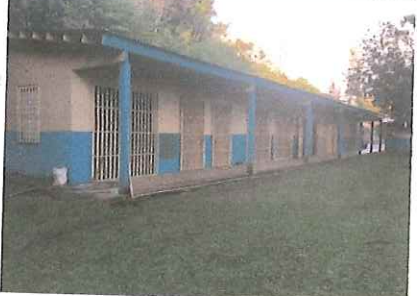
Edificio:	2 – Salones	
Descripción:	Estructura en Madera. No se observaron daños relacionados con los eventos recientes. Se identificaron grietas preexistentes en el suelo y problemas de filtración. Las mismas no presentan evidencia de haberse agravado durante los recientes temblores registrados.

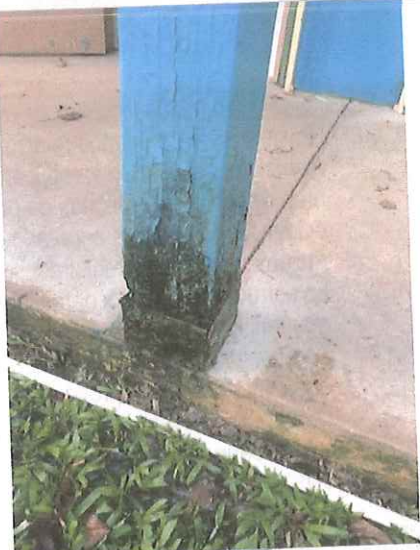
<p>Edificio: 2 – Salones (Pasillo Exterior Cubierto)</p>		
<p>Descripción: Estructura en Madera. No se observaron daños relacionados con los eventos recientes. Las columnas del pasillo presentan señales de deterioro. Se recomienda la reparación de las mismas para evitar daños mayores.</p>

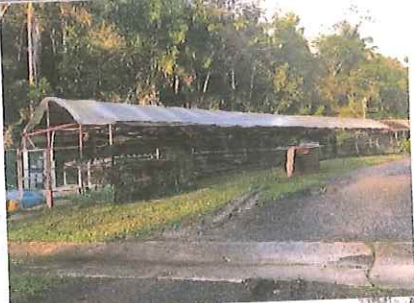
<p>Edificio: 3 – Salón de Actividades y Almacén</p>		
<p>Descripción: Estructura en Madera. No se observaron daños relacionados con los eventos recientes.</p>		 
<p>Edificio: 4 – Viveros Hidropónicos</p>		
<p>Descripción: Estructura en Metal. No se observaron daños relacionados con los eventos recientes.</p>

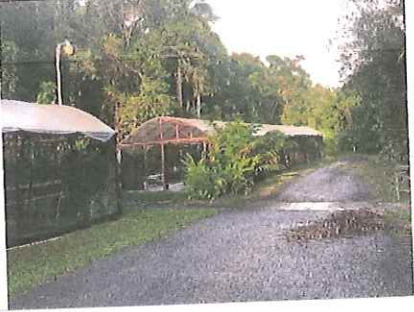
<p>Edificio: 4 – Viveros Hidropónicos</p>		
<p>Descripción: Estructura en Metal. No se observaron daños relacionados con los eventos recientes.</p>

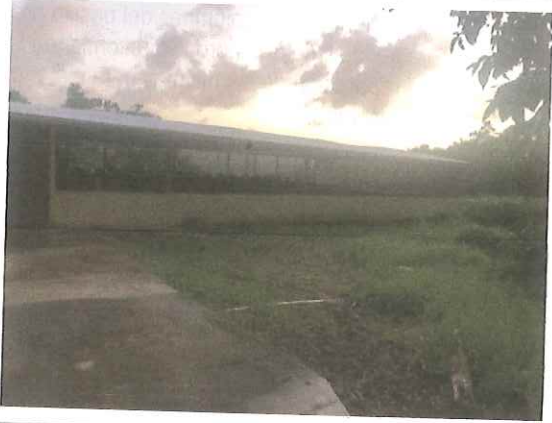
Edificio:	7 – Rancho de Cunicultura	
Descripción:	<p>No se observaron daños relacionados con los eventos recientes. Se identificaron grietas preexistentes. Las mismas no presentan evidencia de haberse agravado durante los recientes temblores registrados. La estructura presenta daños por falta de mantenimiento.</p> <p>Se observan además secciones de la estructura que lucen provenir de construcciones informales. Se recomienda se lleve a cabo una inspección adicional para establecer un alcance de mejoras a la infraestructura.</p>

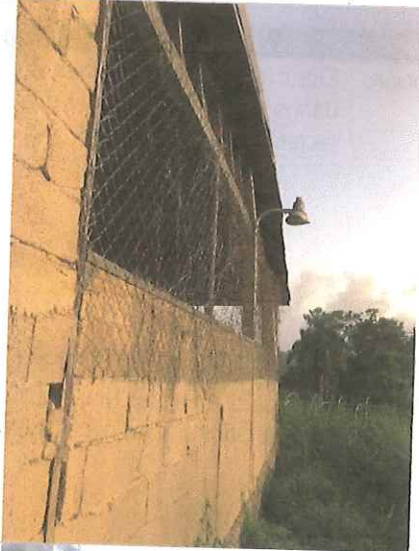
Edificio:	7 – Rancho de Cunicultura	
Descripción:	<p>La estructura presenta daños por falta de mantenimiento.</p> <p>Se observan además secciones de la estructura que lucen provenir de construcciones informales. Se recomienda se lleve a cabo una inspección adicional para establecer un alcance de mejoras a la infraestructura.</p>

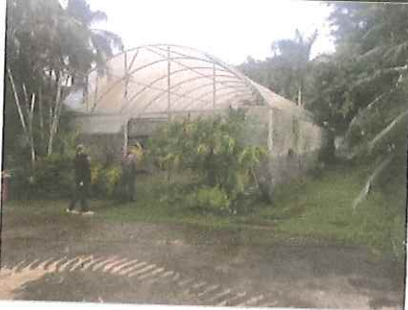
Edificio:	8 – Umbráculo de Plantas Ornamentales

Descripción:	<p>No se observaron daños relacionados con los eventos recientes.</p>

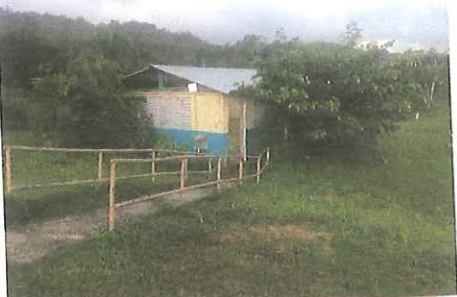
Edificio: 9 – Salón de Horticultura		
Descripción:	No se observaron daños relacionados con los eventos recientes. Se identificaron grietas preexistentes. Las mismas no presentan evidencia de haberse agravado durante los recientes temblores registrados. La estructura se encontraba bajo reparaciones tras el paso del Huracán María. Dichas reparaciones deben completarse previo a la utilización del salón.

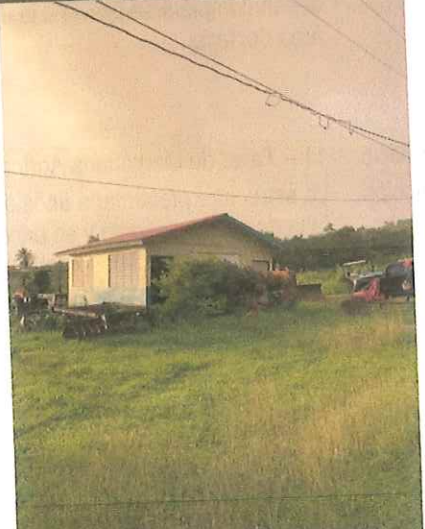
Edificio: 10 – Salón Mecanización Agrícola		
Descripción:	No se observaron daños relacionados con los eventos recientes.

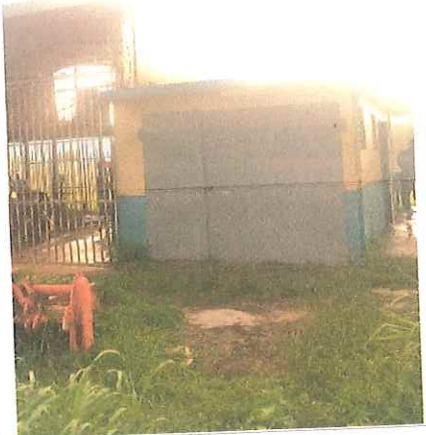
Edificio: 11 – Taller de Maquinaria Agrícola (Baños)		
Descripción:	No se observaron daños relacionados con los eventos recientes. Se identificaron grietas preexistentes. Las mismas no presentan evidencia de haberse agravado durante los recientes temblores registrados.

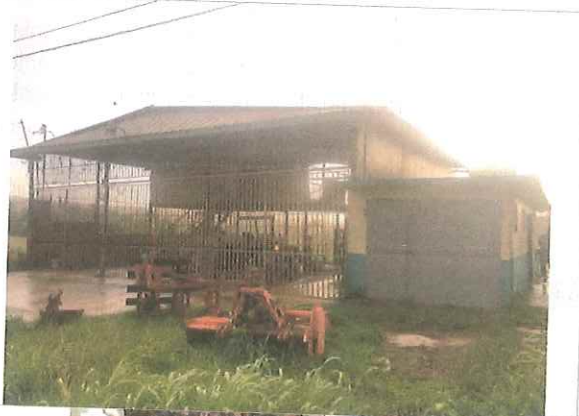
Edificio: 11 – Taller de Maquinaria Agrícola	Descripción: No se observaron daños relacionados con los eventos recientes. Se identificaron grietas preexistentes. Las mismas no presentan evidencia de haberse agravado durante los recientes temblores registrados. La estructura se encontraba bajo reparaciones tras el paso del Huracán María. Dichas reparaciones deben completarse previo a la utilización del área del taller.

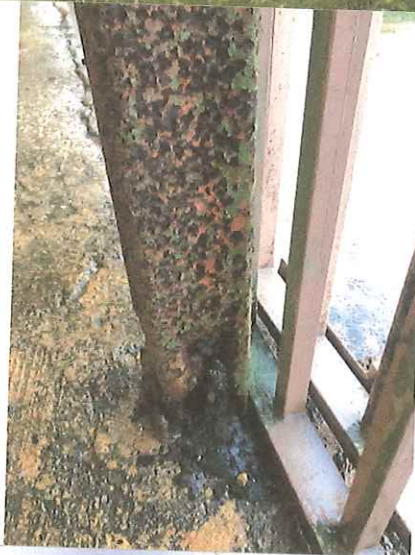
Edificio: 11 – Taller de Maquinaria Agrícola	Descripción: La estructura presentaba unos daños por falta de mantenimiento y se encontraba bajo reparaciones tras el paso del Huracán María. Dichas reparaciones deben completarse previo a la utilización del área del taller.

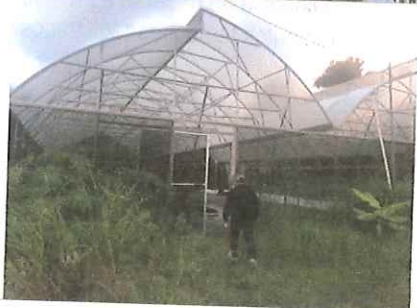
Edificio: 12 – Umbráculo de Caficultura	Descripción: No se observaron daños relacionados con los eventos recientes.
