CARTA DE TRAMITE

Escuela: Bernardo Huyke

Código: (70409)

Municipio: Bayamón

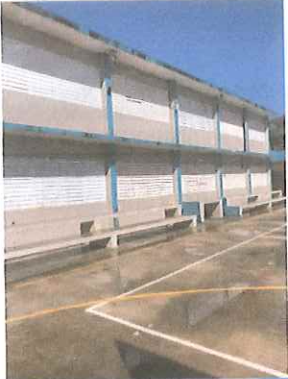
Edificio: 1-O	Descripción: No se observaron daños que pudieran ser relacionados al evento sísmico. Grietas menores y empañetado afectado previo al Terremoto.

Cabe señalar que la estructura presentaba grietas menores, empañetados sueltos preexistentes a los eventos recientes que deben atenderse como parte del mantenimiento ordinario de la facilidad. Hacer referencia a las recomendaciones incluidas en el Anejo A.

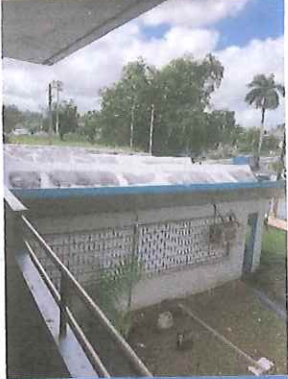
Edificio: 1-O	Descripción: No se observaron daños que pudieran ser relacionados al evento sísmico. Grietas menores y empañetado afectado previo al Terremoto.

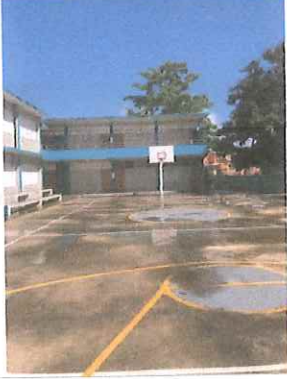
Edificio: 1-N	Descripción: No se observaron daños que pudieran ser relacionados al evento sísmico. Grietas menores y empañetado afectado previo al Terremoto.

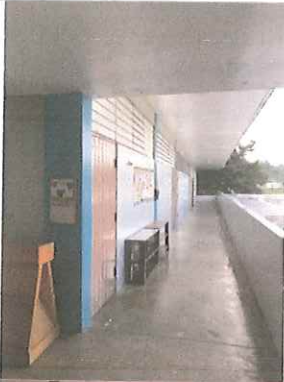
Edificio:	1-N		
Descripción:	No se observaron daños que pudieran ser relacionados al evento sísmico. Grietas menores y empañetado afectado previo al Terremoto.

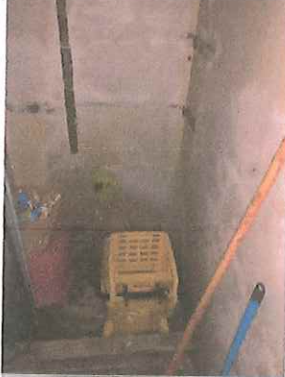
Edificio:	1-N		
Descripción:	Se observó un tubo expuesto en PVC roto que requiere ser reparado. Se trató de cerrar la llave de paso en el contador de la AAA pero no contábamos con las herramientas para hacerlo. Se requiere inmediata reparación.

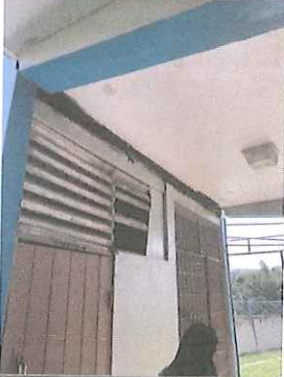
Edificio:	1-S		
Descripción:	No se observaron daños que pudieran ser relacionados al evento sísmico. Grietas menores y empañetado afectado previo al Terremoto.

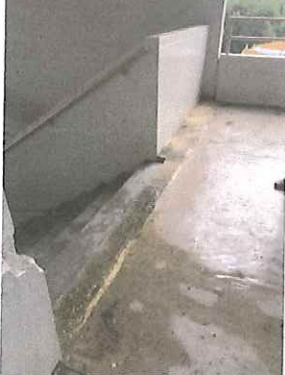
Edificio:	1-S		
Descripción:	No se observaron daños que pudieran ser relacionados al evento sísmico. Grietas menores y empañetado afectado previo al Terremoto.

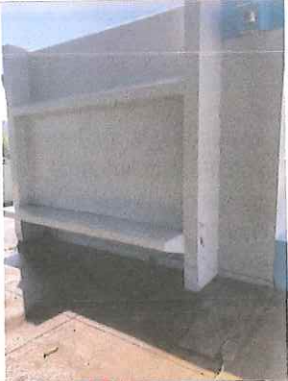
Edificio: 2			
Descripción:	<p>No se observaron daños que pudieran ser relacionados al evento sísmico. Grietas menores y empañetado afectado previo al Terremoto.</p> <p>Se observó la existencia de un asentamiento no uniforme y grietas en el piso que no representan riesgo de falló estructural, pero deben ser inspeccionadas en detalle para corregirlas.</p>

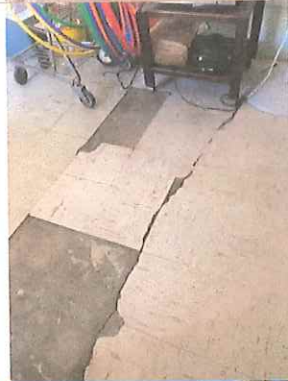
Edificio: 2			
Descripción:	<p>No se observaron daños que pudieran ser relacionados al evento sísmico. Grietas menores y empañetado afectado previo al Terremoto.</p> <p>Se observó la existencia de un asentamiento no uniforme y grietas en el piso que no representan riesgo de falló estructural, pero deben ser inspeccionadas en detalle para corregirlas.</p>

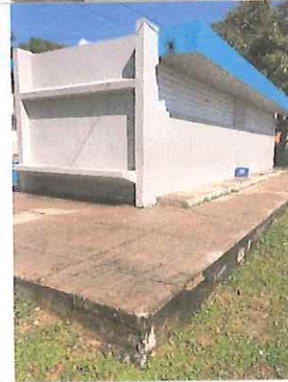
Edificio: 2			
Descripción:	<p>No se observaron daños que pudieran ser relacionados al evento sísmico. Grietas menores y empañetado afectado previo al Terremoto.</p> <p>Se observó la existencia de un asentamiento no uniforme y grietas en el piso que no representan riesgo de falló estructural, pero deben ser inspeccionadas en detalle para corregirlas.</p>

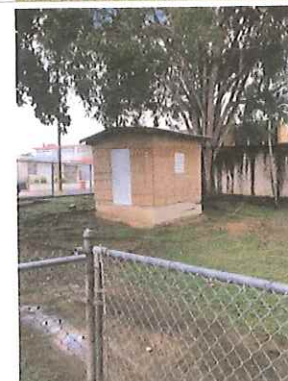
Edificio: 3			
Descripción:	<p>Estructura en madera de aparente construcción informal. No se observaron daños que pudieran ser relacionados al evento sísmico. Se observó la existencia de un asentamiento no uniforme de una pared que deben ser inspeccionadas en detalle. No se recomienda el uso de este salón hasta una segunda inspección más detallada, sin embargo, por esta estar localizada en un área cerrada con verjas que impide el acceso de estudiantes, entendemos que no incide en la operación del resto de las estructuras.</p>
