G. RECOMENDACIÓN AL SECRETARIO

Departamento de Educación
Dr. Eligio Hernández Pérez
Secretario de Educación

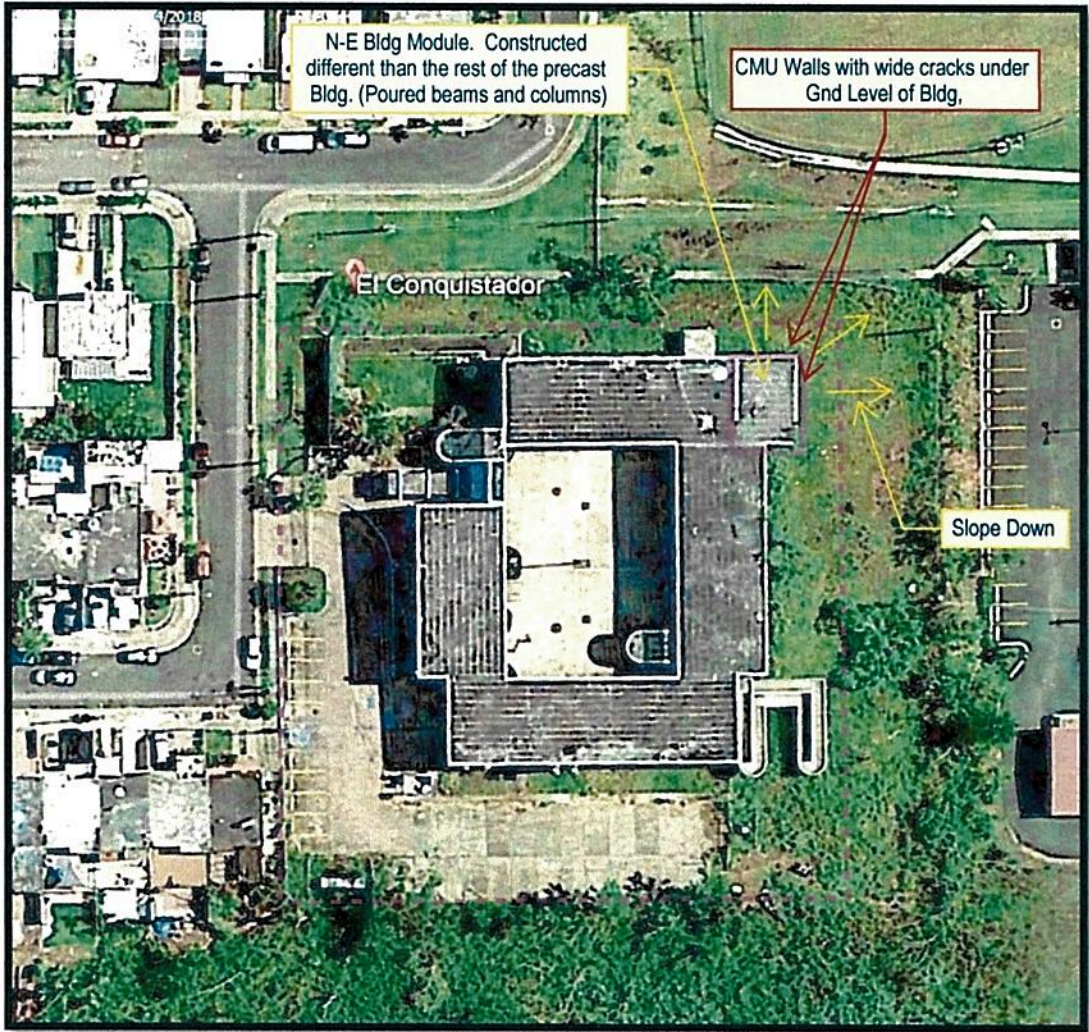
School: **El Conquistador**
 City: Trujillo Alto
 Date: Jan-17-2020

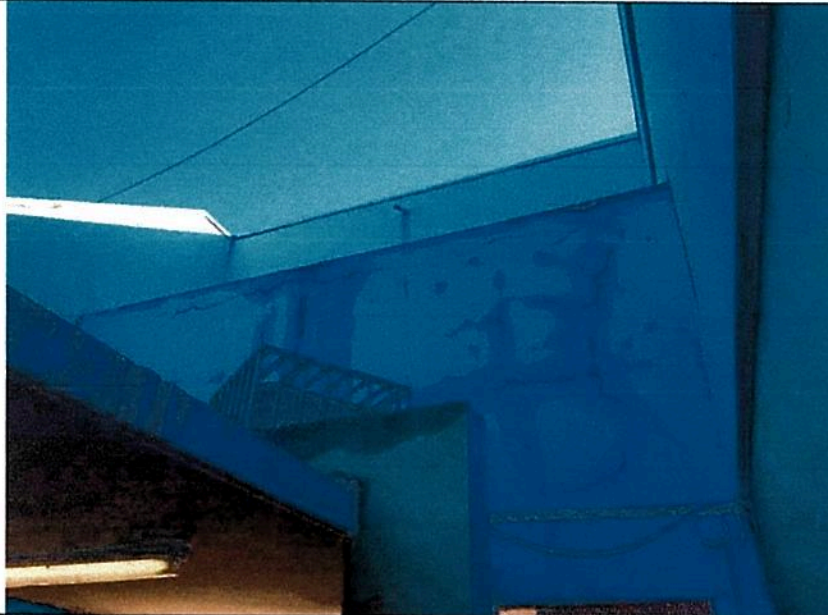
Picture 1 – Exterior CMU wall over main entrance beam has multiple horizontal and vertical cracks that go all the way through the wall section – Exterior View

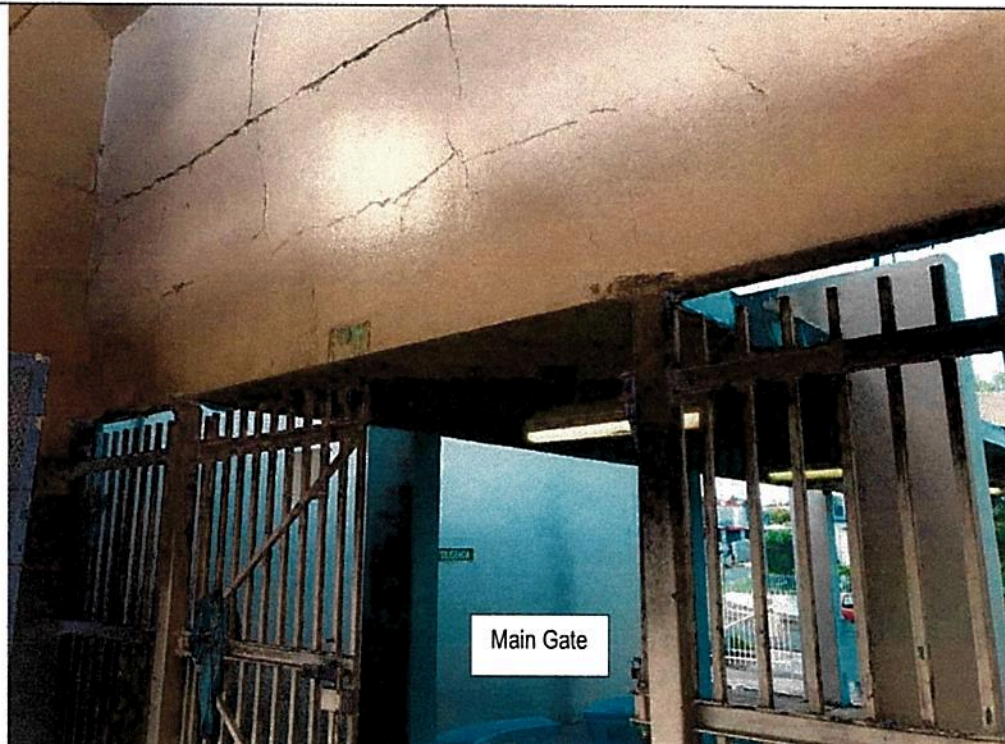
Picture 2 – Exterior CMU wall over main entrance beam has multiple horizontal and vertical cracks that go all the way through the wall section – Interior View

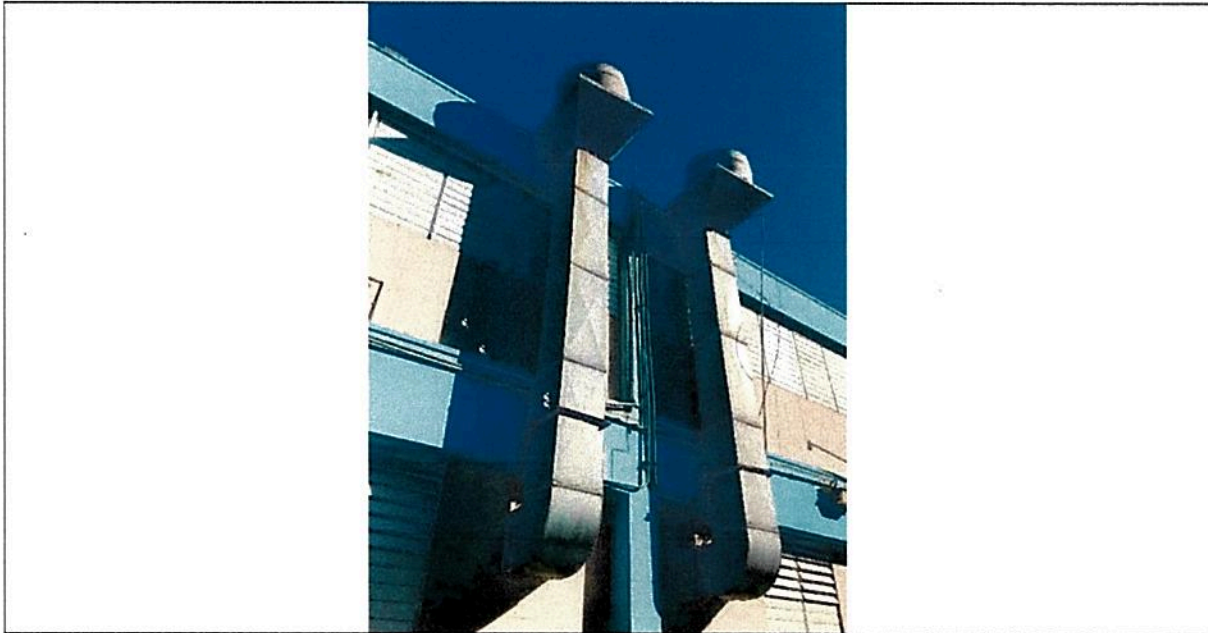
Picture 3 -Kitchen Ventilation Ductwork and Fans 2ea (Exterior) - Supports at roof level are extremely corroded and they are temporarily attached to the building by a coated wire with eye bolts.

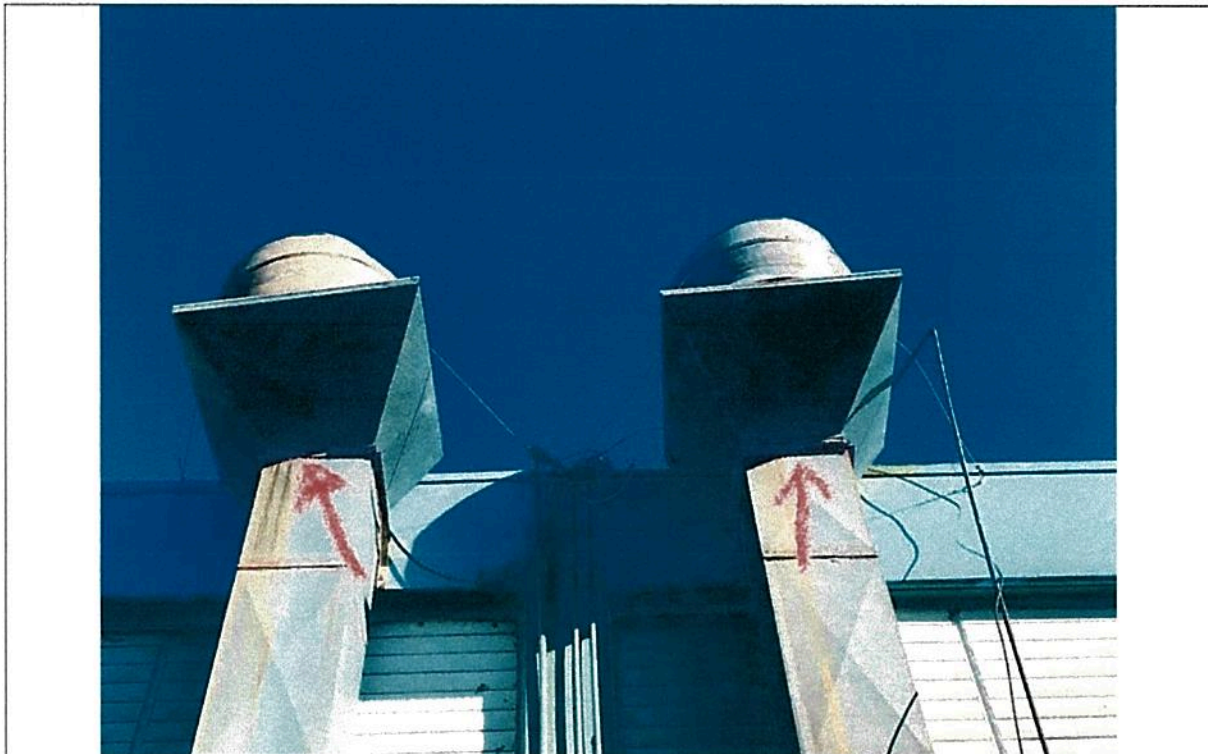
Picture 4 – Kitchen Ventilation Ductwork and Fans 2ea (Exterior) - Supports at roof level are extremely corroded and they are temporarily attached to the building by a coated wire with eye bolts.

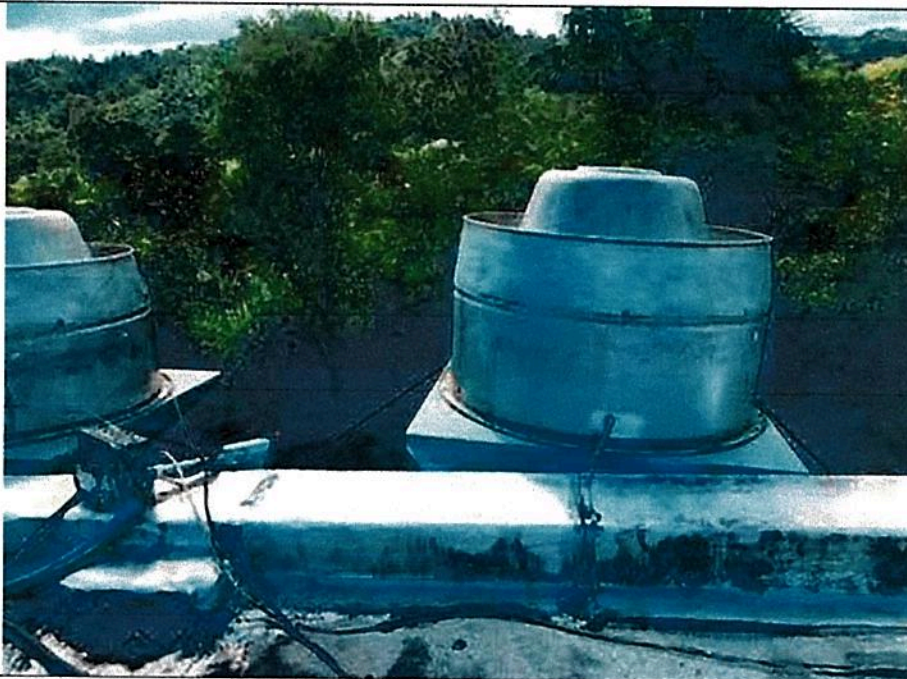
Picture 5 – Kitchen Ventilation Ductwork and Fans 2ea (Exterior) - Supports at roof level are extremely corroded and they are temporarily attached to the building by a coated wire with eye bolts. Both fan assemblies are wobbly.

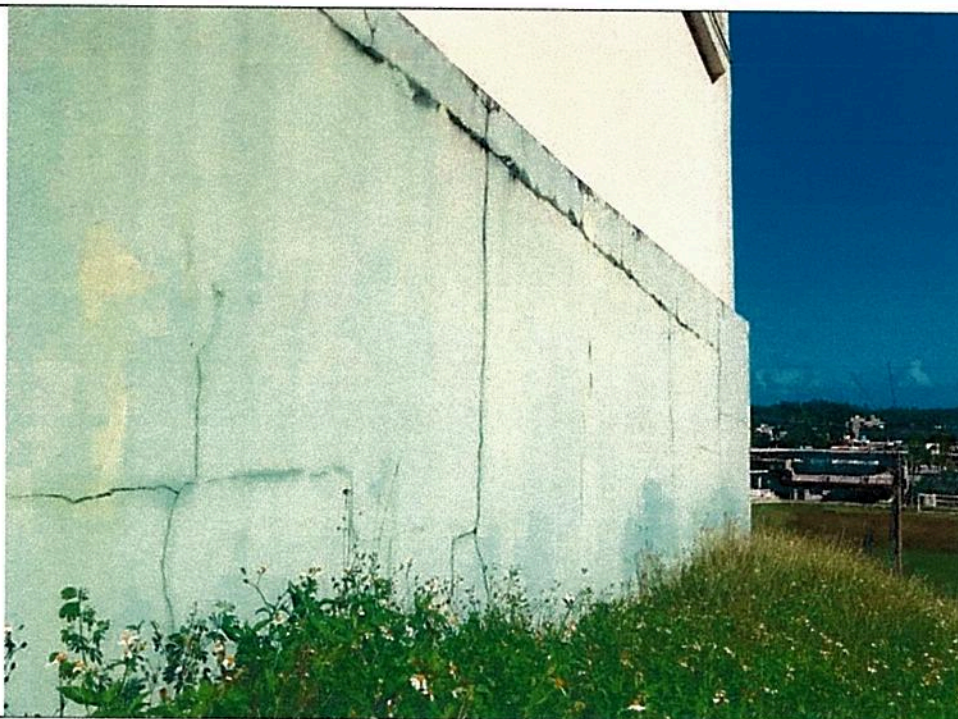
Picture 6 - Wide cracks (horizontal and vertical) at CMU wall under North-East part of the building. East side of the N-E corner.

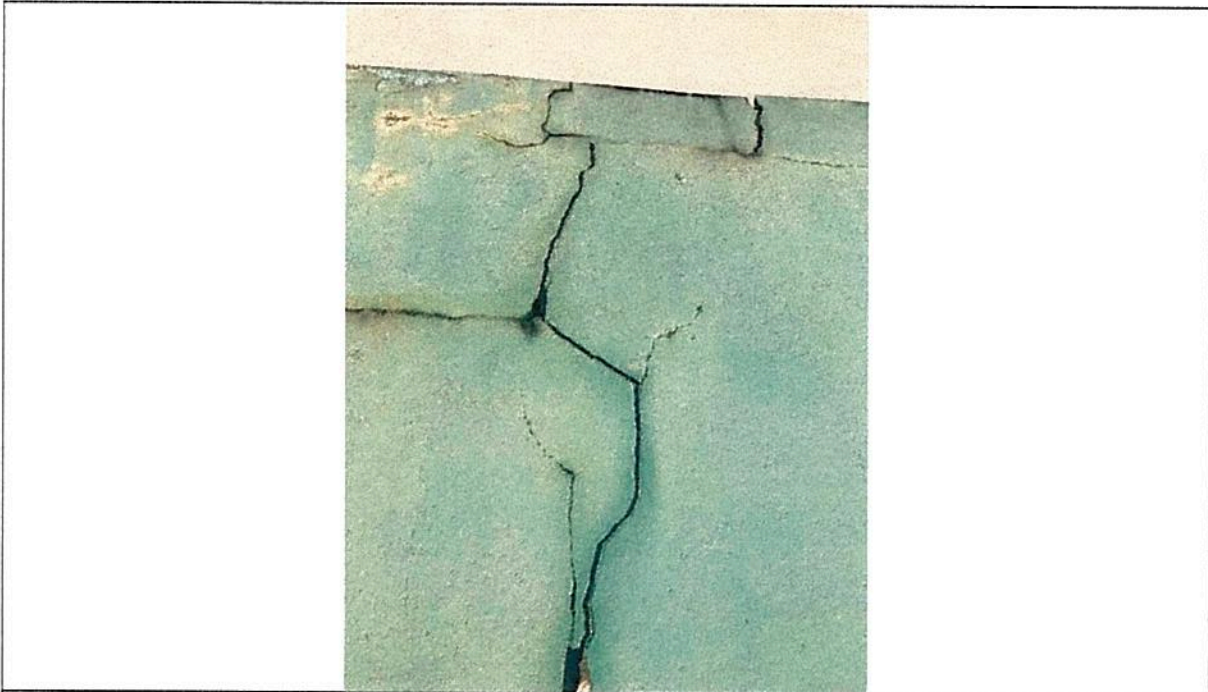
Picture 7 - Wide cracks (horizontal and vertical) at CMU wall under North-East part of the building. East side of the N-E corner.

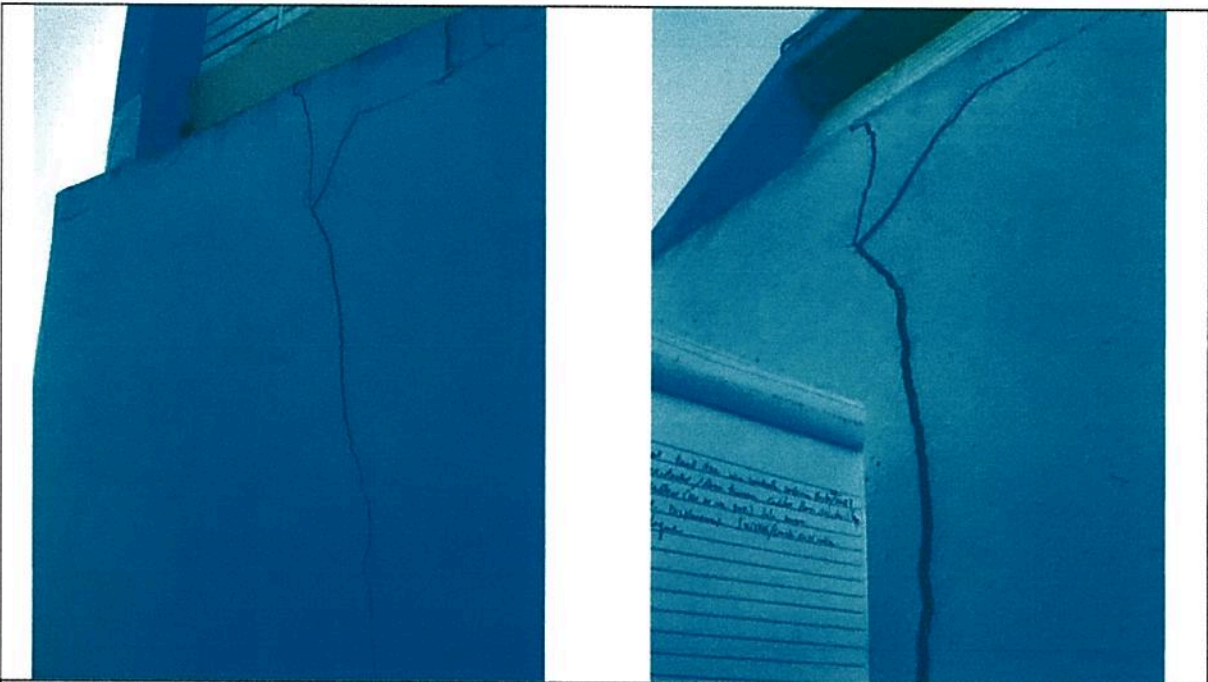
Picture 8 - Wide cracks (horizontal and vertical) at CMU wall under North-East part of the building. North side of the N-E corner.

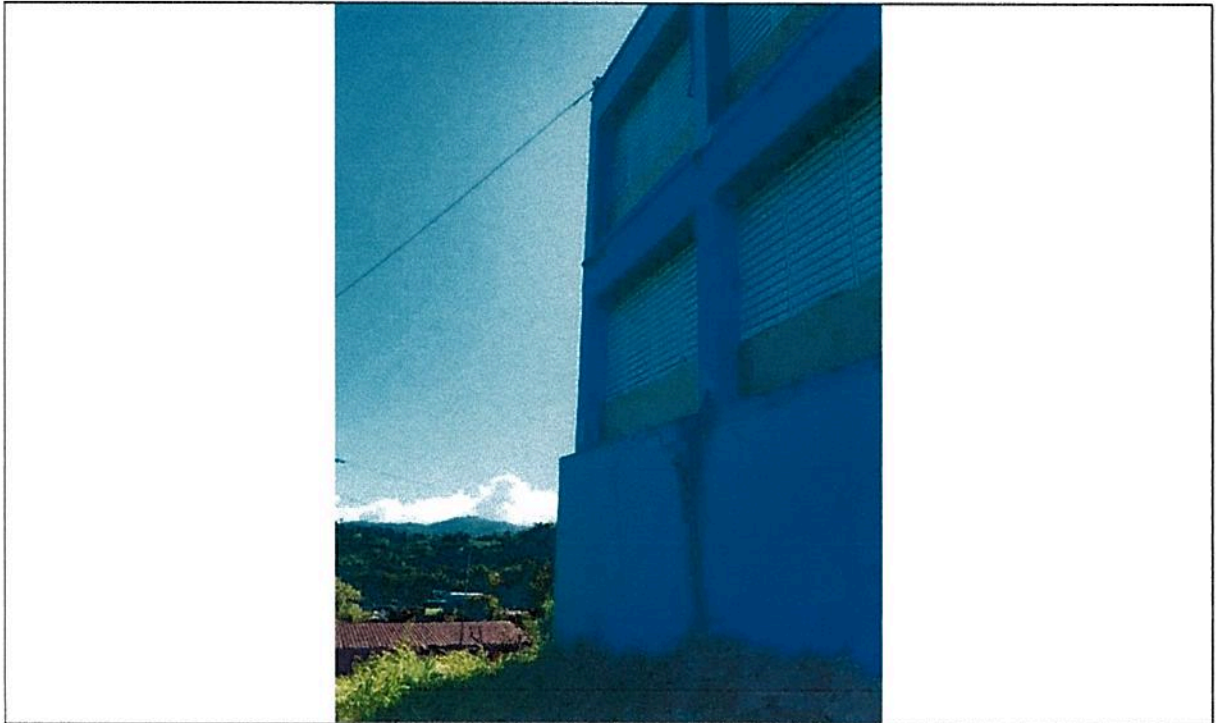
Picture 9 - Wide cracks (horizontal and vertical) at wall under North-East part of the building. North side of the N-E corner.

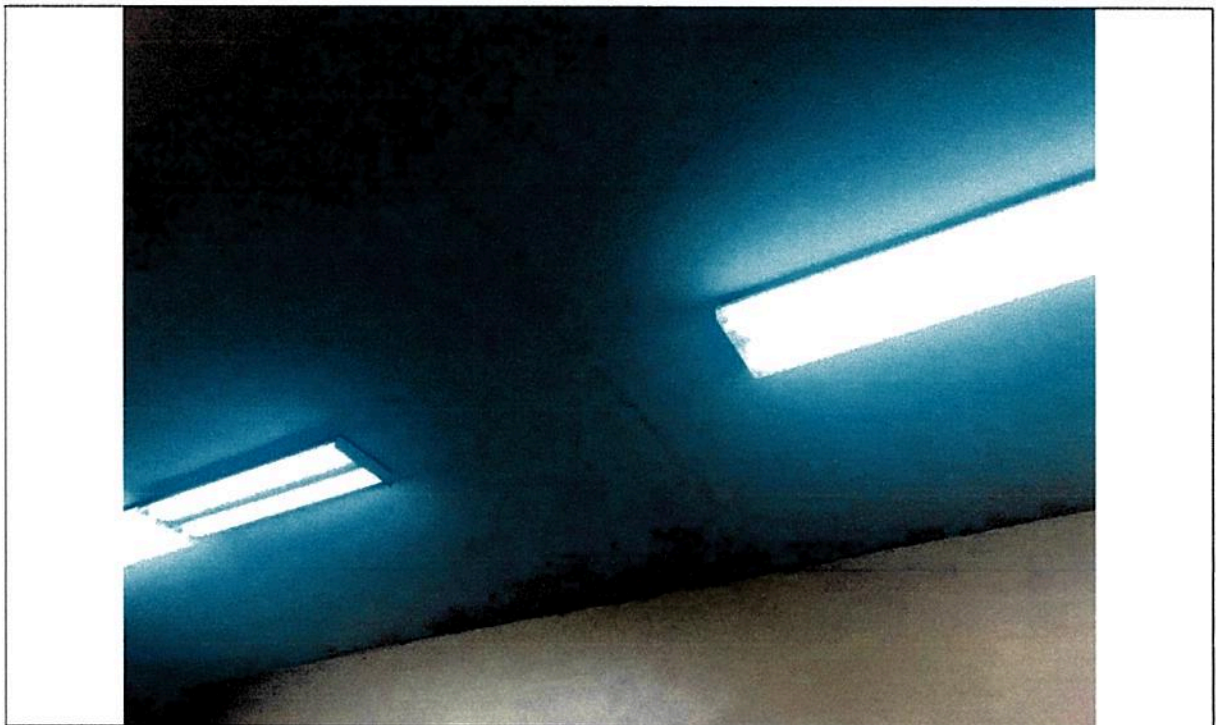
Picture 10 - Floor and roof slab cracks at the N-E building module (Classrooms)

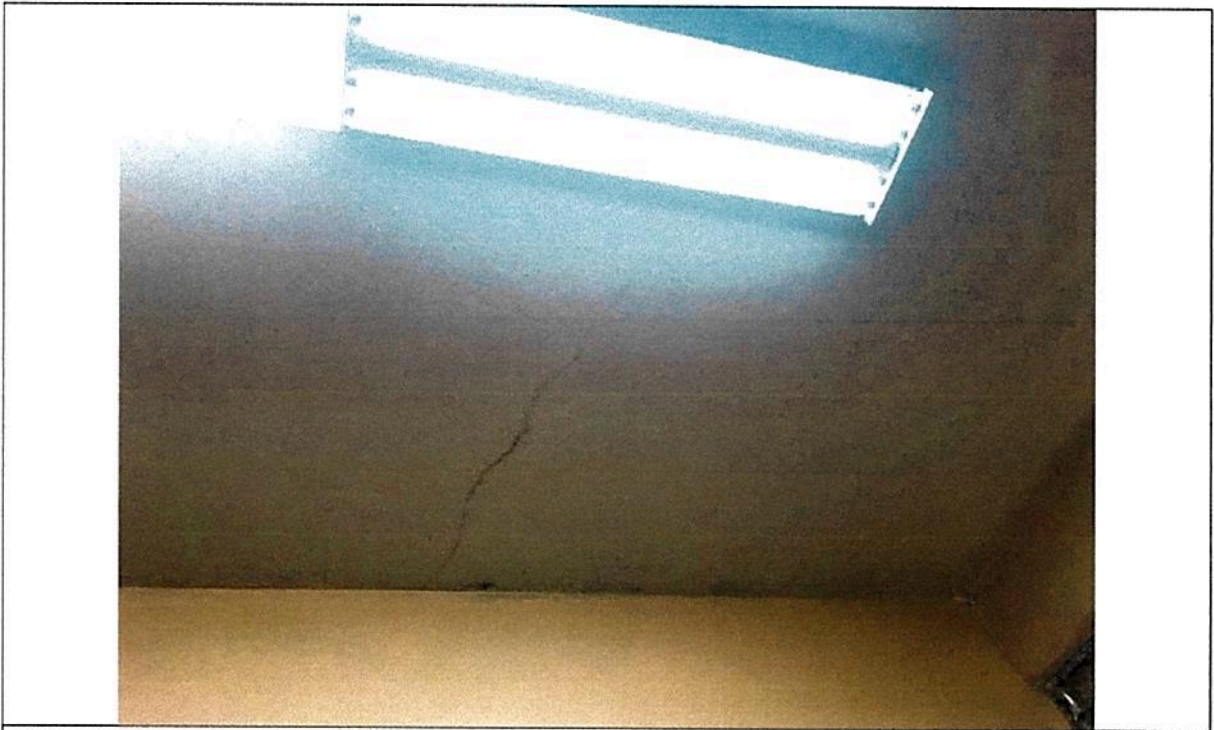
Picture 11 – Floor and roof slab cracks at the N-E building module (Classrooms)

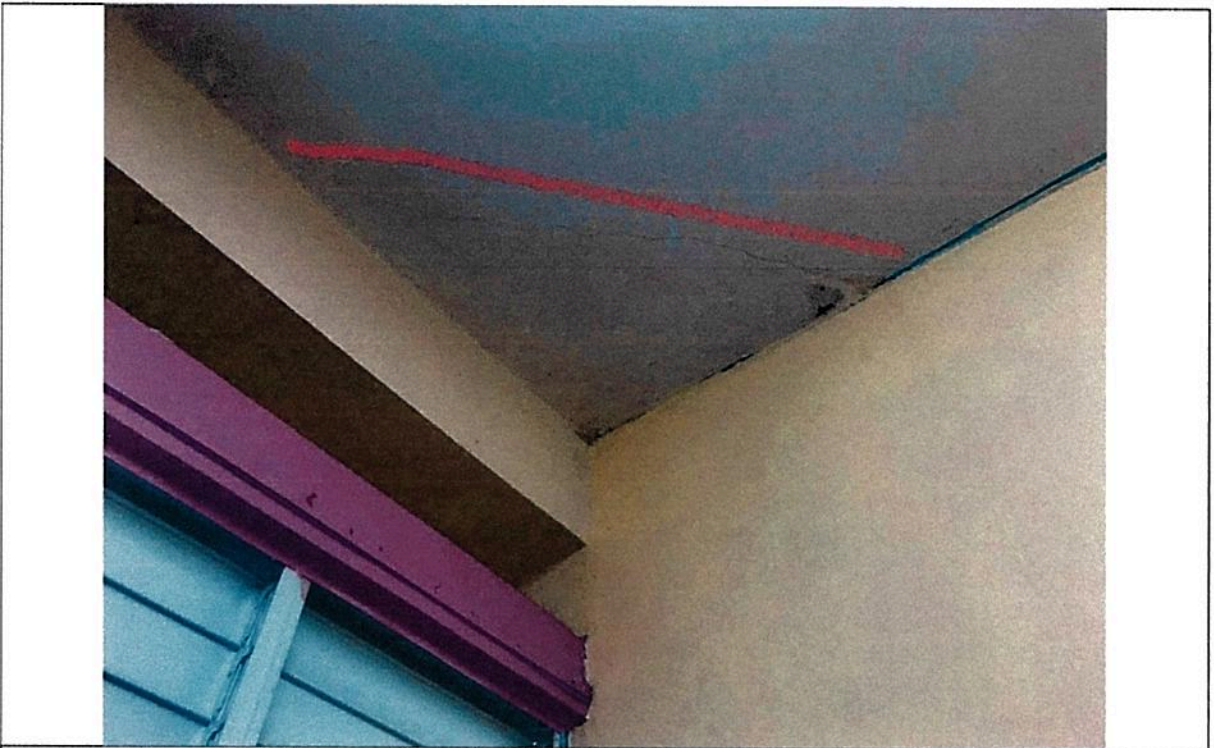
Picture 12 - Floor and roof slab cracks at the N-E building module (Classrooms)

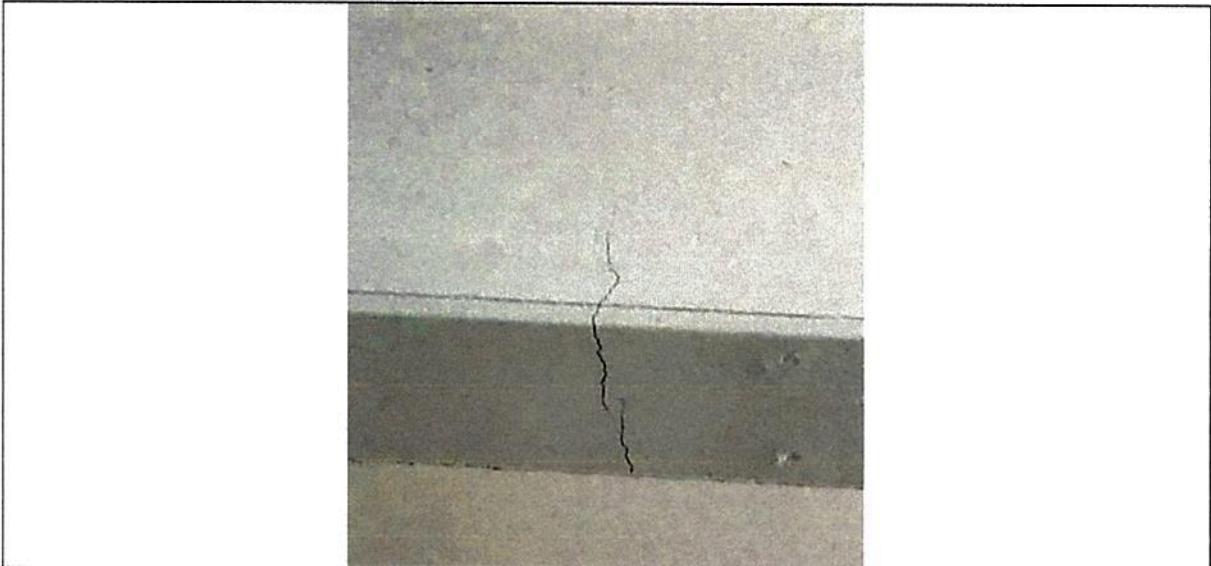
Picture 13 – Noticeable diagonal and vertical fine cracks at various 2ble T Slab webs in Classrooms (typically at the exterior coupling end of the slab-beam).

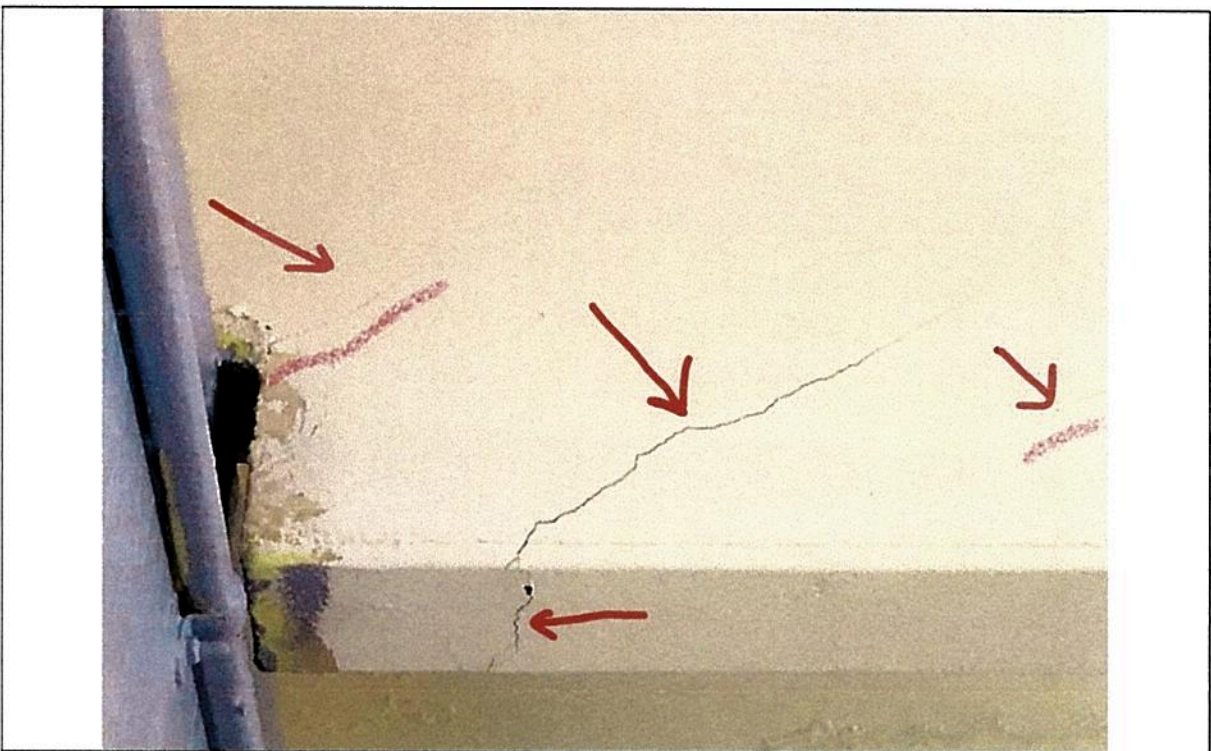
Picture 14 – Noticeable diagonal and vertical fine cracks at various 2ble T Slab webs in Classrooms (typically at the exterior coupling end of the slab-beam). Image shows one of 4 webs with fine cracks in Classroom 6B (Exterior beam side).

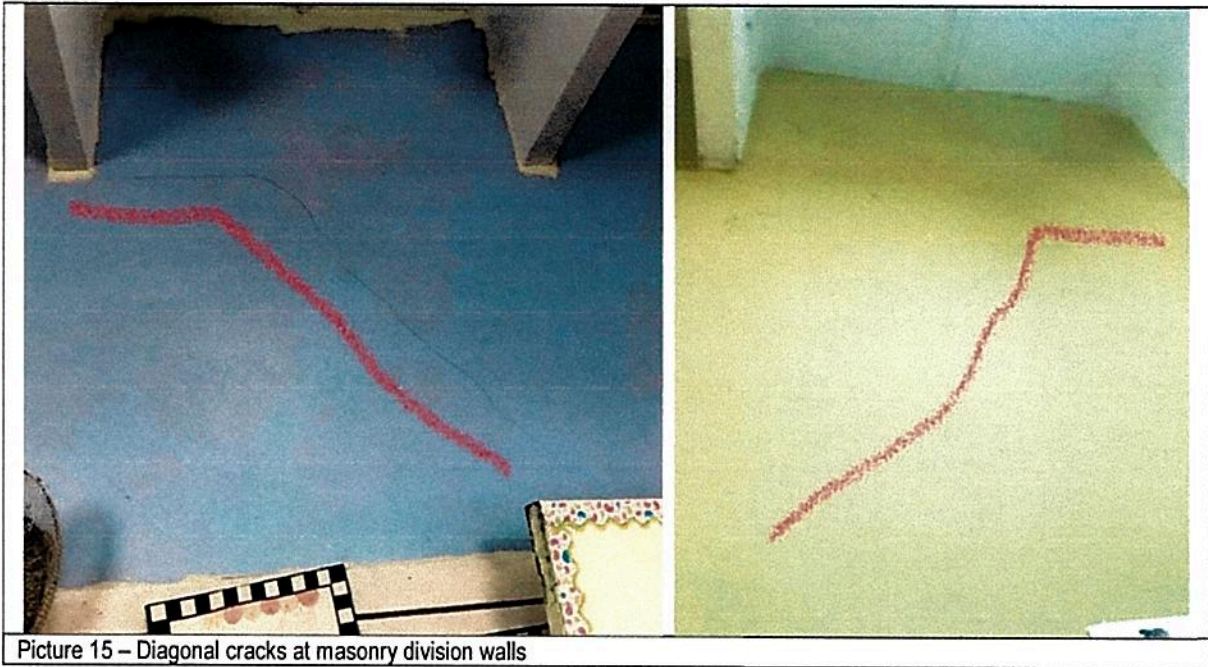
Picture 15 – Diagonal cracks at masonry division walls

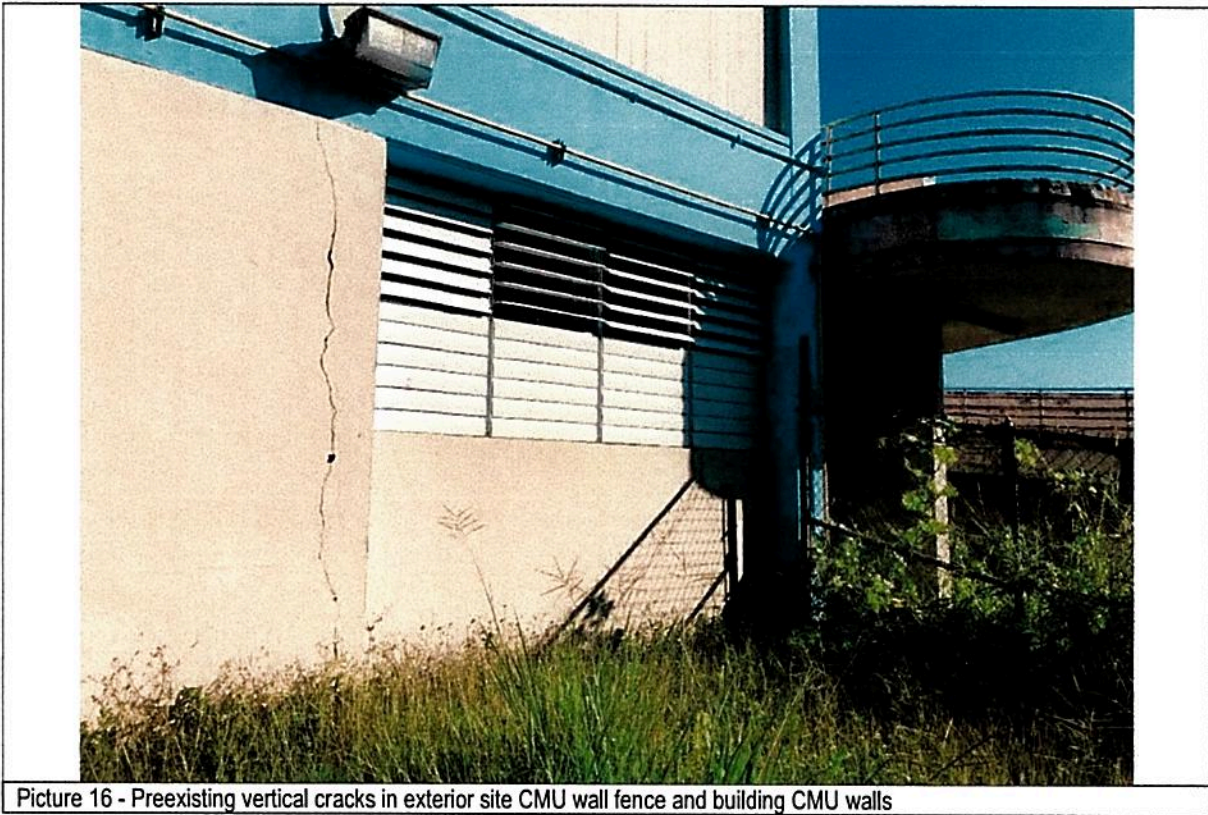
Picture 16 - Preexisting vertical cracks in exterior site CMU wall fence and building CMU walls

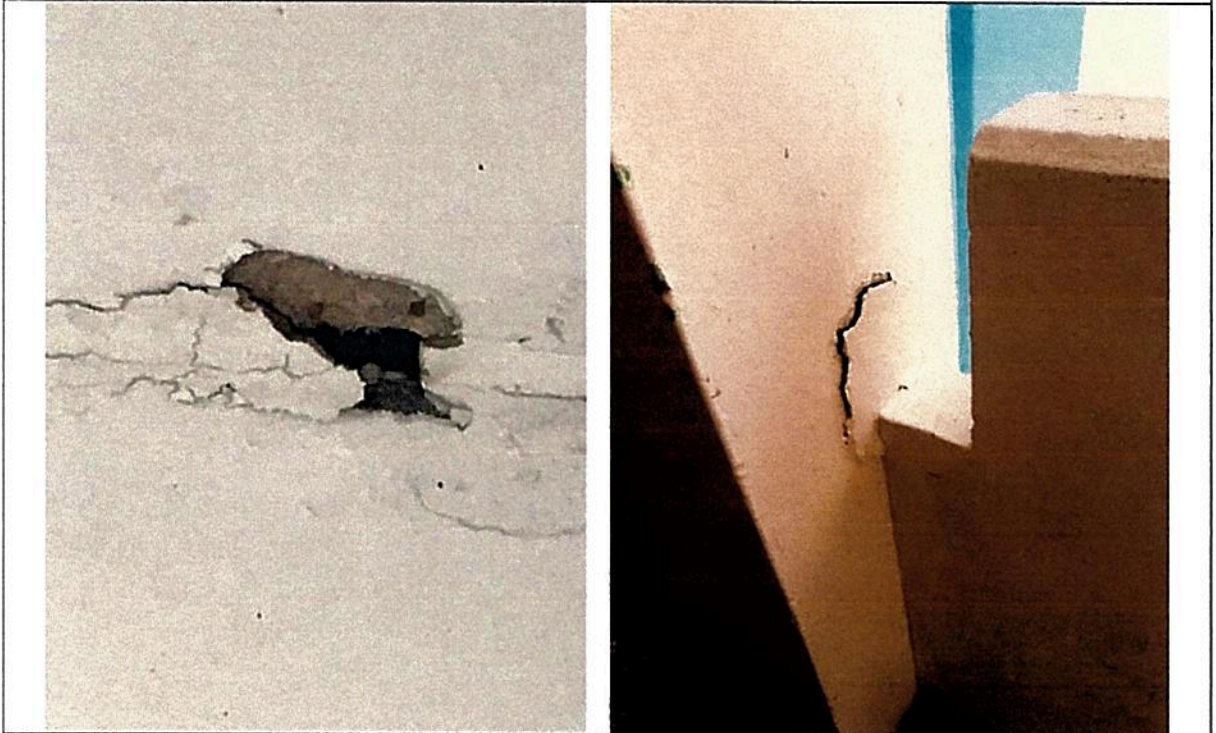
Picture 18 - Concrete Delamination or Spalling at borders or local areas

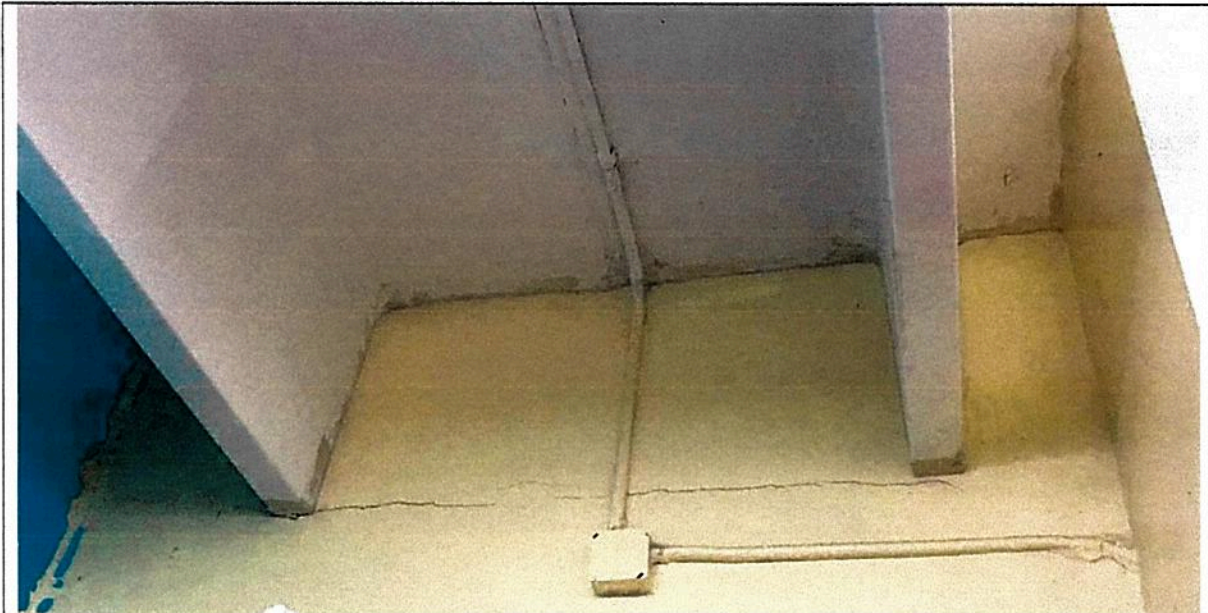
Picture 19 - Cracks (Horz.) between CMU walls and same CMU wall sections between each 2ble T Beam webs (many cases)

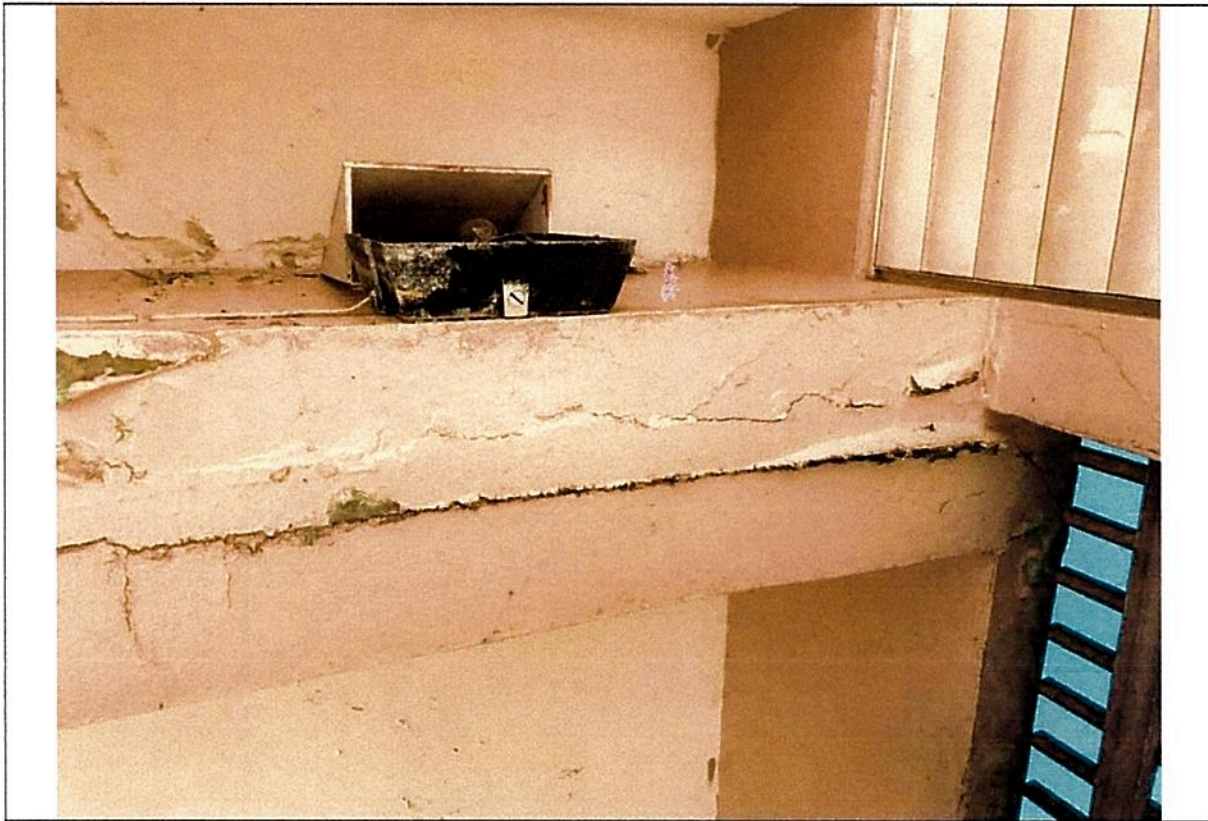
Picture 20 - Separations at building expansion joints causing cement plaster to break and fall.

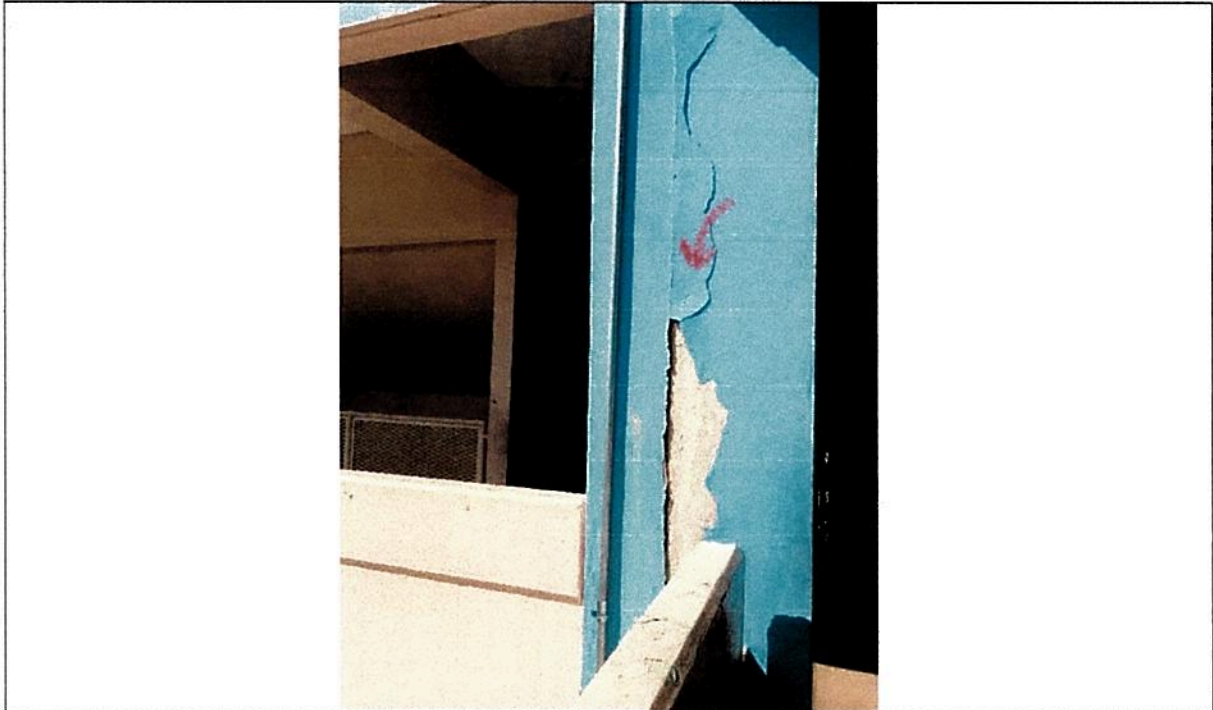
Picture 21 - Horizontal separations or cracks at CMU division walls joint with the slab or bottom of the 2ble T web (this image)

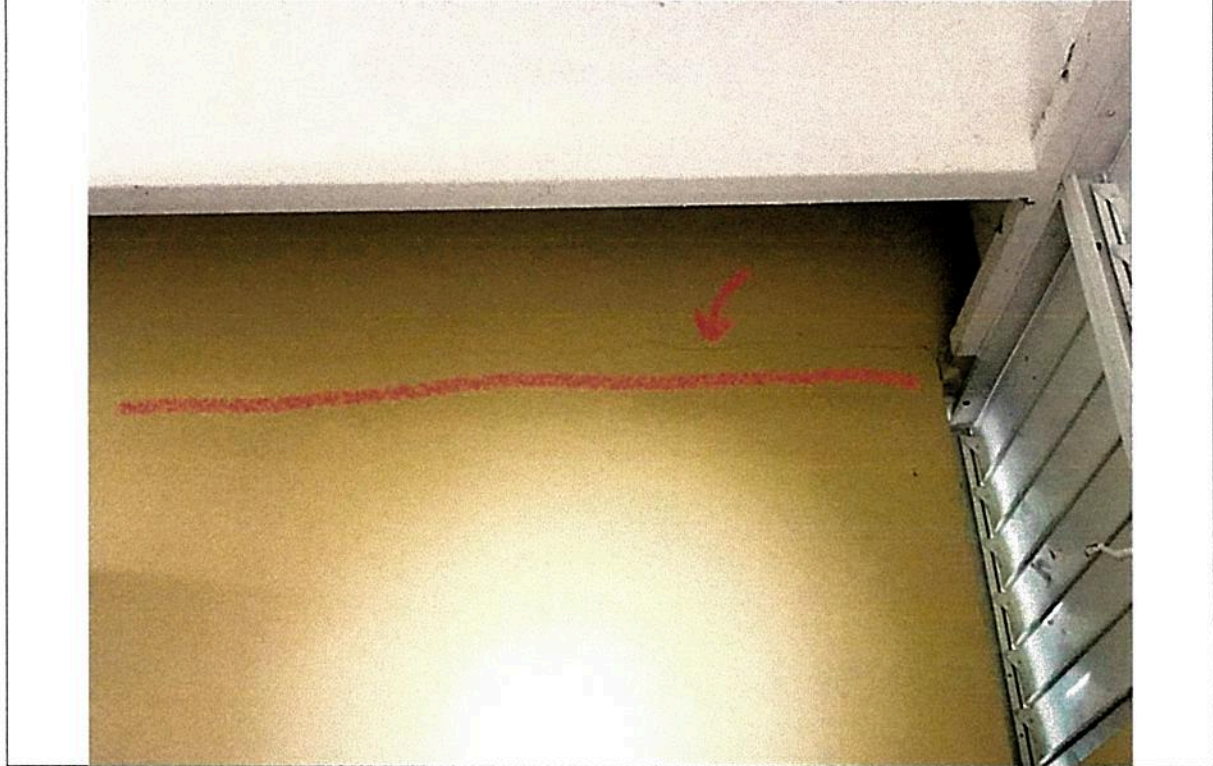
Picture 22 - Horizontal separations or cracks at CMU division walls joint with the slab or bottom of the 2ble T web (this image)

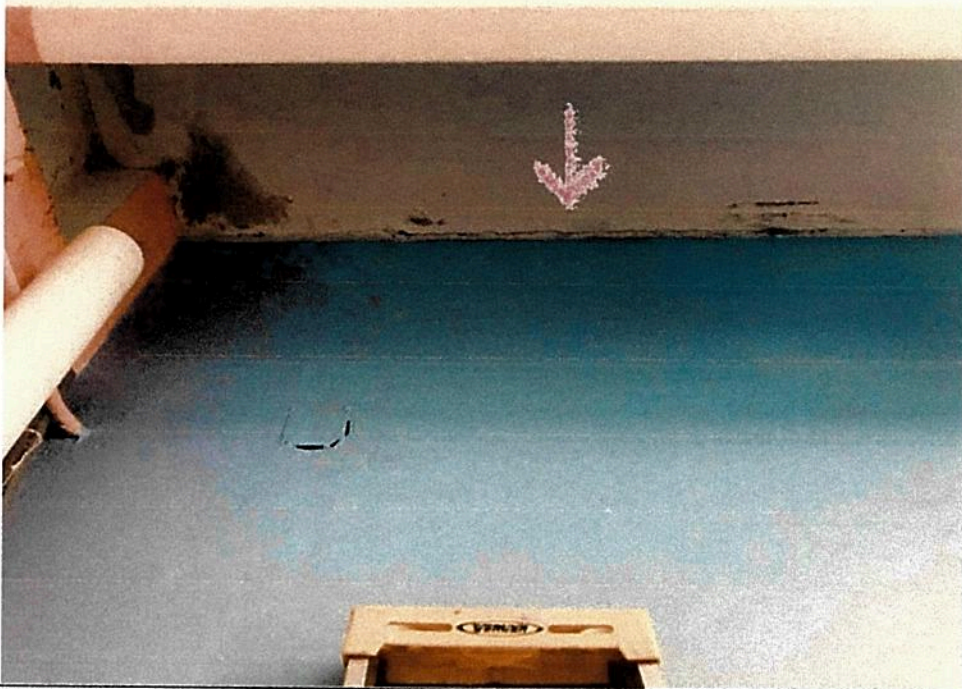
Picture 23 - Horizontal separations or cracks at CMU division walls joint with the slab (this image) or bottom of the 2ble T web

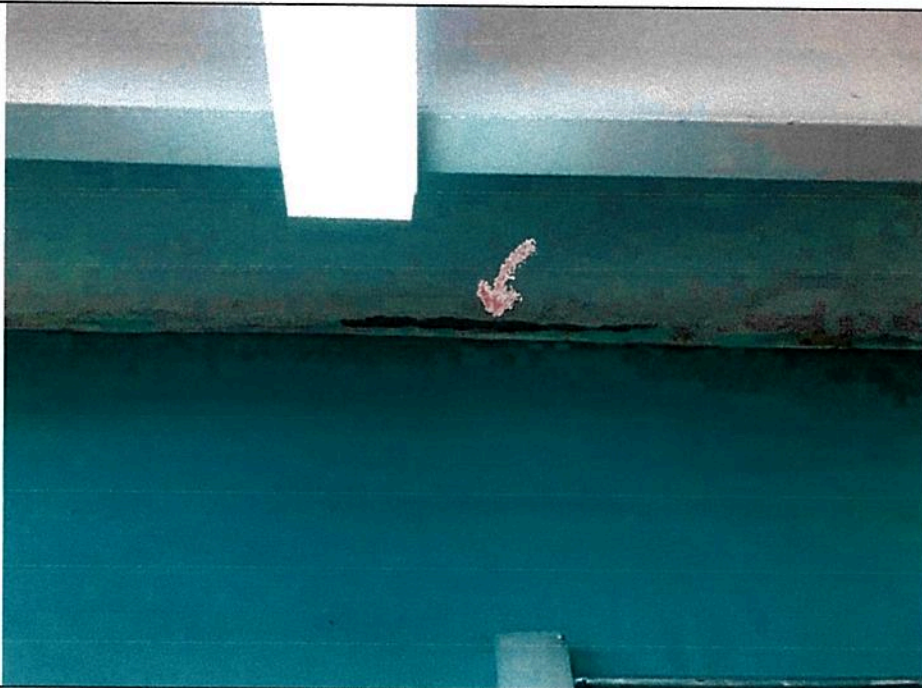
Picture 24 - Horizontal separations or cracks at CMU division walls joint with the slab or bottom of the 2ble T web – This image shows case where delamination of the 2ble T Flange occurred.
