OCULAR INSPECTION CHECKLIST

1. Street Address of the School: Carr. # 134
 City: Hatillo State: P.R. Zip: _____
 2. School Name: Esc. Rafael Zanut Cruz
 3. Date of inspection: 31/10/20
 4. Inspector's Name: Ing. Juan R. CINTRÓN FUENTES, P.E.

FOTOS: ESCUELA RAFAEL ZAMOT CRUZ

HATILLO, PUERTO RICO

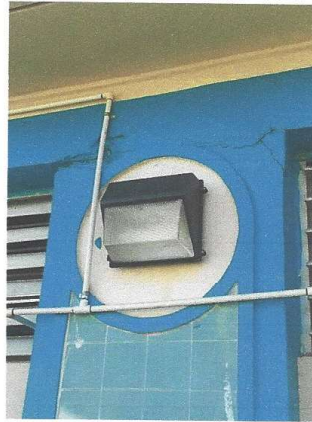
Se observaron pequeñas grietas de empastado en paredes y techos de fácil corrección. El edificio puede continuar con su uso.

Grietas en el empañetado de fácil corrección

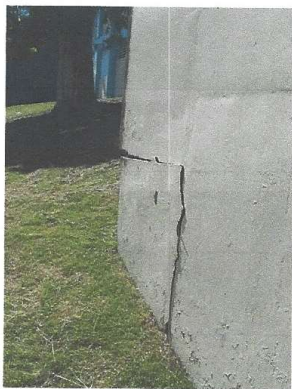
Grieta en pared de bloques de fácil corrección
