CARTA DE TRAMITE

Escuela: **Generosa E. Morales**

Código: **(23309)**

OCULAR INSPECTION CHECKLIST

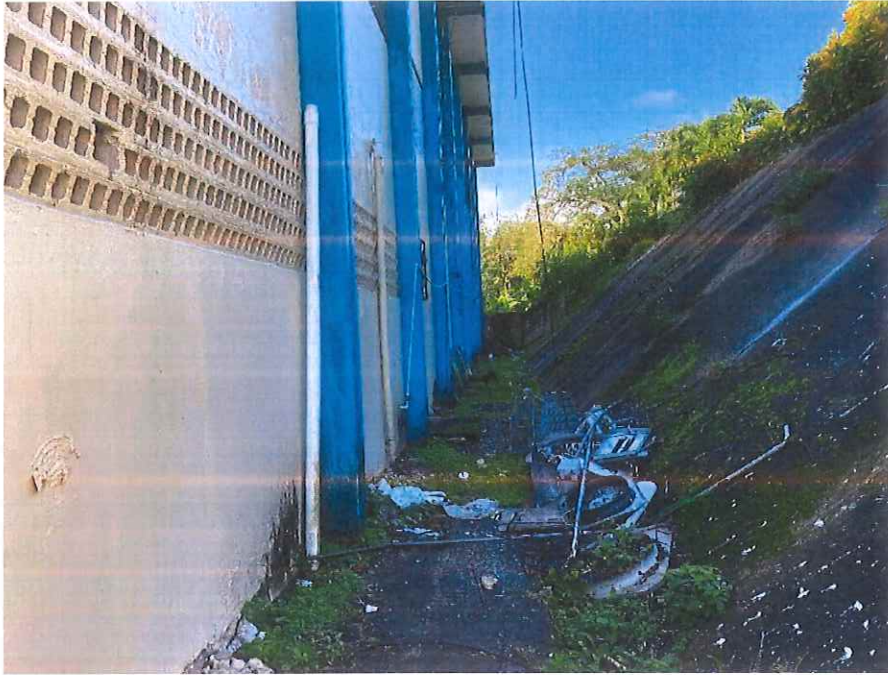
Foto 1: Al rededor del patio del plantel hay escombros de maquinaria de aire acondicionado tirados y cables colgando del techo.

1. Al rededor del patio del plantel hay escombros de maquinaria de aire acondicionado tirados y cables colgando del techo. Se recomienda la remoción de los escombros antes de iniciar las clases. (VER FOTO 1, 2 Y 3)

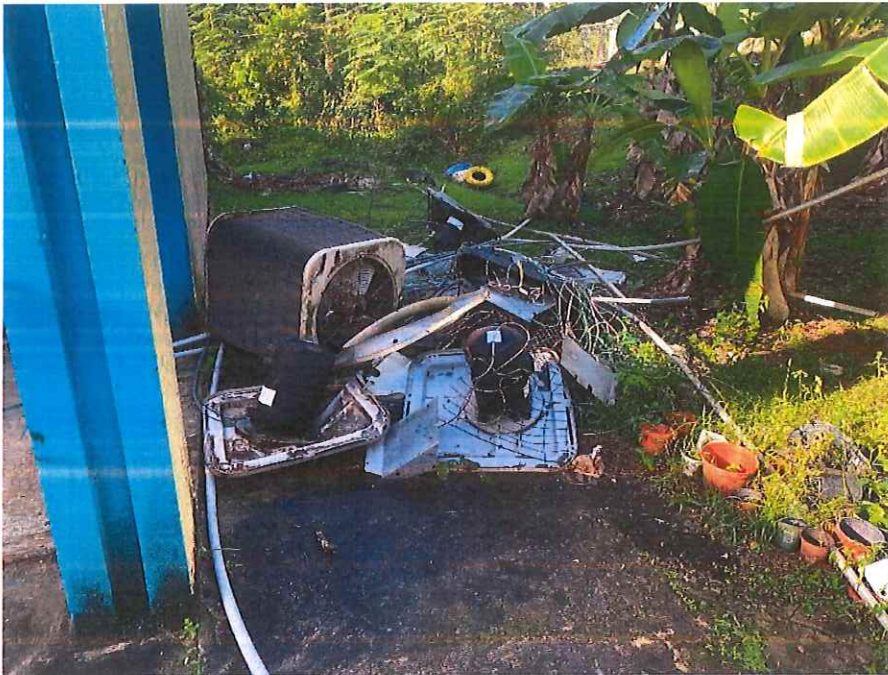
Foto 2: Al rededor del patio del plantel hay escombros de maquinaria de aire acondicionado tirados y cables colgando del techo.

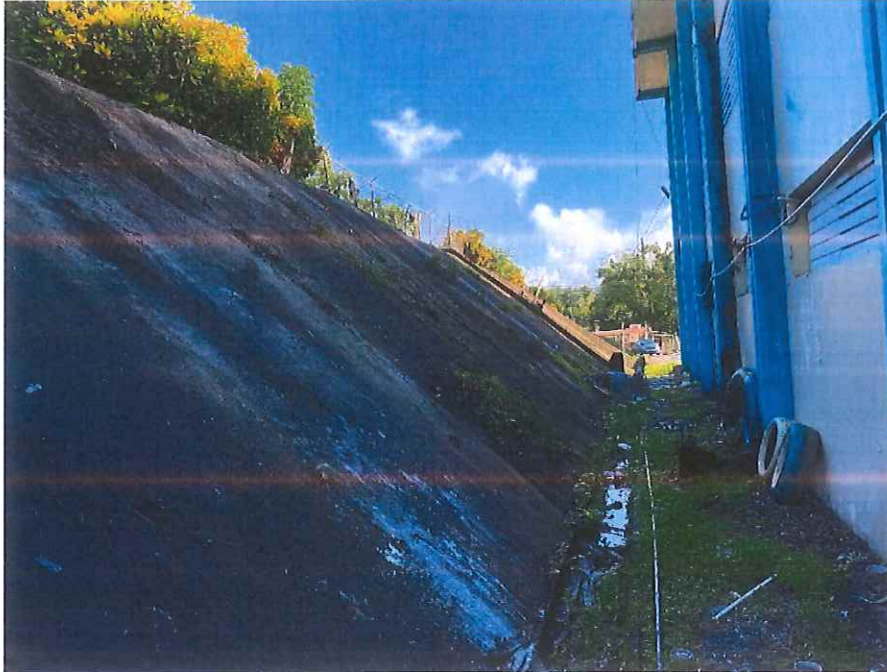
Foto 3: Al rededor del patio del plantel hay escombros de maquinaria de aire acondicionado tirados y cables colgando del techo.

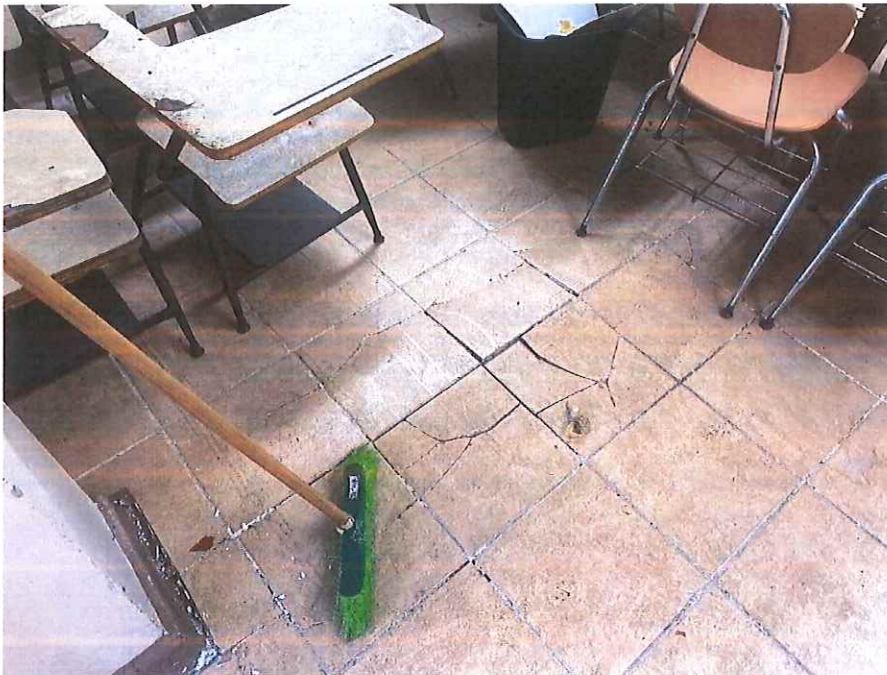
Foto 4: Salón de economía doméstica, el cual ya está clausurado, tiene las losas del piso levantadas y rotas.

2. Salón de economía doméstica, el cual ya está clausurado, tiene las losas del piso levantadas y rotas. Se recomienda cierre del salón hasta que se corrija. (VER FOTO 4). 3. El plantel tiene problemas de filtraciones al rededor de todos los edificios. (VER FOTO 5 Y 6).

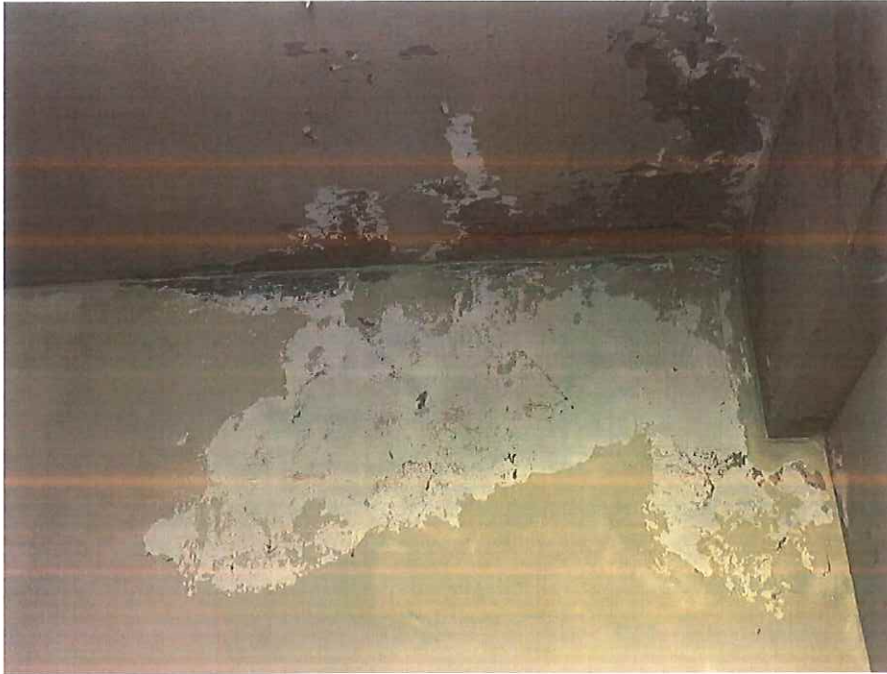
Foto 5: El plantel tiene problemas de filtraciones alrededor de todos los edificios.

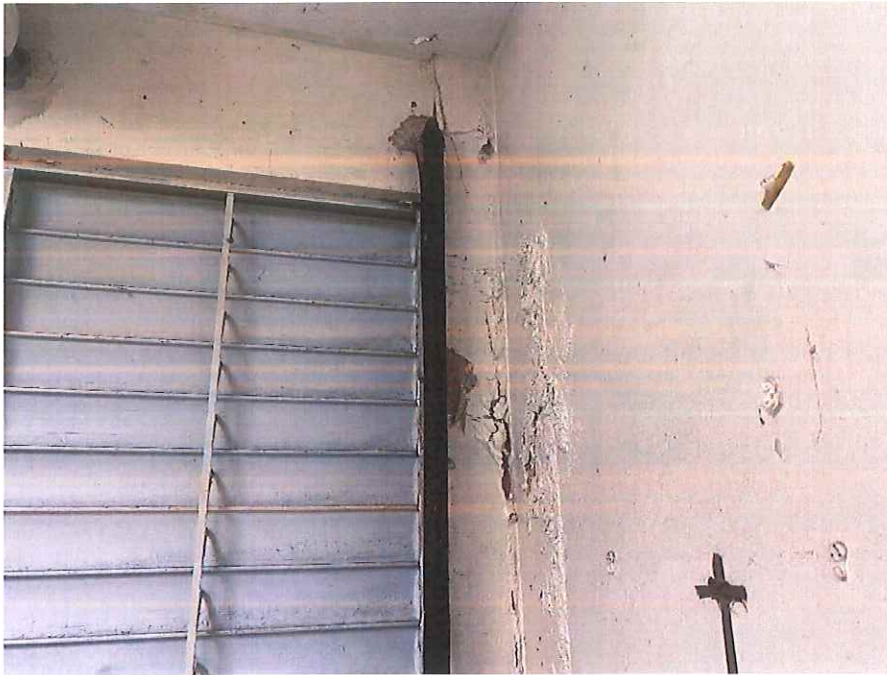
Foto 6: El plantel tiene problemas de filtraciones alrededor de todos los edificios.
