CARTA DE TRAMITE

Escuela: Carmen Arzuaga de Rivera

Municipio: Juncos

OCULAR INSPECTION CHECKLIST

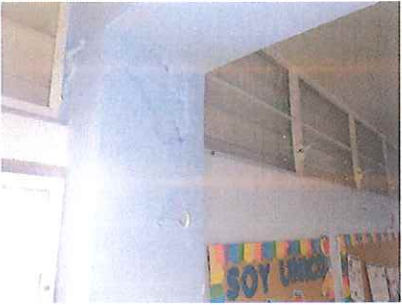
<p>Edificio: 1.Planta A</p> <p>Descripción: No Apta S-1-07-04 , S-1-08-04 , S-1-11-04</p> <ol style="list-style-type: none"> 1. Se encontraron que en la columna central de estos tres salones tiene una grieta en donde todas son repetitivas. 2. Hay un salón S-1-08-04 en donde hay un empañetado sobresaliente. <p>Apta Salones S-1-09-04 , S-1-10-04 , S-1-12-04 , S-1-13-04</p>

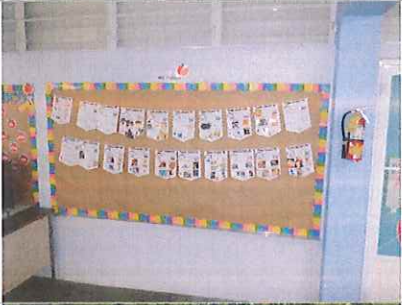
<p>Edificio: 2.Planta B</p> <p>Descripción: Apta No hay Daños</p>

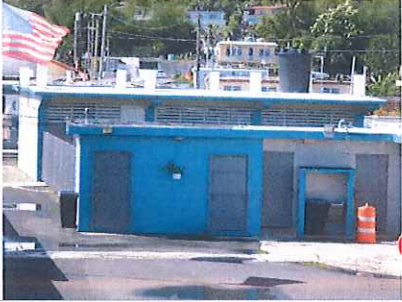
<p>Edificio: 3. Planta C</p> <p>Descripción: No Apta Salón de Orientación</p> <ol style="list-style-type: none"> 1. Se encontró el empañetado del techo el cual está por desprenderse. Área de 2ft. <p>Apta Salones de Trabajador Social, Baños, Covacha, Salón de Educación Especial.</p>

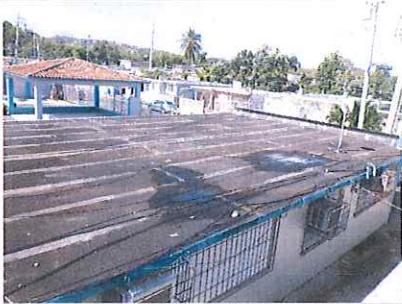
<p>Edificio: 4. Planta D</p> <p>Descripción: No Apta Baños de Niños sobre la lámpara hay un empañetado de aprox. 2ft el cual esta brotado y representa un riesgo.</p> <p>Apta Sala de Facultad, Secretaría, Directora y Educación Física</p>

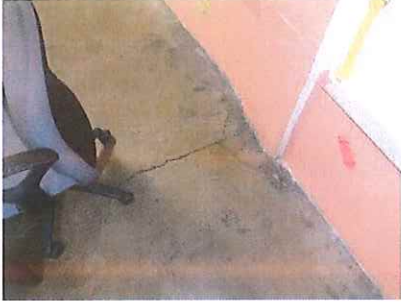
Edificio:	5. Planta E

Descripción:	No Apta Salones del segundo nivel - Almacén, S-1-06-03 , S-1-05-03 1. Se encontró grietas sobre el piso del segundo nivel a lo largo de los salones de norte a sur y de este a oeste. Apta Salones del primer nivel - S-1-03-02 y S-1-04-02	
Edificio:	6. Planta F

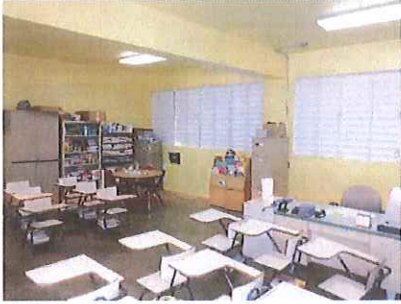
Descripción:	No Apta Salones del segundo nivel - S-2-03-03 , S-2-02-23 , S-2-01-03 1. Se encontró grietas sobre el piso del segundo nivel a lo largo de los salones de norte a sur y de este a oeste. Apta Salón del primer nivel Comedor - C-1-02-02	
Edificio:	Glorieta

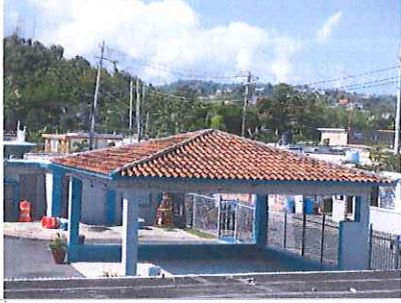
Descripción:	Apta No hay Daños	
Descripción:
