Escuela: JOSE DE DIEGO Código: 40378  
Municipio: AGUADILLA Fecha de Inspección: 1/11/20

GENERAL EARTHQUAKE DAMAGE INSPECTION CHECKLIST

No earthquake related, damage was observed on the main structural elements of the buildings inspected. Some pre-existing conditions were observed. Removal and re-installation of concrete plaster/cover recommended on the southern building cold joint, bridge connection so as to avoid falling debris issues during a future earthquake. See next page for additional comments.

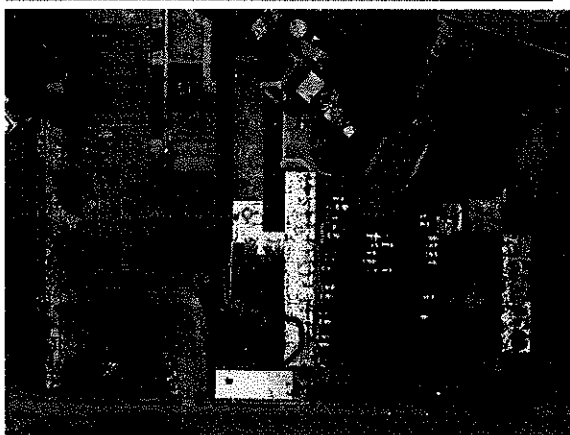
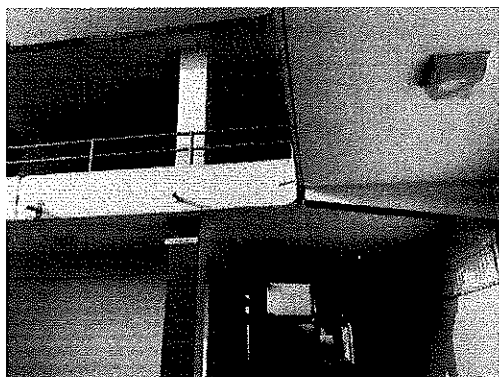
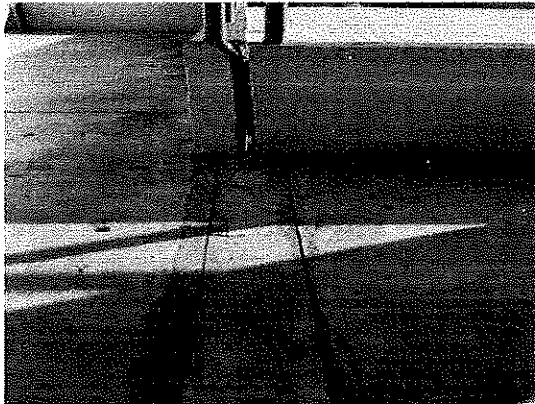
Agrietamiento del encubrimiento del hormigón

Localizado en junta fría en conexión entre dos edificios. Condición preexistente causada por leve asentamiento de un edificio relativo al otro. Al estos edificios estar en contacto representa un riesgo donde pequeños pedazos de hormigón pueden desprenderse y caer al suelo durante un movimiento telúrico.

Some pre-existing conditions were observed. Removal and re-installation of concrete plaster/cover recommended on the southern building cold joint, bridge connection so as to avoid falling debris issues during a future earthquake. See next page for additional comments.

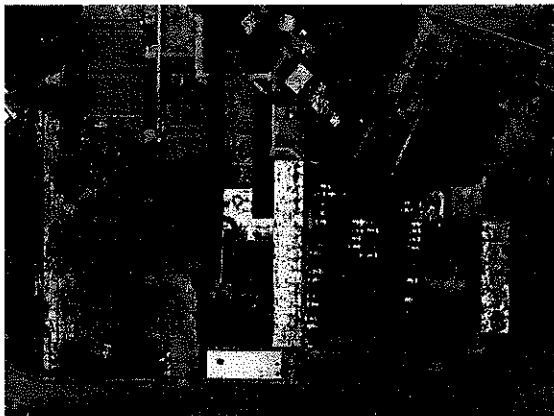
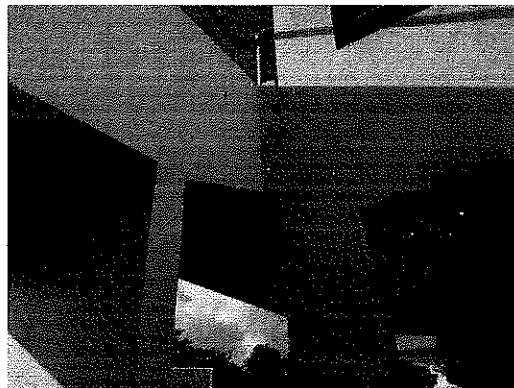
Agrietamiento levemente de encubrimiento del hormigon en junta de escaleras con edificio. Condición pre-existente.  
Zona escaleras suroeste.

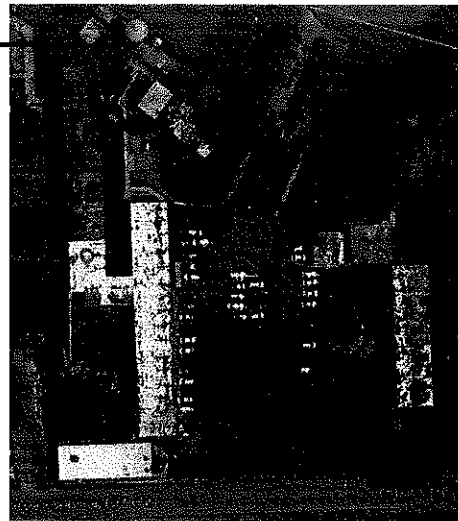
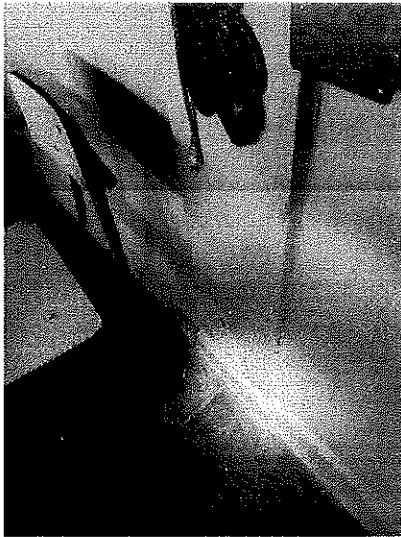
Condición pre-existente en zona inferior de columna. Relacionado a posible corrosión de varilla en columna.

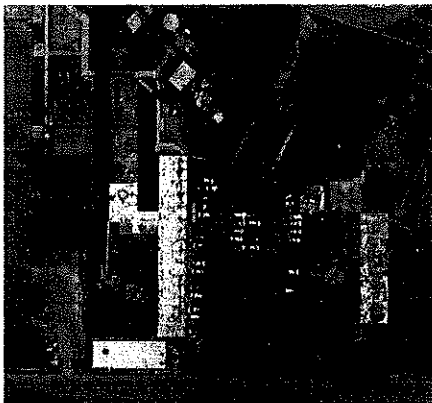
Agrietamiento encubrimiento de hormigón, parte inferior de viga adyacente a pared.  
Material con riesgo a desprenderse no se encuentra sobre áreas de asientos escolares.

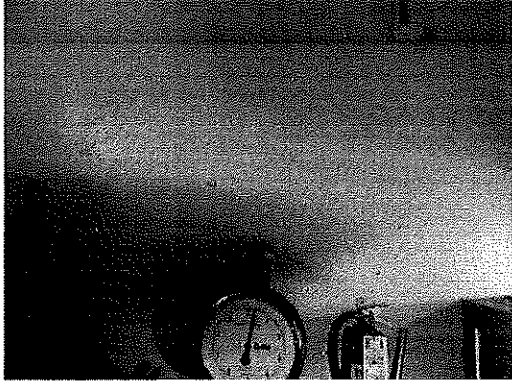
Agrietamiento pre-existente pared zona de almacén cocina de comedor.  
Se nos informa que es condición preexistente y esto es evidente.

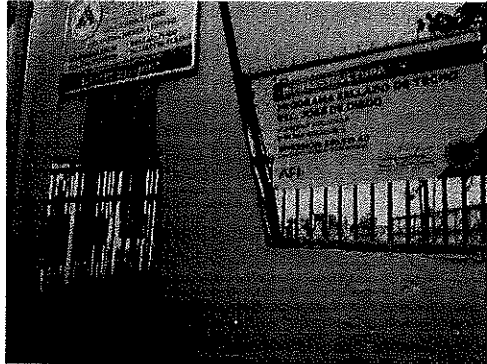
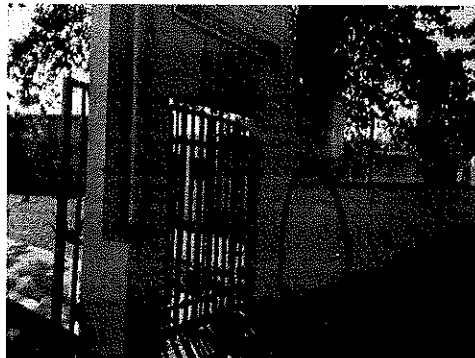
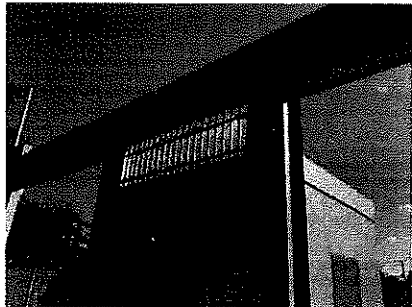
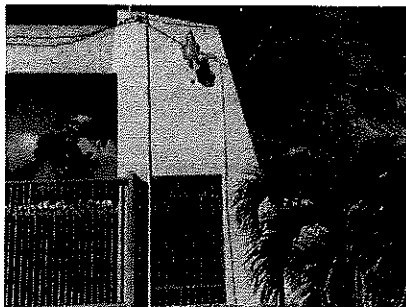
Fachada/arco de entrada al plantel escolar

Agrietamiento localizado en la continuidad de un lado de dicha fachada con verja adyacente.
