CARTA DE TRAMITE

Escuela: Herminio E. Arzola (Quebradas) Código: (51292)
Municipio: Guayanilla Fecha de: 9-enero-20
Inspección

OCULAR INSPECTION CHECKLIST

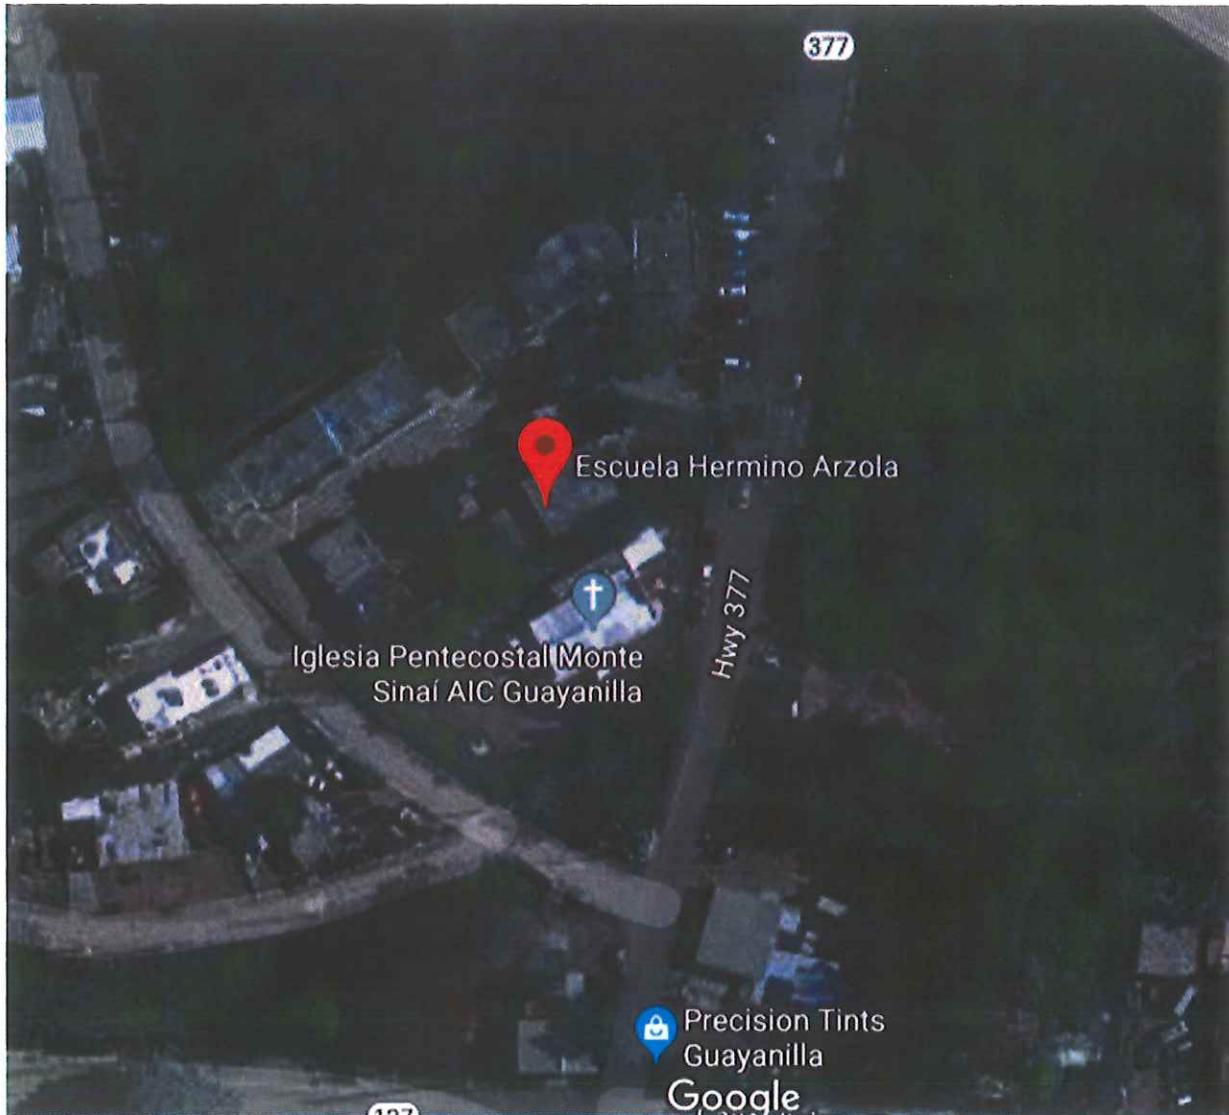
Plano de Sitio

Descripción: Vista aérea de la escuela / Plano de planta de escuela para identificar las áreas evaluadas.

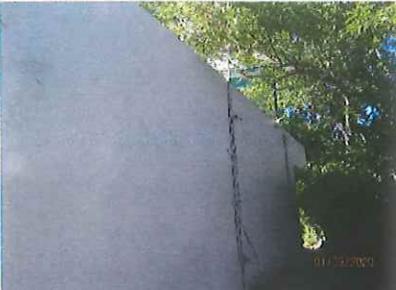
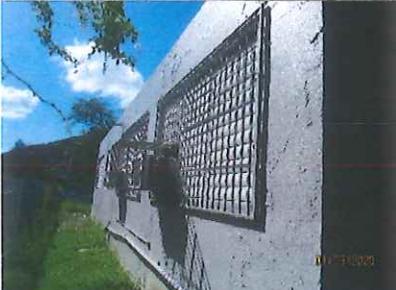
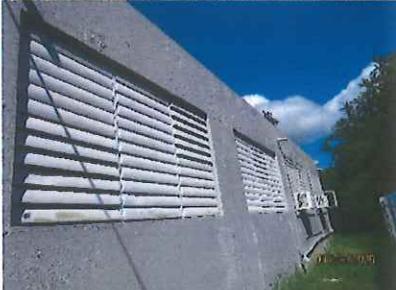
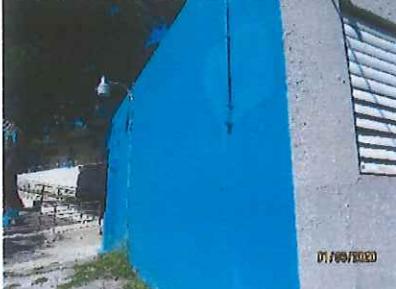
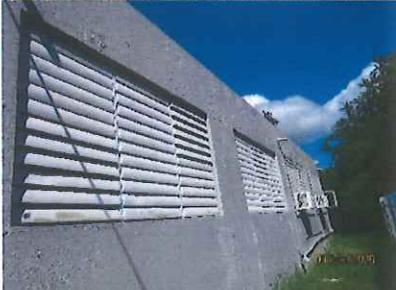
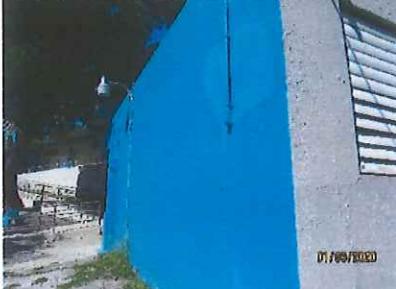
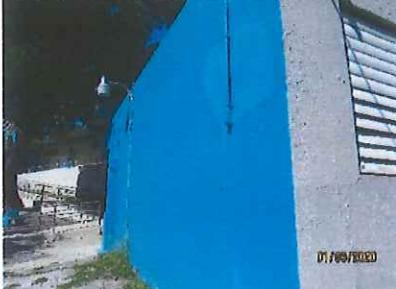
EN LA ESTRUCTURA #1, #4, #5, #6 Y #7 NO SE OBSERVARON DAÑOS EXTERIORES.

Descripción:	No se observaron daños exteriores en esta estructura. No hubo acceso para entrar a los salones.	
Edificio:	1	
Descripción:	No se observaron daños exteriores en esta estructura. No hubo acceso para entrar a los salones.	
Edificio:	1

Descripción:	No se observaron daños exteriores en esta estructura. No hubo acceso para entrar a los salones.	
Edificio:	1

Descripción:	No se observaron daños exteriores en esta estructura. No hubo acceso para entrar a los salones.

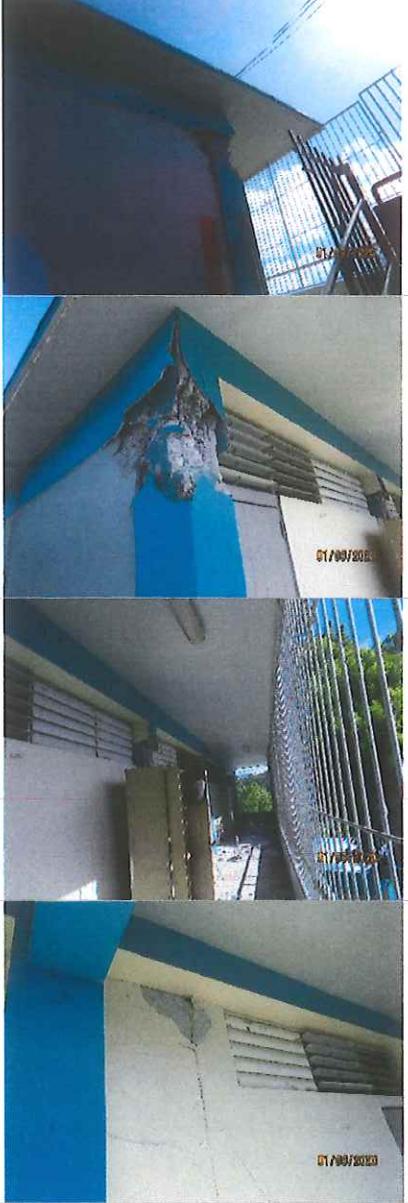
LAS ESTRUCTURAS #2, #3 Y #8 AL IGUAL QUE LA ESCALERA ENTRE LAS ESTRUCTURAS #2 Y #3 PRESENTARON DAÑOS ESTRUCTURALES CONSIDERABLES EN LAS VIGAS Y COLUMNAS. ESTAS ESTRUCTURAS SON DE 2 PISOS. SE OBSERVÓ TAMBIÉN UNAS GRIETAS EN LA ACERA FRENTE AL EDIFICIO #2.

Descripción:	Estructura de 2 pisos con severos daños estructurales.		
Edificio:	2		
Descripción:	Estructura de 2 pisos con severos daños estructurales.		
Edificio:	2	Estructura de 2 pisos con severos daños estructurales.	
Descripción:	Estructura de 2 pisos con severos daños estructurales.

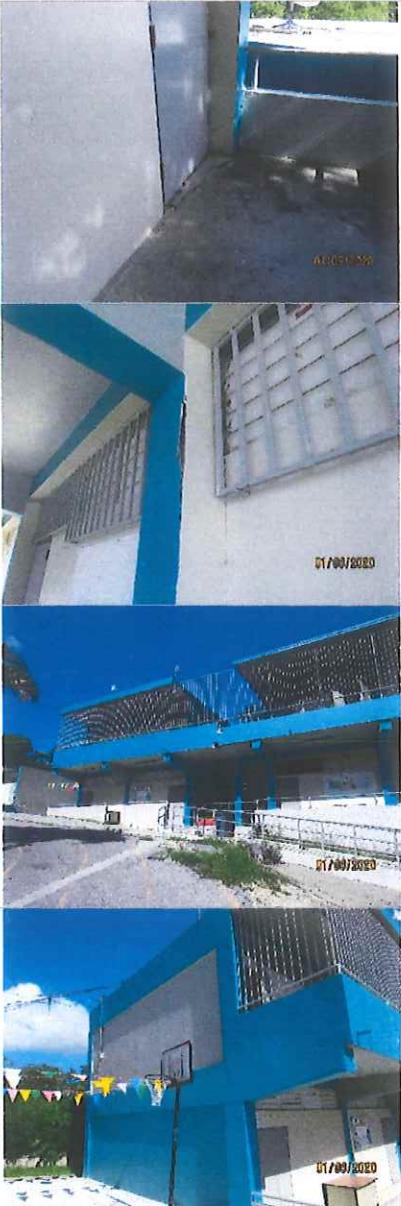
Descripción:	Estructura de 2 pisos con severos daños estructurales.	
Edificio:	2	
Descripción:	Estructura de 2 pisos con severos daños estructurales.	
Edificio:	3

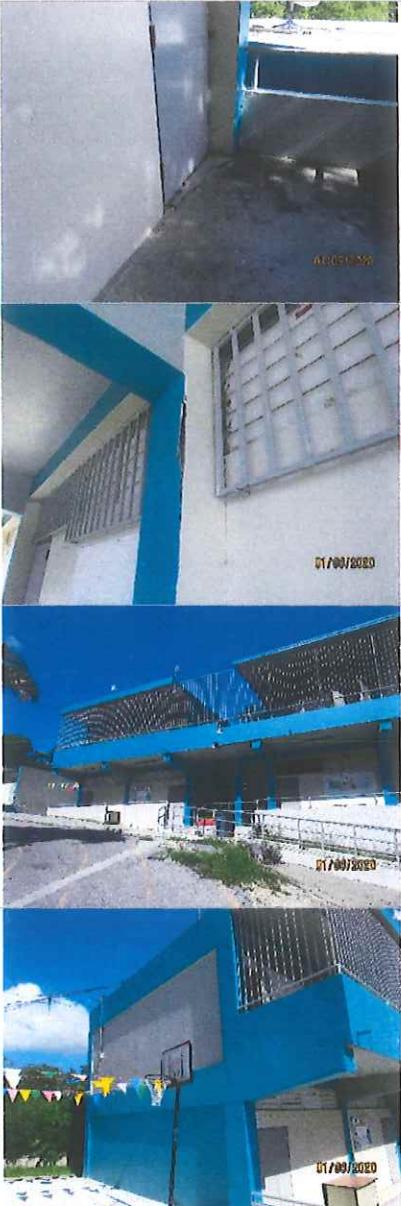
Descripción:	Estructura de 2 pisos con severos daños estructurales.	
Edificio:	3

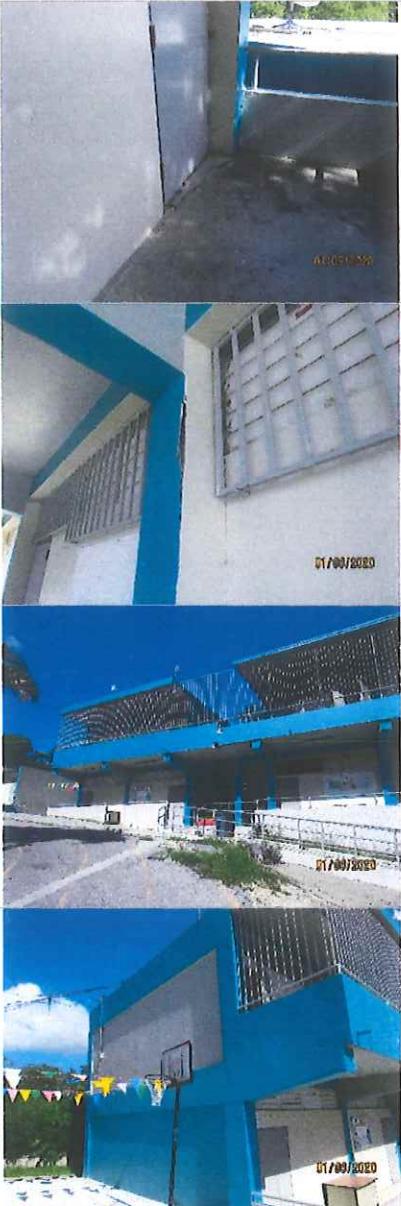
Descripción:	Estructura de 2 pisos con severos daños estructurales.

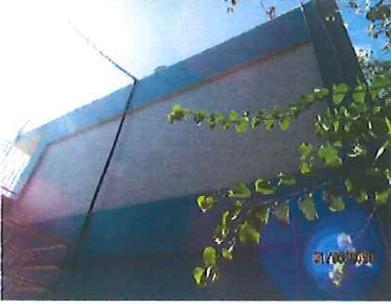
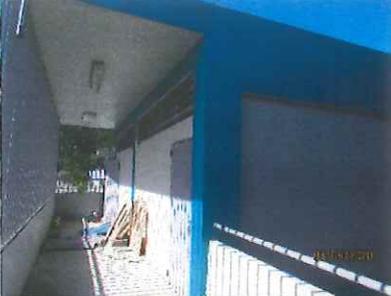
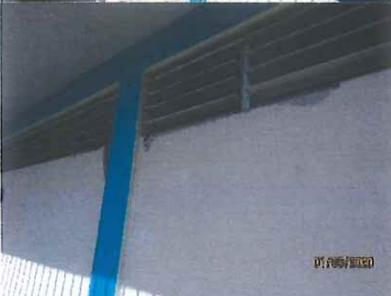
Edificio:	3	
Descripción:	Estructura de 2 pisos con severos daños estructurales.

Descripción:	Estructura de 2 pisos con severos daños estructurales.	
Edificio:	3	
Descripción:	Estructura de 2 pisos con severos daños estructurales.

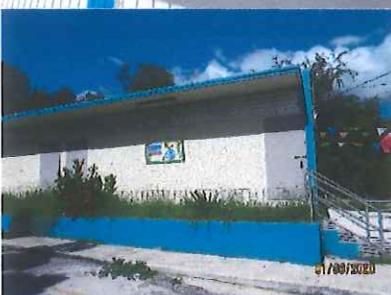
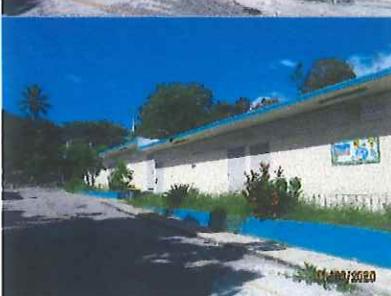
Edificio:	4	
Descripción:	No se observaron daños exteriores en esta estructura. No hubo acceso para entrar a los salones.

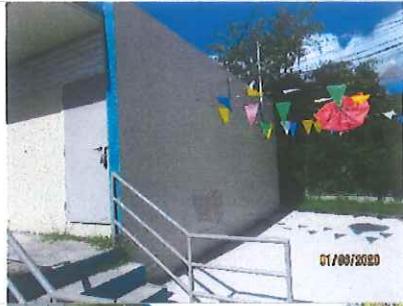
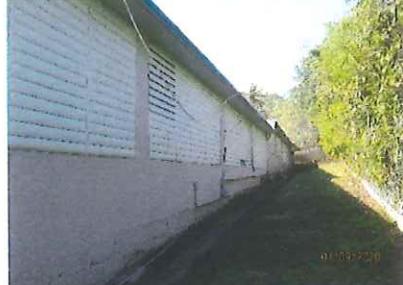
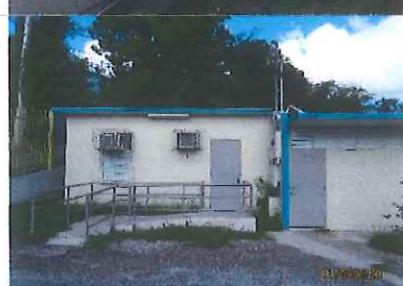
Edificio:	4

Descripción:	No se observaron daños exteriores en esta estructura. No hubo acceso para entrar a los salones.

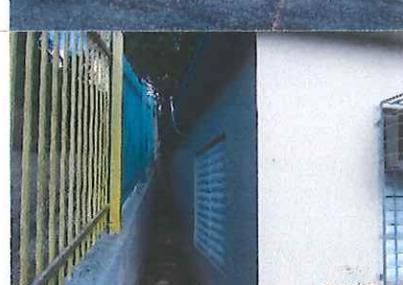
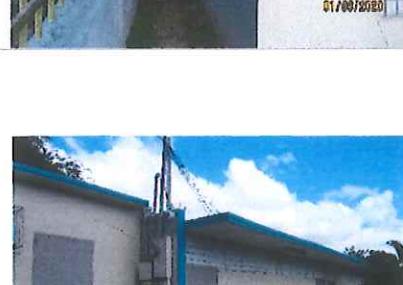
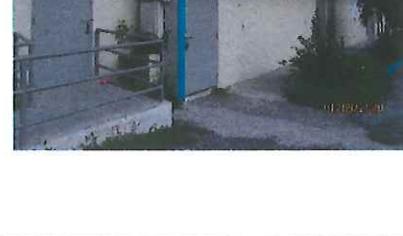
Edificio:	5

Descripción:	No se observaron daños exteriores en esta estructura. No hubo acceso para entrar a los salones.

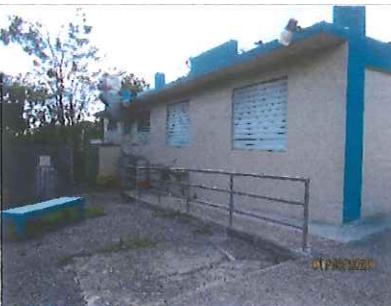
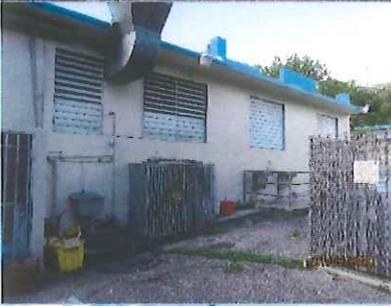
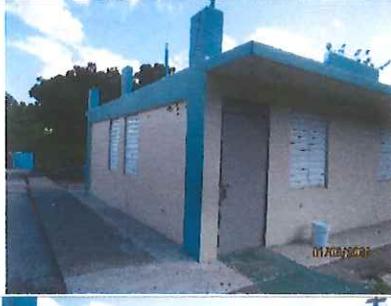
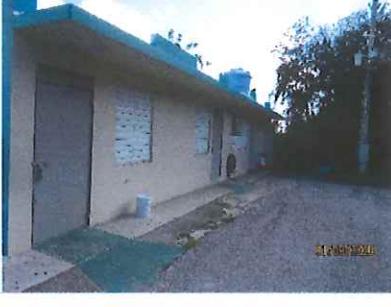
Descripción:	No se observaron daños exteriores en esta estructura. No hubo acceso para entrar a los salones.	
Edificio:	6

Descripción:	No se observaron daños exteriores en esta estructura. No hubo acceso para entrar a los salones.	
Edificio:	7

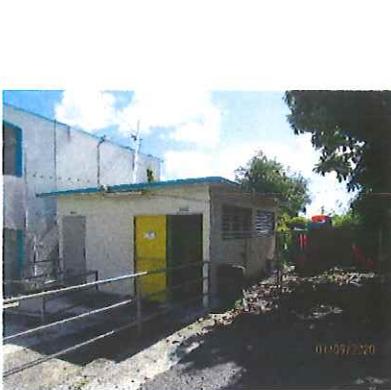
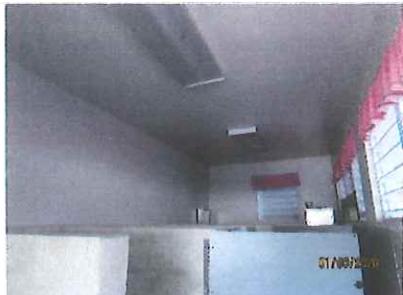
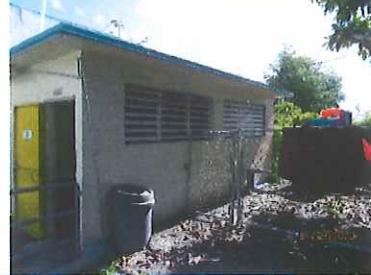
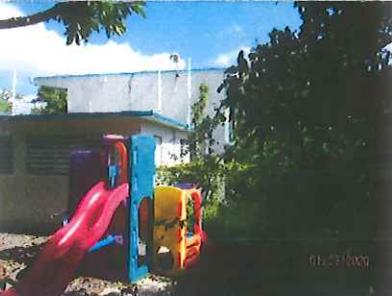
Descripción:	No se observaron daños exteriores en esta estructura. No hubo acceso para entrar a los salones.

Descripción:	No se observaron daños exteriores en esta estructura. No hubo acceso para entrar a los salones.	
Edificio:	7

Descripción:	No se observaron daños exteriores en esta estructura. No hubo acceso para entrar a los salones.	
Edificio:	8

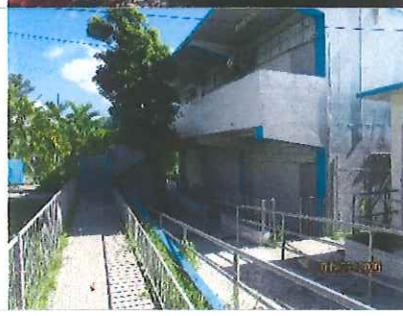
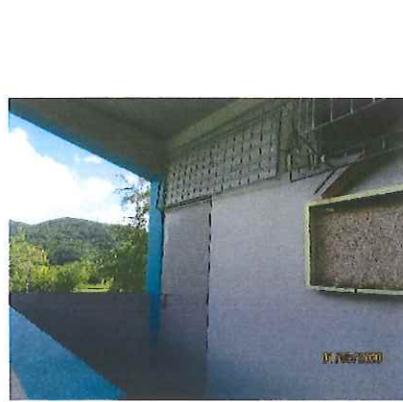
Descripción:	Estructura de 2 pisos con severos daños estructurales.	
Edificio:	8

Descripción:	Estructura de 2 pisos con severos daños estructurales.

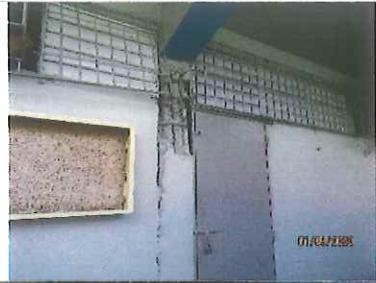
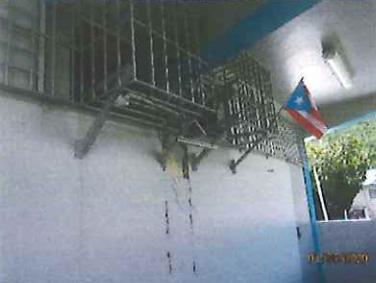
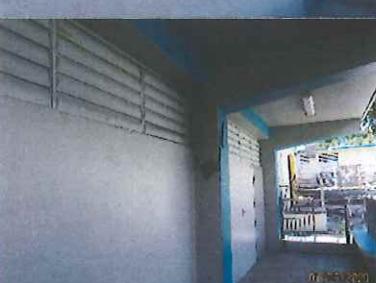
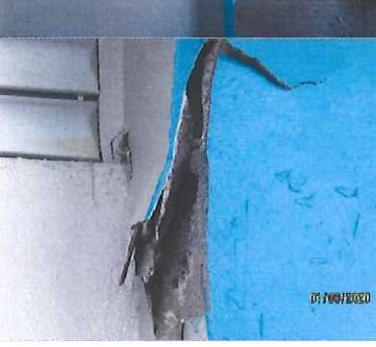
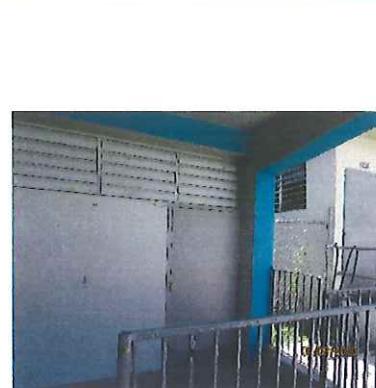
Descripción:	Estructura de 2 pisos con severos daños estructurales.	
Edificio:	8

Descripción:	Estructura de 2 pisos con severos daños estructurales.

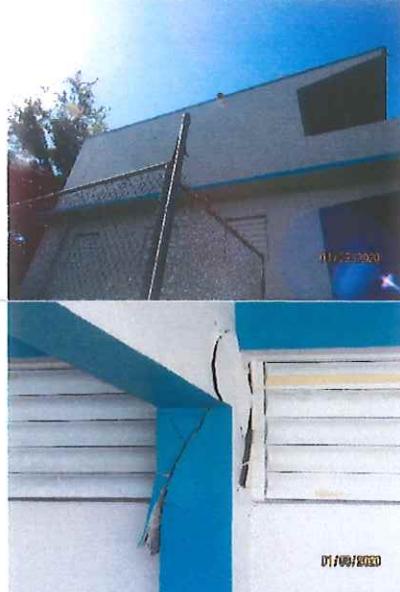
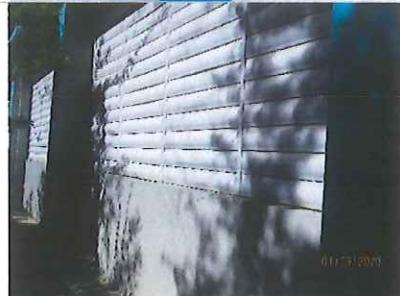
Descripción:	Estructura de 2 pisos con severos daños estructurales.	
Edificio:	8	
Descripción:	Estructura de 2 pisos con severos daños estructurales.	
Edificio:	8	
Descripción:	Estructura de 2 pisos con severos daños estructurales.

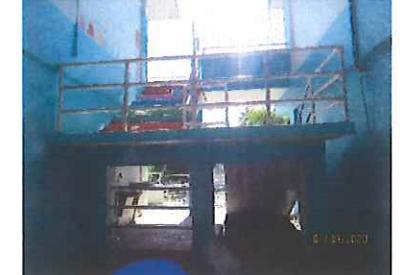
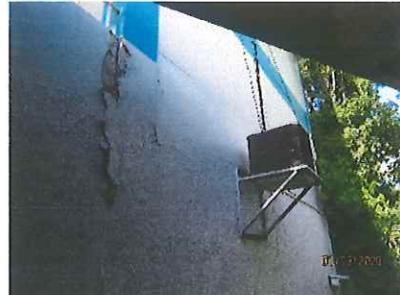
Descripción:	Hay una separación de la escalera y los edificios.	
Edificio:	Escalera entre Edificio 2 y 3

Descripción:	Hay una separación de la escalera y los edificios

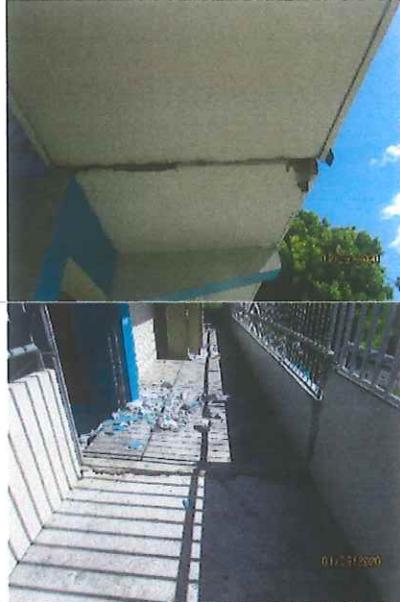
Descripción:	Hay una separación de la escalera y los edificios	
Edificio:	Escalera entre Edificio 2 y 3	
Descripción:	Hay una separación de la escalera y los edificios	
Edificio:	Acera frente a Edificio 2

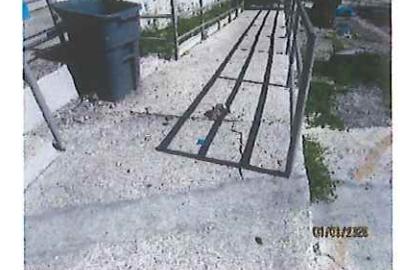
Descripción:	Grietas en la acera/rampa frente al Edificio 2
