CARTA DE TRAMITE

Escuela: SALVADOR BRAU (INTERMEDIA) Código: 60442

Municipio: CAROLINA Fecha de Inspección: 1/11/20

GENERAL EARTHQUAKE DAMAGE INSPECTION CHECKLIST

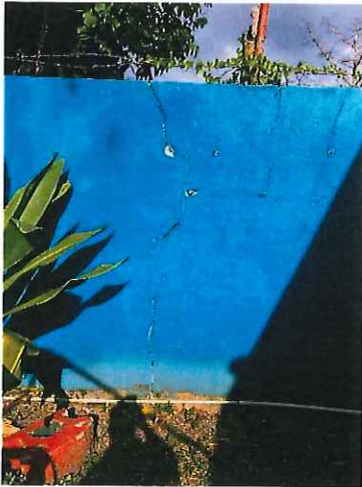
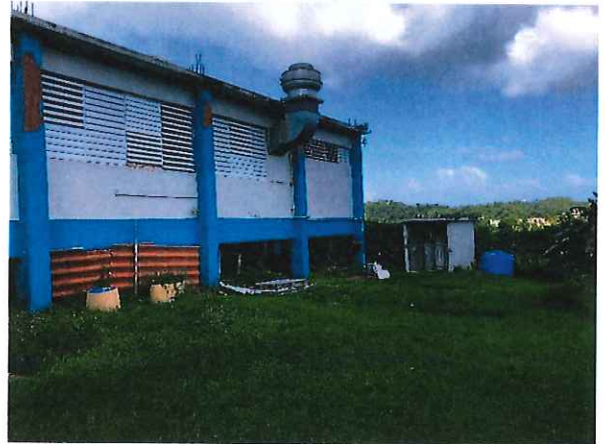
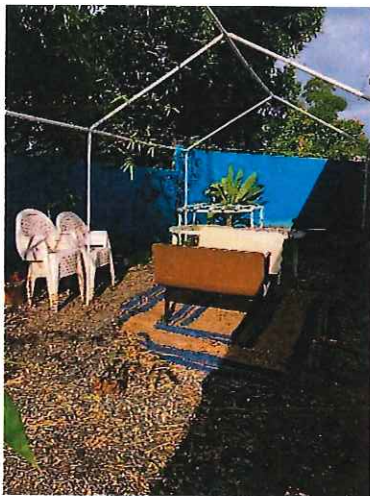
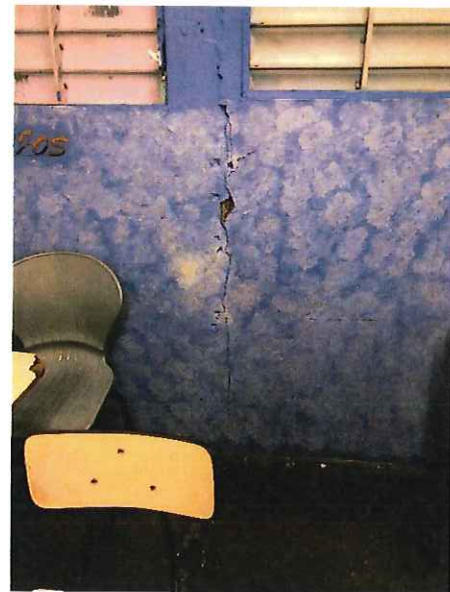
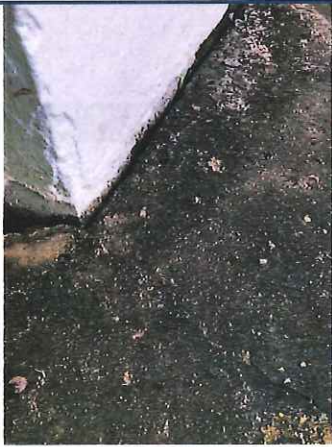
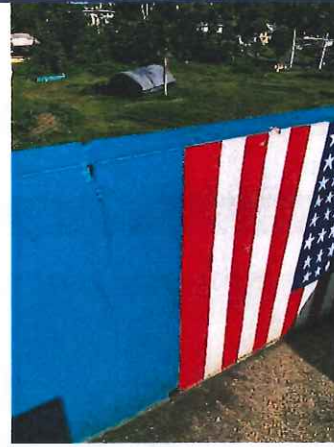
PHOTOS

Se verificaron los elementos estructurales del primer y segundo nivel según sea el caso por edificio. En el momento de la inspección se encontró grieta localizada en la loza de piso continuando a una de las columnas del edificio "C" comprometiendo su integridad estructural. Se encontró inclinación y grieta en la verja de perímetro al noreste del mencionado edificio. Se recomienda no ocupar dicho edificio y áreas aledañas a la mencionada verja de perímetro.
