Escuela: Manuel Elizalde

## GENERAL EARTHQUAKE DAMAGE INSPECTION CHECKLIST

1. Street Address of the school: Calle Madison Res. Las Casas  
City: San Juan State: Puerto Rico Zip: \_\_\_\_\_
2. School Name: Manuel Elzaburu y Vizcarrondo
3. Date of inspection: 17 de enero de 2020
4. Inspector's Name: José A. Cora Rodríguez / José Gaya Gil - Supervisor / Raul Gaya - Inspector

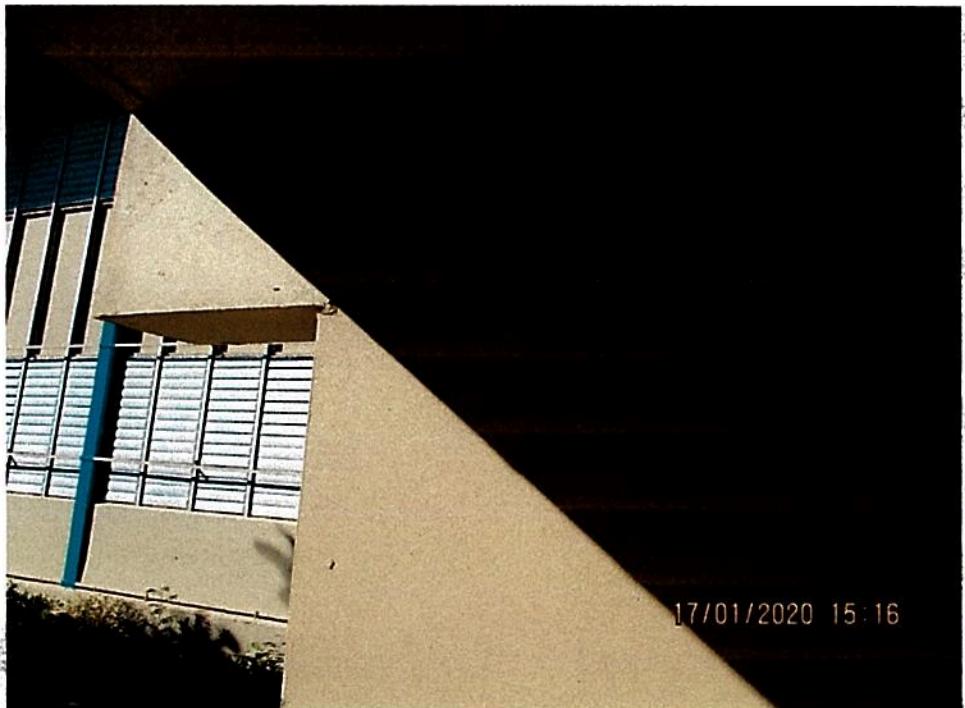
IMG\_3177

2. Grieta en pared de bloque localizada en cuarto de cisterna construido debajo de rampa de acceso. Dicha construcción fue realizada posteriormente a la construcción original de la estructura. Condición preexistente. Se recomienda reparar el empaquetado. Ver foto IMG\_3178 y IMG\_3177.

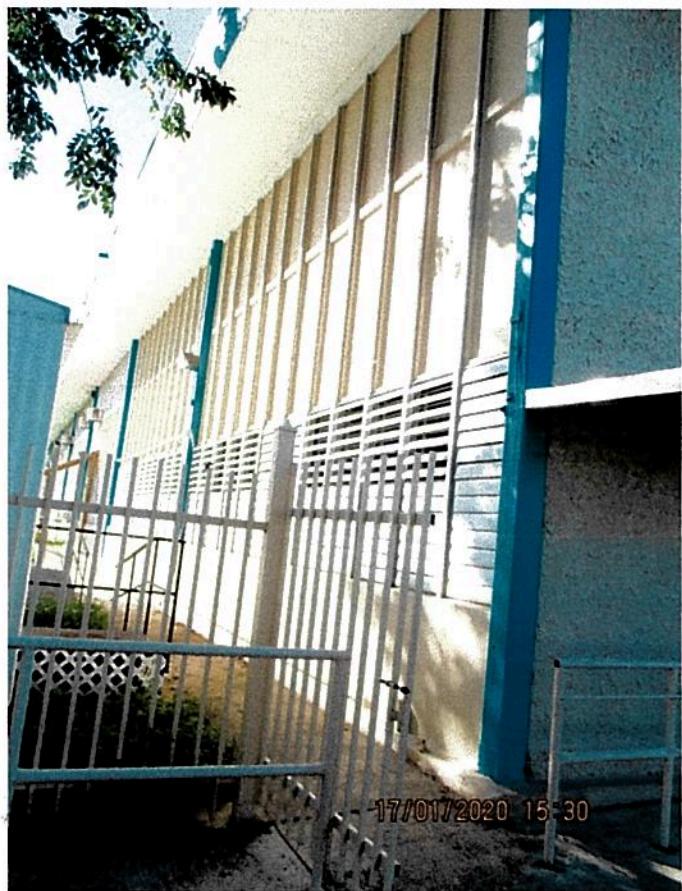
No se encontró daño estructural luego del terremoto a la fecha de inspección del 17 de enero de 2020 hora 5:00pm. No obstante en la base de columna de acero de la estructura principal se observó un serio deterioro por corrosión en dicha sección. Esta condición preexistente compromete la estabilidad y seguridad de la estructura en un evento sísmico o de viento. Por lo que se recomienda el cierre de este plantel hasta que se realice dicha reparación.

4. Base de columna de acero corroída localizada en esquina de estructura principal. Condición preexistente. No relacionado con el terremoto. Se recomienda reparar y reforzar la sección. Ver foto IMG\_3227 y IMG\_3234.

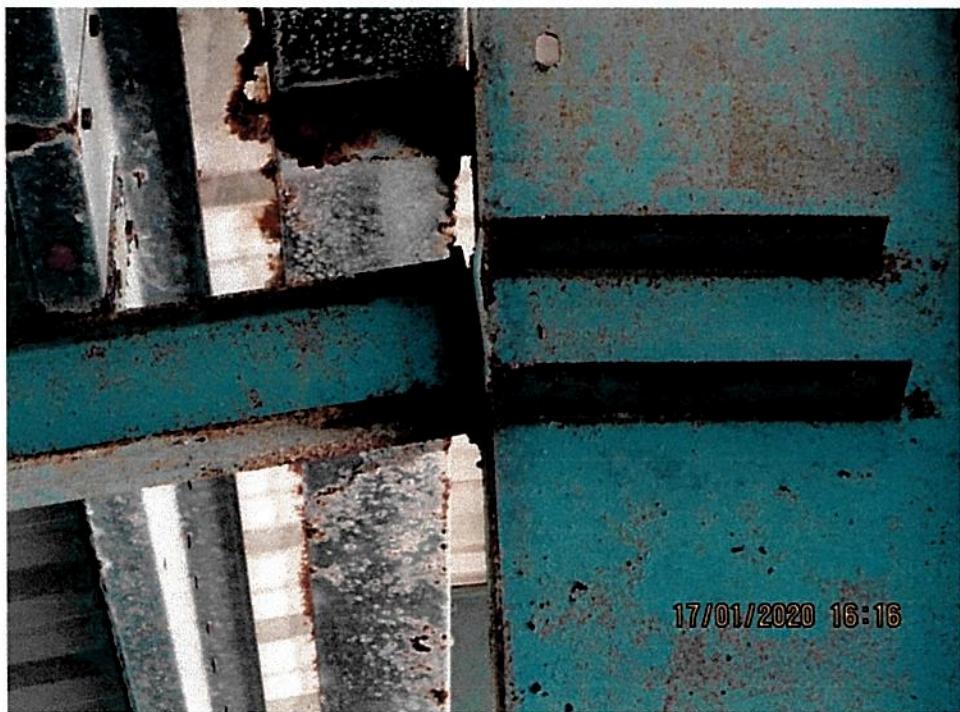
IMG\_3532

7. Cancha bajo techo. A) Bases de columnas de acero estructural seriamente corroídas. Ver foto IMG\_3539. B) Viga en techo en cantiléver. En las conexiones atornilladas se observan serios daños por corrosión lo cual están ocasionando el desplome del techo. Por las condiciones de daños por corrosión al acero recomendamos por seguridad el cierre de esta área. Indicamos que estos son condiciones preexistentes no relacionadas con el terremoto. Ver foto IMG\_3532.
